## 1. General information

Location Plan:		Stonehaven coastal defences Assessment Date: 14/05/2018

# COASTAL ASSET CONDITION SURVEY REPORT

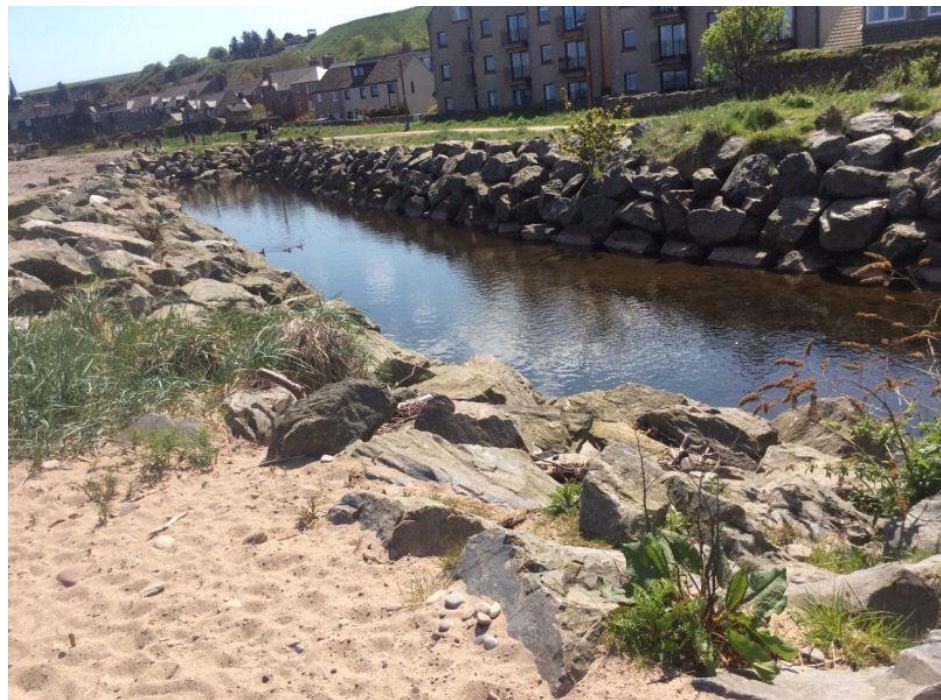
**Description:** View of Section F (looking south)  
Asset Type: Defence  
Sub Type: Embankment  
Elements: Beach and rock armour  
**Photo number: 8**

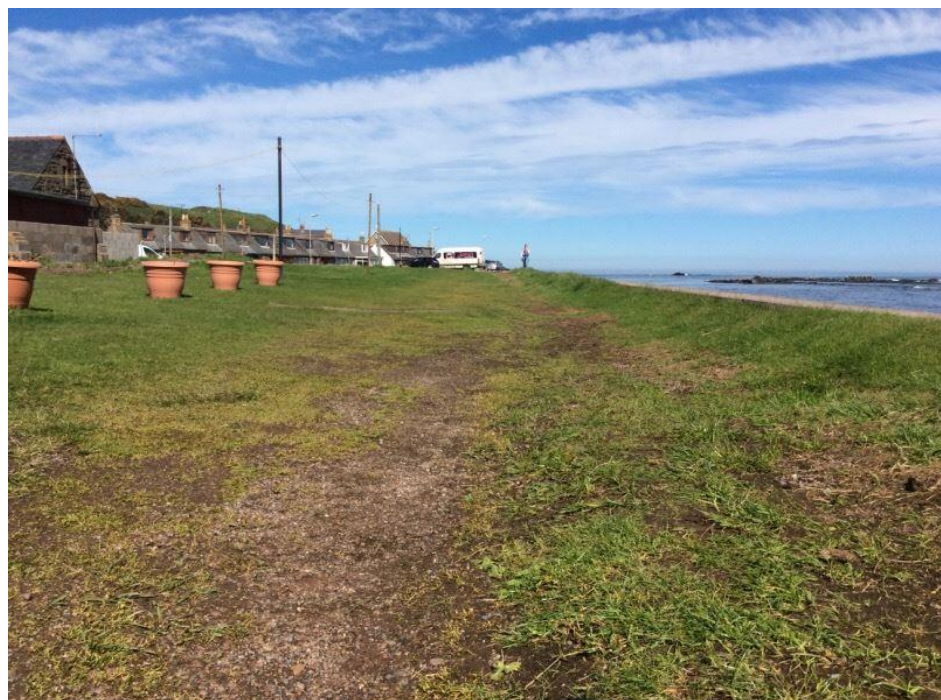
Defect Ref No.	Defect Location (NGR)	Sub Type	Element	Photo Ref	Defect Description	Recommendations	Defect Priority
D1	387886, 786644	Wall	Crest	63	Poorly vegetated / worn crest.	Resurface vegetated crest.	29
D2	387867, 786632	Wall	Crest	64	Depression of crest.	Resurface vegetated crest.	29
D3	387925, 786664	Wall	Exposed face	48	Cracked and spalling concrete between wall types	Repoint / patch repair damaged concrete.	5
D4	387925, 786663	Wall	Exposed face	49	Spalling concrete approximately 1 x 0.3m.	Consider refacing spalling repairs.	13
D5	387904, 786656	Wall	Exposed face	50	Broken flap valve	Replace flap valve.	21
D6	387903, 786654	Wall	Exposed face	51	Loss of cover exposing corroded steel evenly spaced in the frontage.	Breakout and repair corroded area.	23
D7	387898, 786648	Wall	Exposed face	52	No. 12 missing flap valves.	Consider installing flap valves.	21
D8	387891, 786642	Wall	Exposed face	53	Spalling of concrete along the construction joint.	Reface spalling concrete.	6

**Section B  
Crest  
Defect Ref: D2  
Description: D2 -  
Depression of crest  
Photo number: 64**

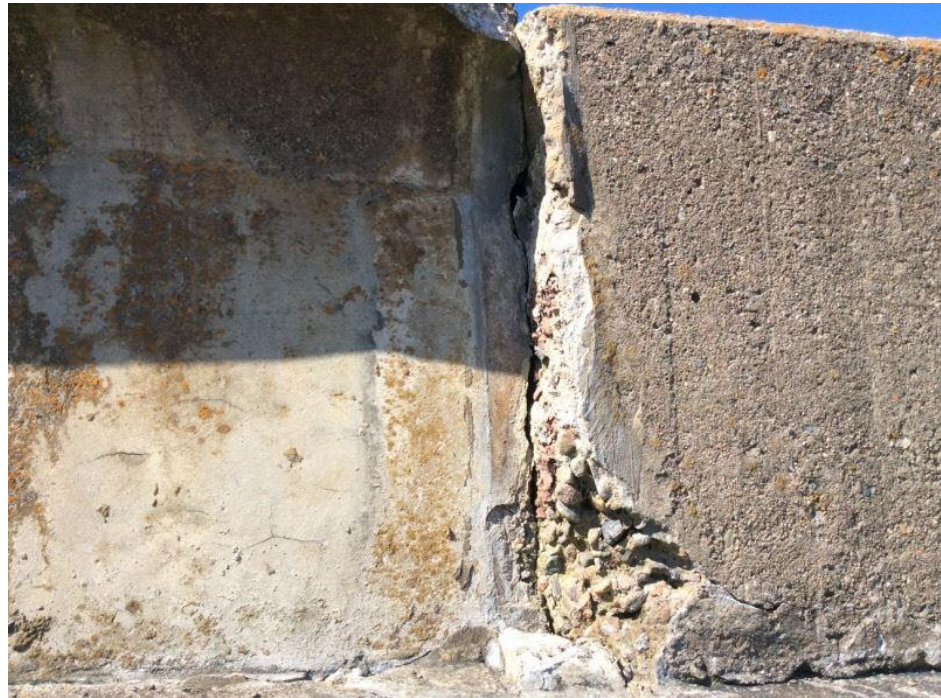
**Section B**  
**Exposed face**  
**Defect Ref: D3**  
**Description: D3 -**  
Cracked and spalling  
concrete  
**Photo number: 48**

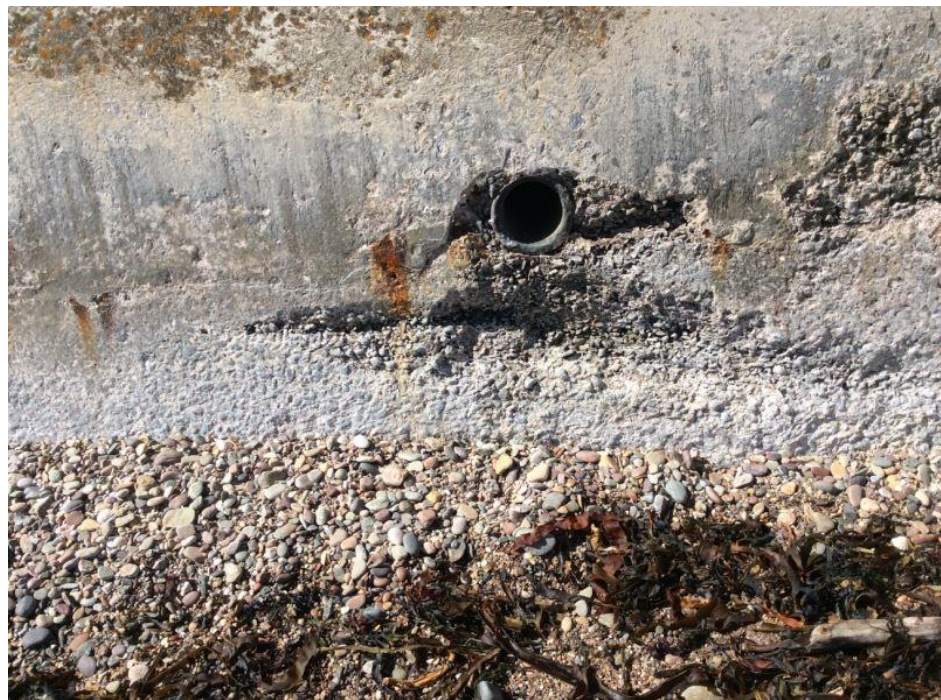
**Section B**  
**Exposed face**  
**Defect Ref: D4**  
**Description: D4 -**  
Spalling concrete  
**Photo number: 49**

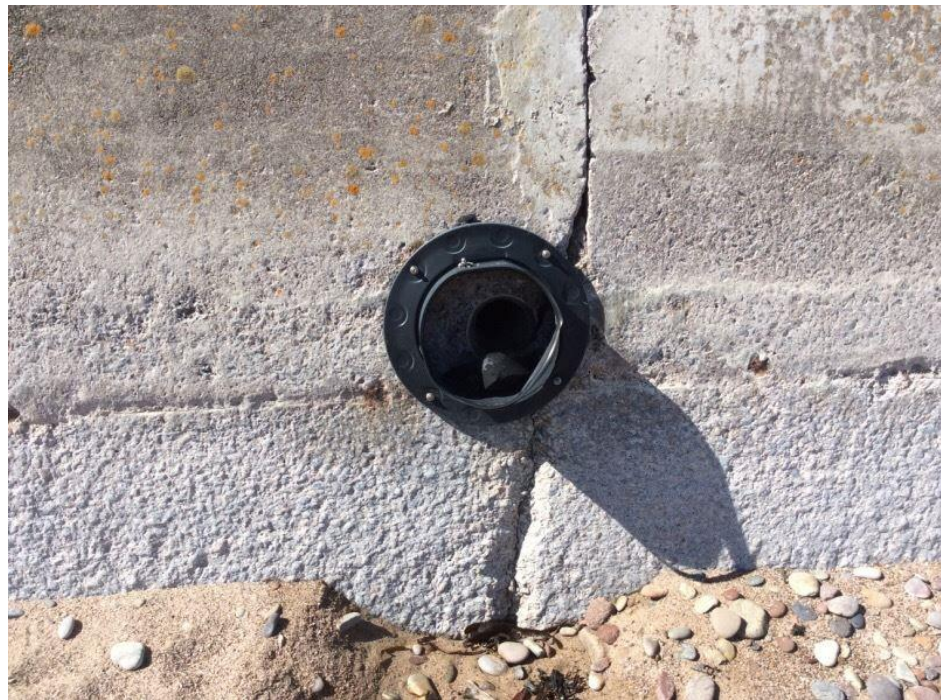
**Section B**  
**Exposed face**  
**Defect Ref: D5**  
**Description: D5 -**  
**Broken flap valve**  
**Photo number: 50**

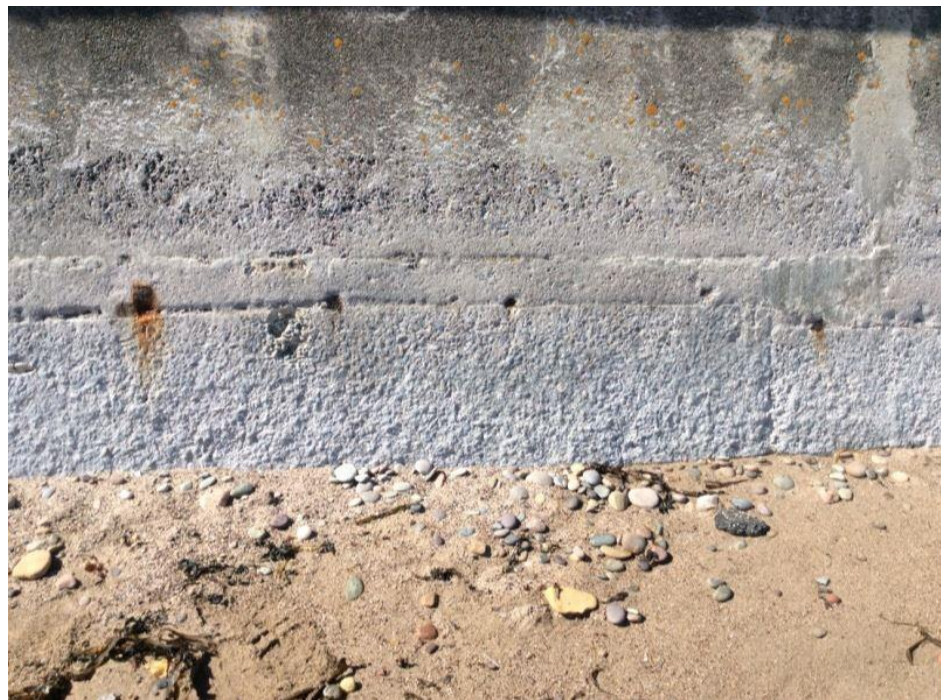
**Section B**  
**Exposed face**  
**Defect Ref: D6**  
**Description: D6 - Cover**  
**loss exposing corroded**  
**reinforcement**  
**Photo number: 51**

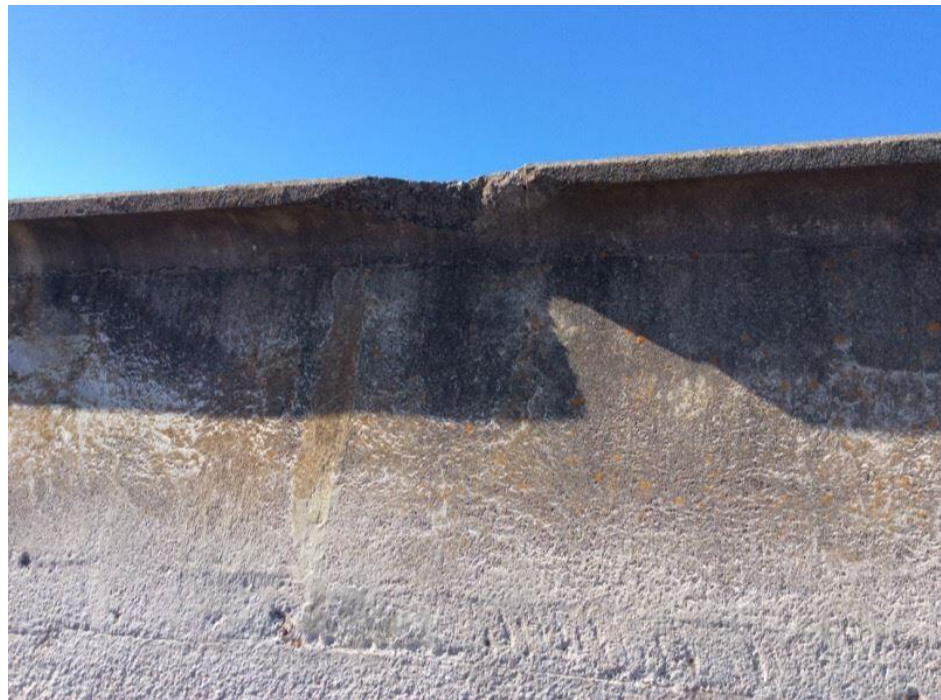
D9	387885, 786640	Wall	Exposed face	54	Damaged recurve approximately 0.5m x 0.3m.	Patch repair damaged recurve.	17
D10	387815, 786593	Wall	Exposed face	55	Damaged recurve approximately 0.3m long.	Patch repair damaged recurve.	17
D11	387809, 786587	Wall	Exposed face	56	Minor crack 1m long approx.	Repoint fracture and monitor wall for signs of movement.	18

**Section B**  
**Exposed face**  
**Defect Ref: D9**  
**Description: D9 -**  
**Damaged recurve**  
**Photo number: 54**

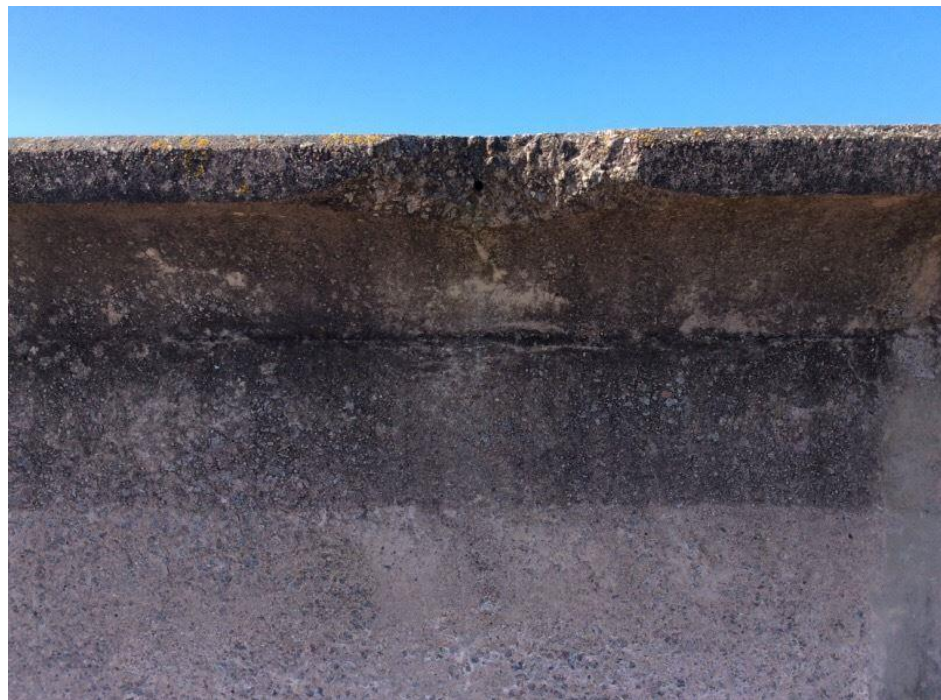
**Section B**  
**Exposed face**  
**Defect Ref: D10**  
**Description: D10 -**  
**Damaged recurve**  
**Photo number: 55**

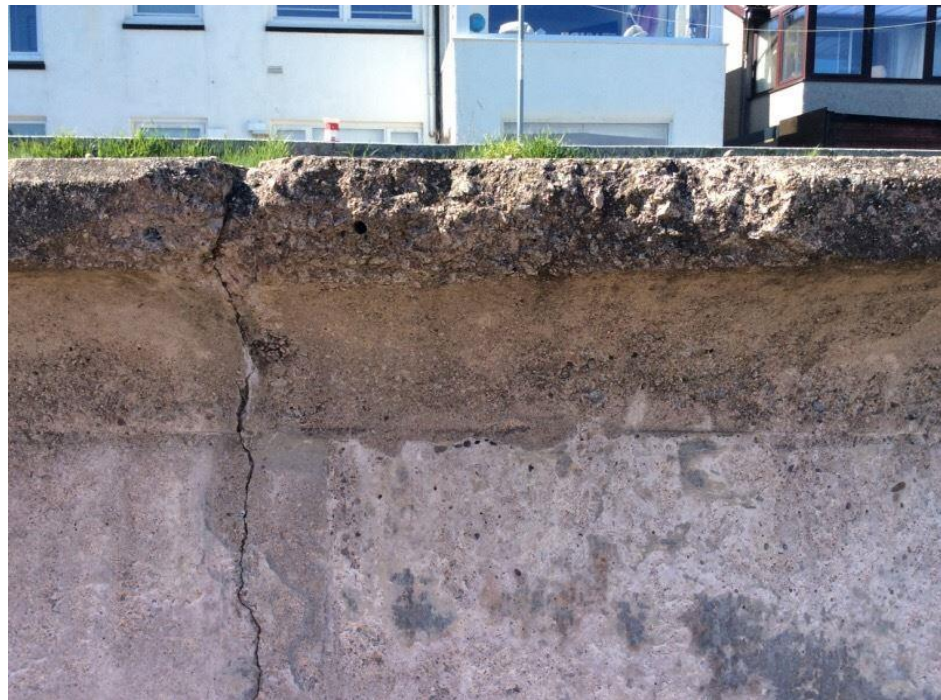
**Section B**  
**Exposed face**  
**Defect Ref: D13**  
**Description: D13 -**  
**Damaged recurve**  
**Photo number: 58**

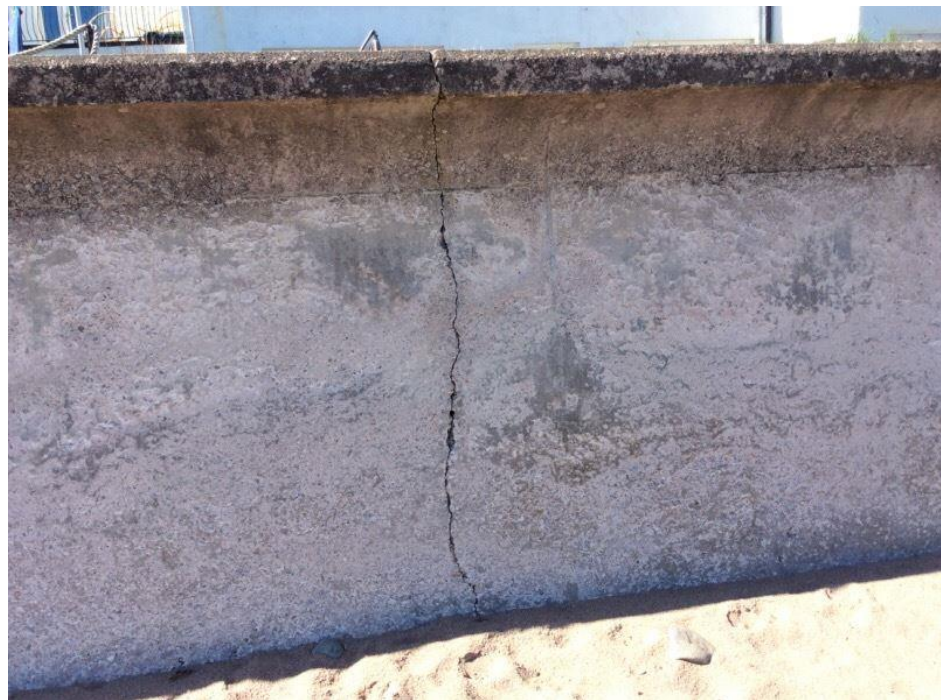
**Section B**  
**Exposed face**  
**Defect Ref: D14**  
**Description: D14 -**  
**Vertical crack**  
**Photo number: 59**

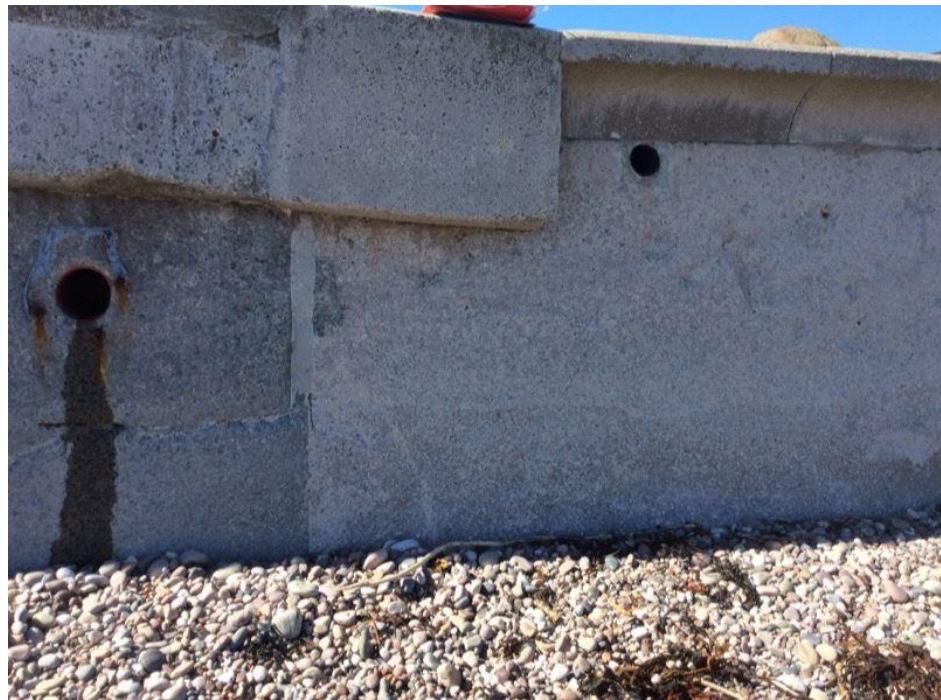
**Section B**  
**Exposed face**  
**Defect Ref: D17**  
**Description: D17 -**  
**Blocked drainage pipes**  
**Photo number: 62**

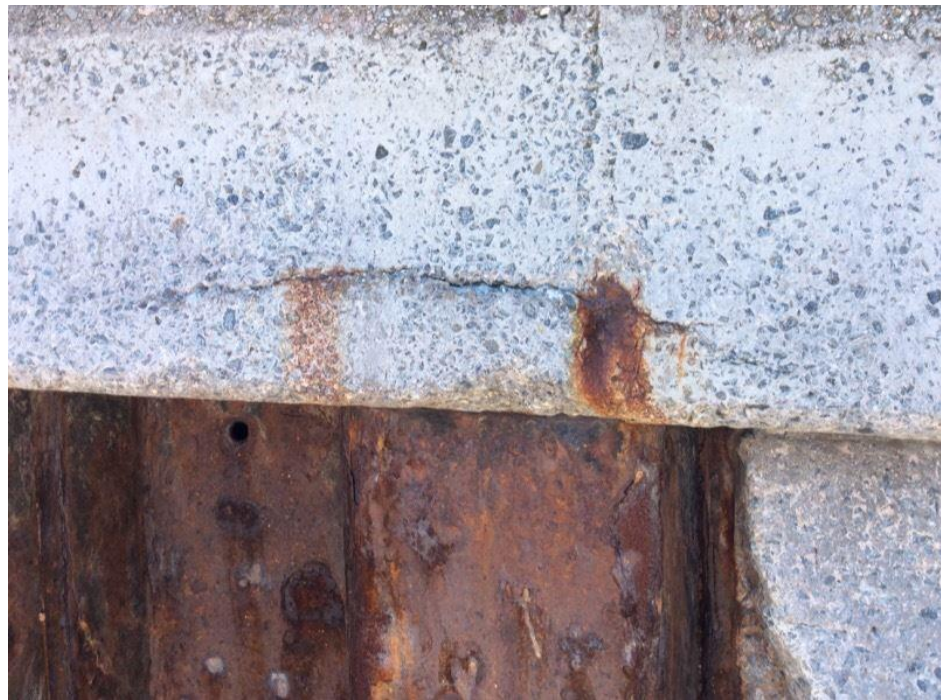
D19	387725, 786516	Wall	Exposed face	66	Cracking in the capping beam approximately 0.5m long.	Repoint crack.	18
D20	387719, 786511	Wall	Exposed face	67	Section loss of sheet piles.	Monitor and undertake further survey to determine pile thickness. Consider replacing sheet piles with an alternative coastal defence solution.	1
D21	387714, 786507	Wall	Exposed face	68	Cracking in the capping beam.	Repoint crack.	11
D22	387714, 786501	Embankment	Exposed face	69	Missing handrailing.	Replace timber handrails with a more durable solution.	1
D23	387714, 786503	Embankment	Exposed face	70	Corroded handrailing support.	Replace timber handrails with a more durable solution.	19

**Section B**  
**Exposed face**  
**Defect Ref: D19**  
**Description:** D19 -  
Cracking in the capping  
beam  
**Photo number: 66**

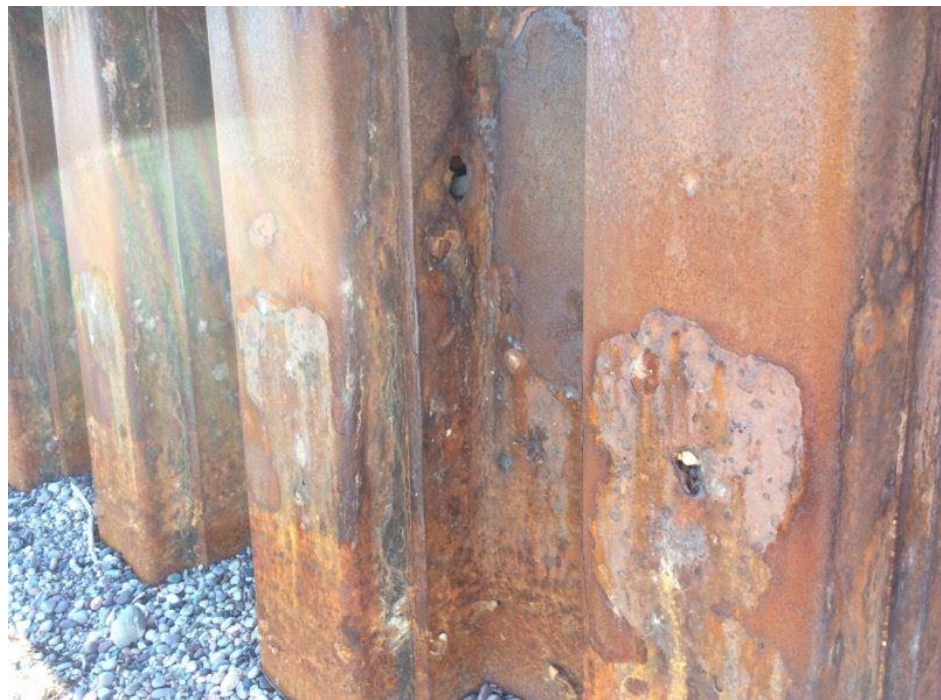
**Section B**  
**Exposed face**  
**Defect Ref: D20**  
**Description:** D20 -  
Section loss of sheet  
piles  
**Photo number: 67**

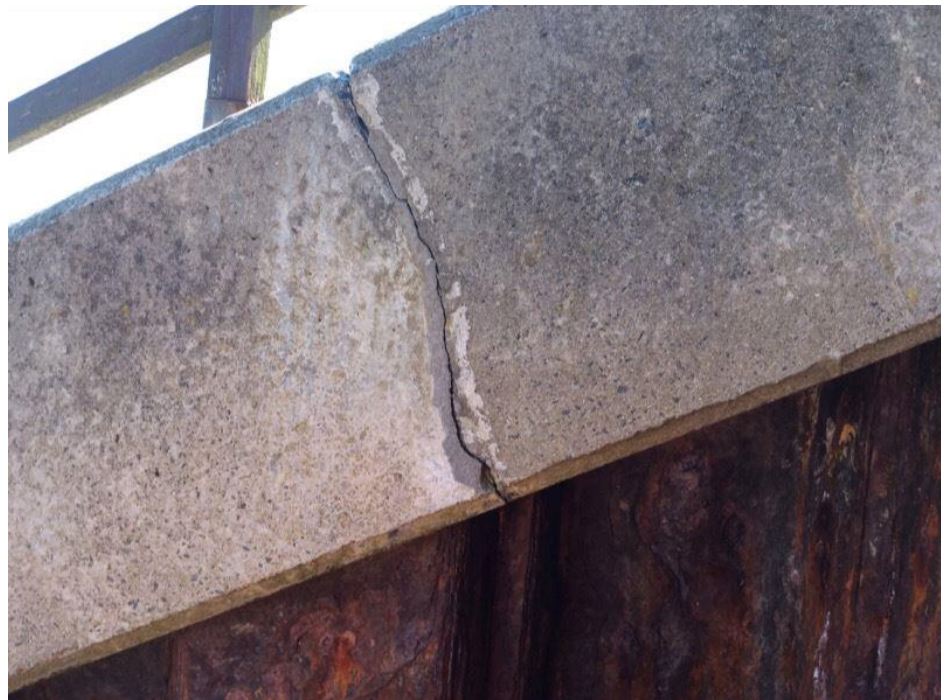
**Section B**  
**Exposed face**  
**Defect Ref: D21**  
**Description: D21 -**  
Crack in the capping  
beam  
**Photo number: 68**

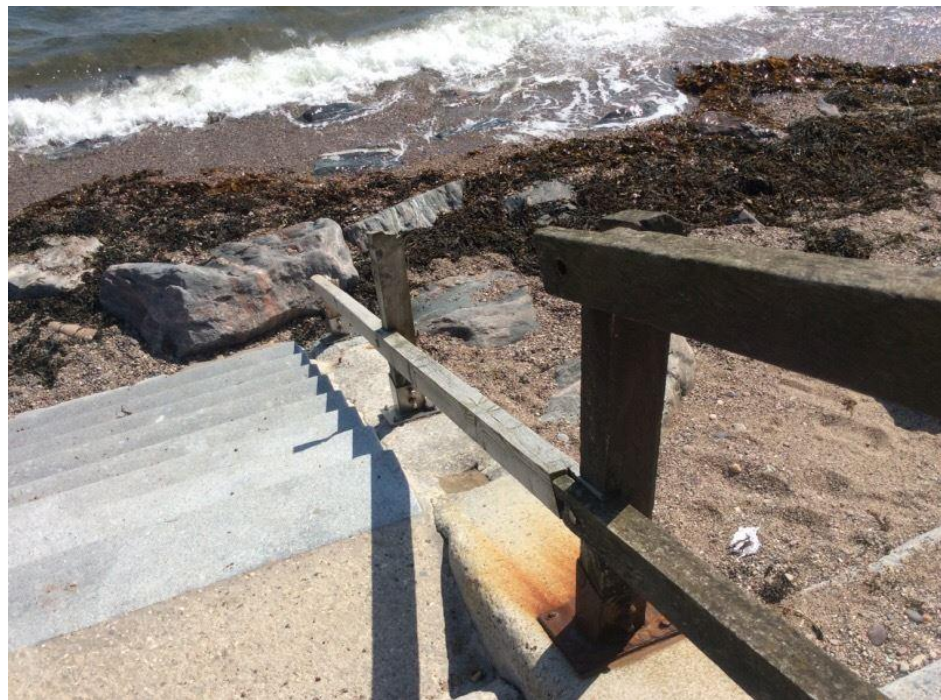
**Section C**  
**Exposed face**  
**Defect Ref: D22**  
**Description: D22 -**  
Missing handrailing  
**Photo number: 69**

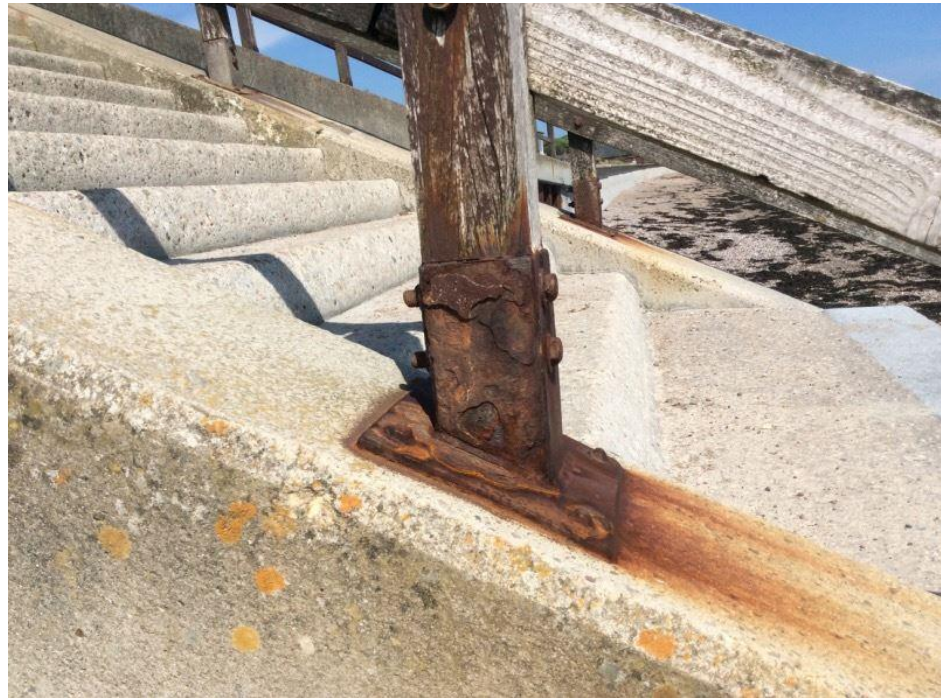
**Section C**  
**Exposed face**  
**Defect Ref: D23**  
**Description:** D23 - Corroded handrailing support.  
**Photo number: 70**

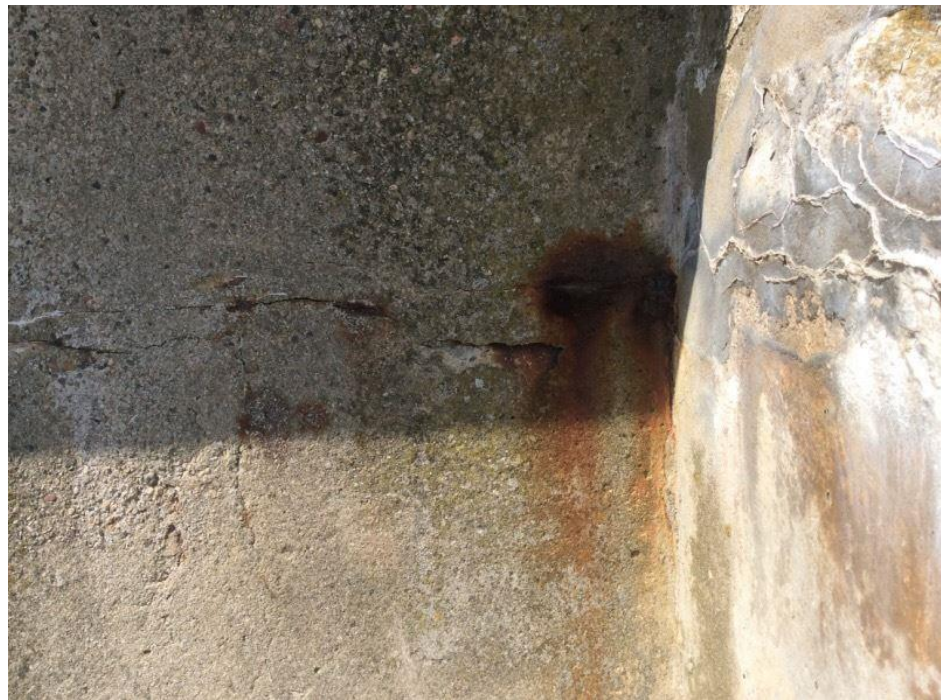
**Section C**  
**Splash wall**  
**Defect Ref: D25**  
**Description: D25 -**  
Corroded reinforcement  
**Photo number: 72**

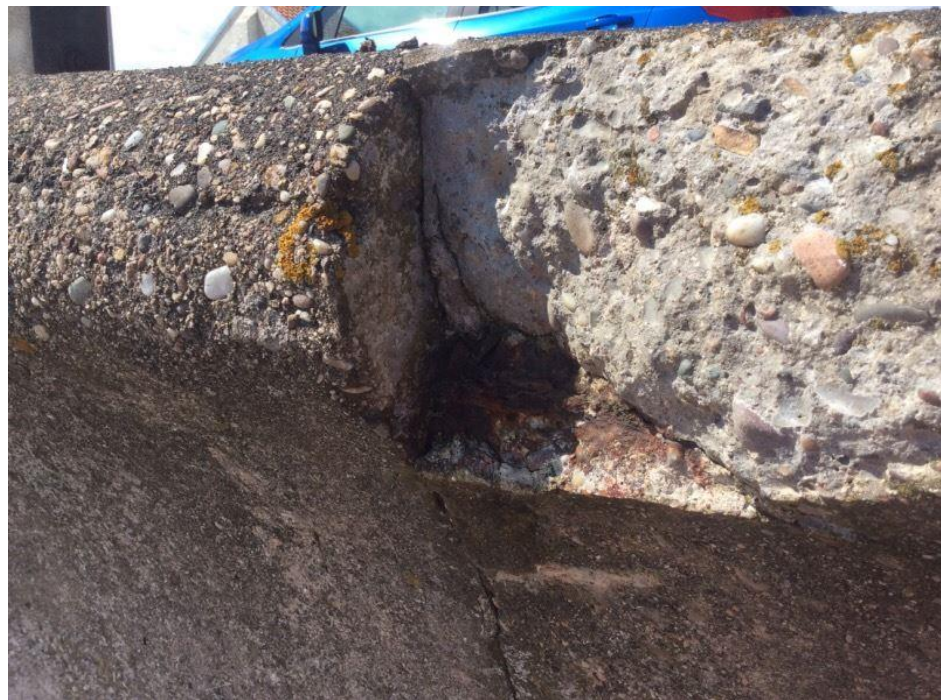
**Section C**  
**Splash wall**  
**Defect Ref: D26**  
**Description: D26 -**  
Chipped concrete  
exposing reinforcement  
**Photo number: 73**

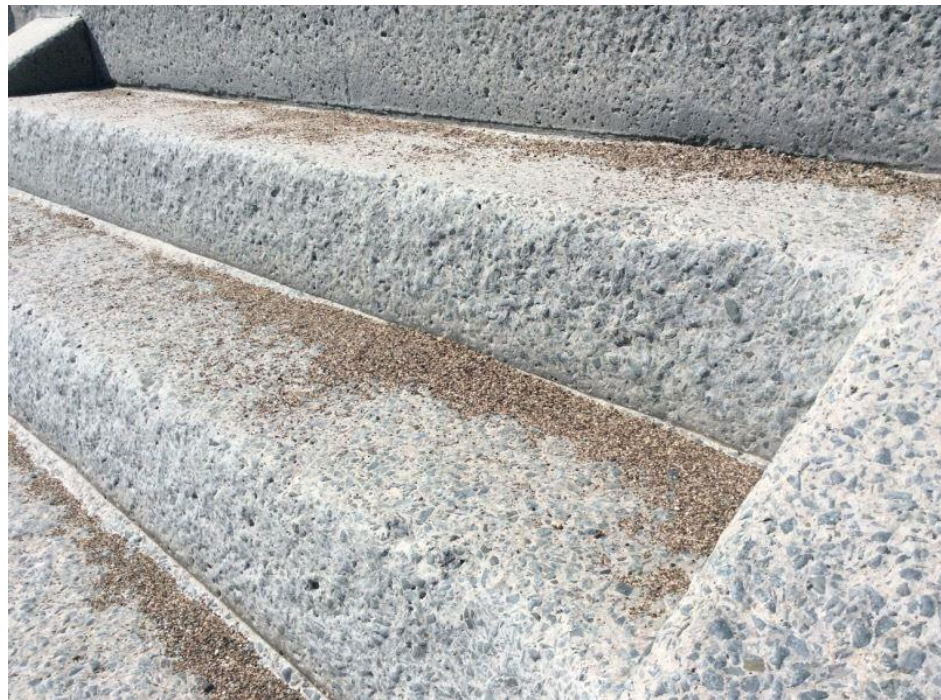
**Section C**  
**Splash wall**  
**Defect Ref: D27**  
**Description: D27 -**  
General abrasion of  
steps  
**Photo number: 74**

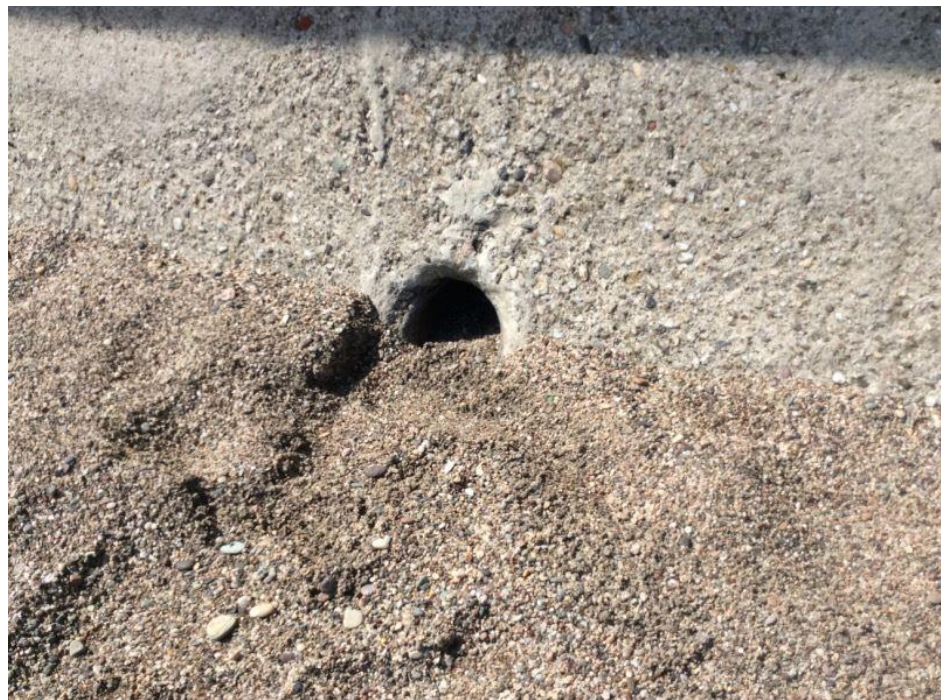
**Section C**  
**Splash wall**  
**Defect Ref: D34**  
**Description: D34 - 24 outfalls missing flap valves**  
**Photo number: 81**

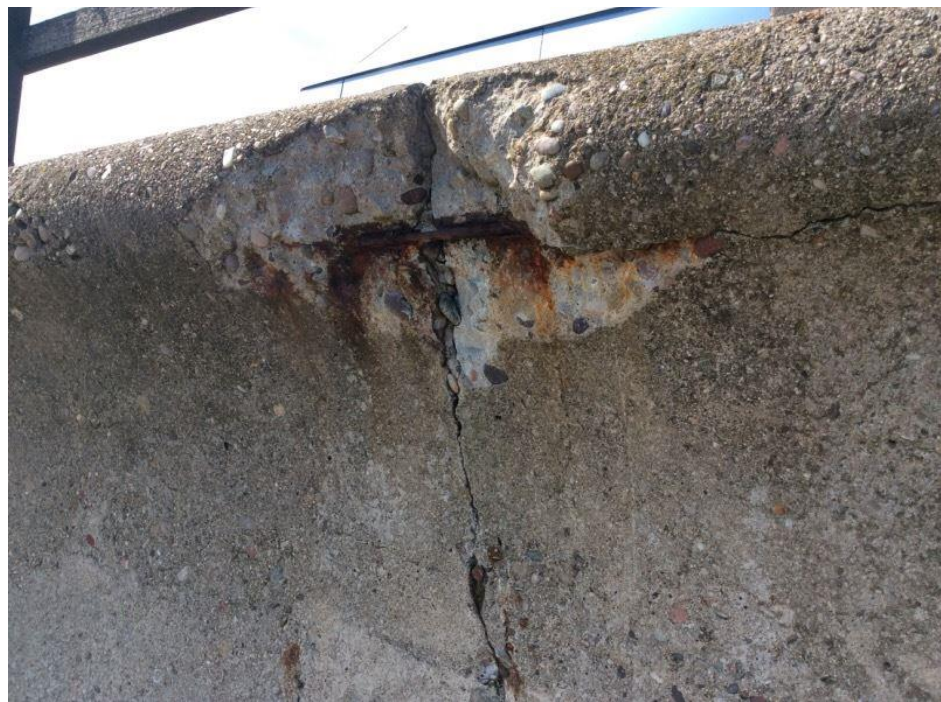
**Section C**  
**Splash wall**  
**Defect Ref: D35**  
**Description:** D35 - Loss of concrete exposing reinforcement  
**Photo number: 82**

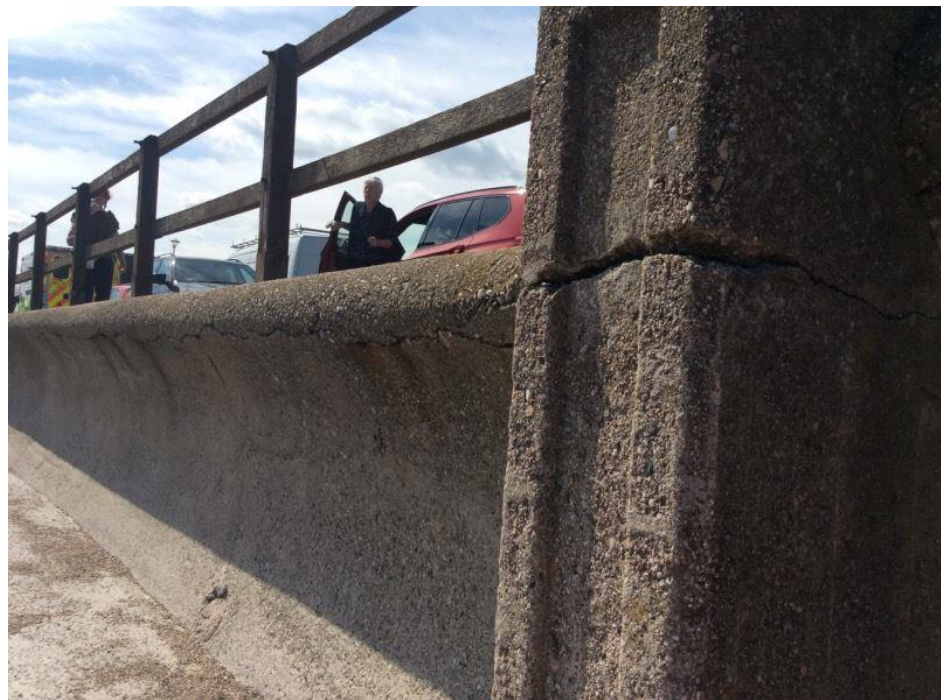
**Section C**  
**Splash wall**  
**Defect Ref: D36**  
**Description:** D36 - Horizontal crack on sea wall and buttress wall  
**Photo number: 83**

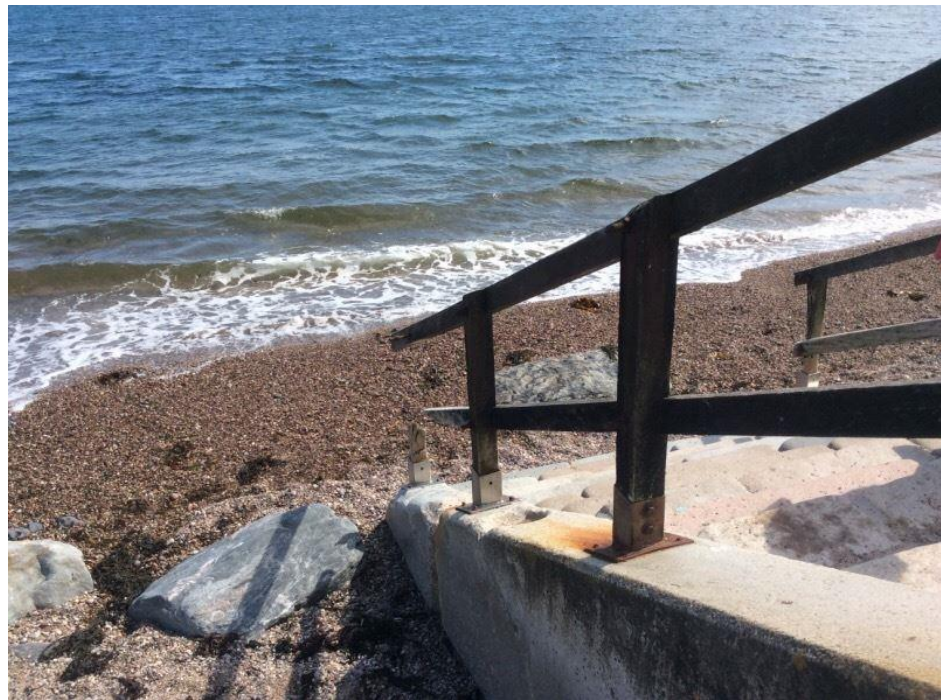
**Section C**  
**Splash wall**  
**Defect Ref: D39**  
**Description: D39 -**  
**Handrailing missing**  
**Photo number: 86**

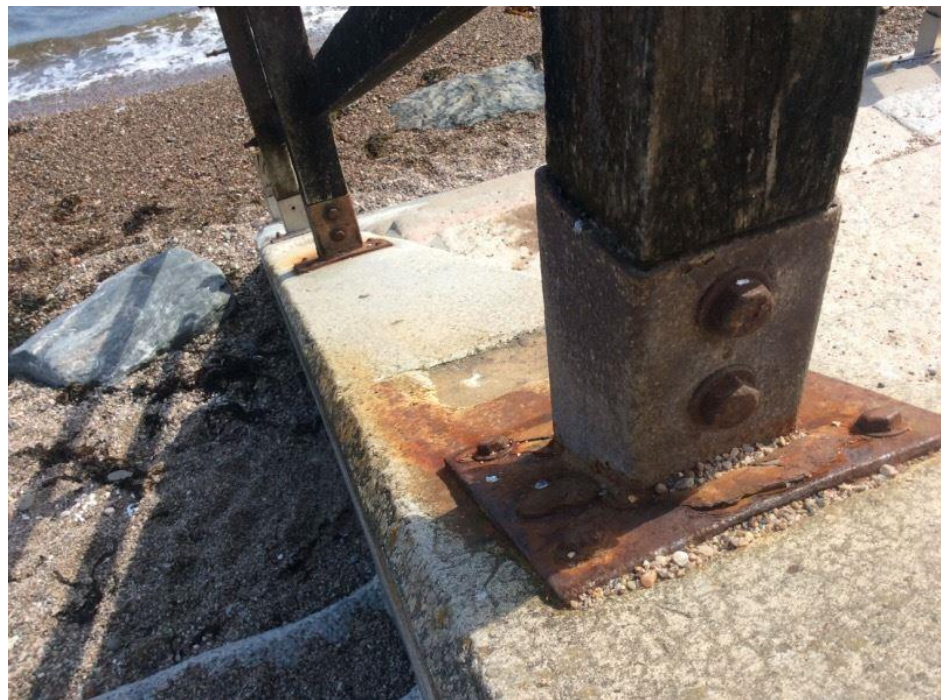
**Section C**  
**Splash wall**  
**Defect Ref: D40**  
**Description: D40 -**  
**Corroded handrail**  
**supports**  
**Photo number: 87**

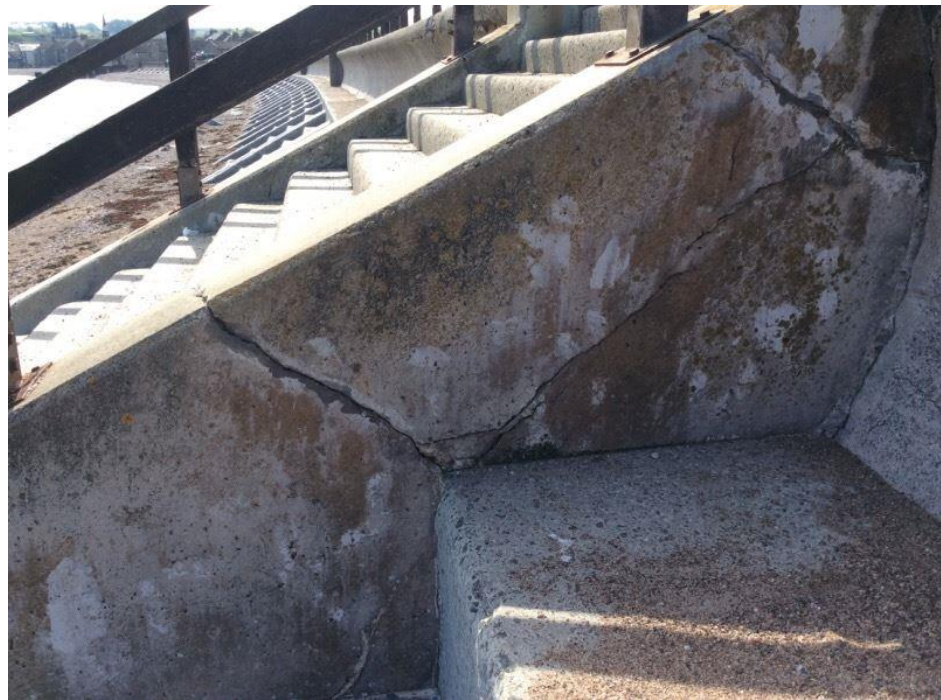
**Section C**  
**Splash wall**  
**Defect Ref: D41**  
**Description:** D41 -  
Cracks in concrete on  
steps  
**Photo number: 88**

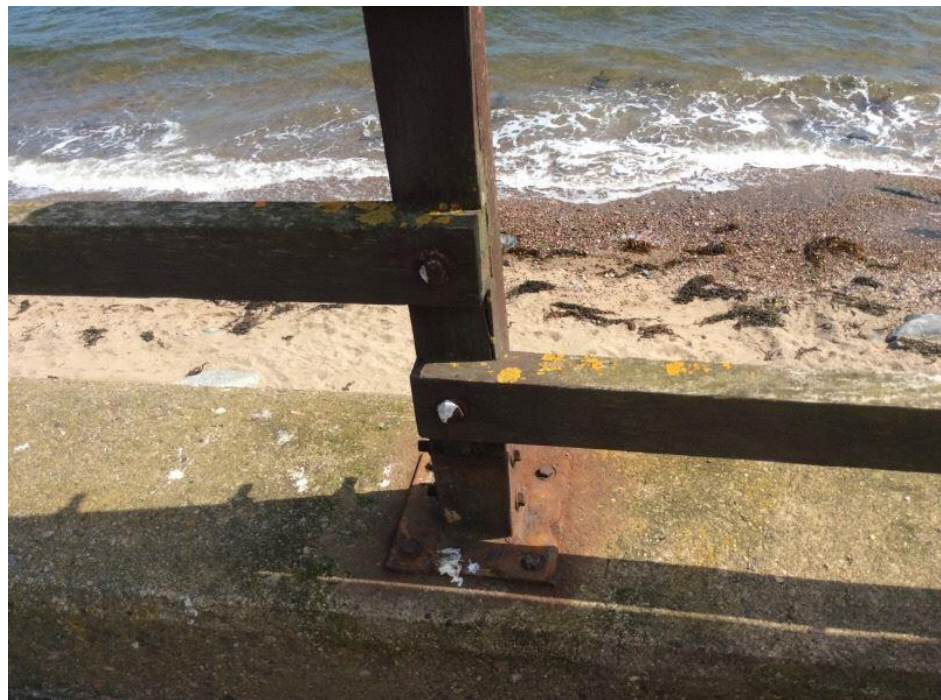
**Section C**  
**Splash wall**  
**Defect Ref: D42**  
**Description:** D42 -  
Corroded handrail  
supports  
**Photo number: 89**

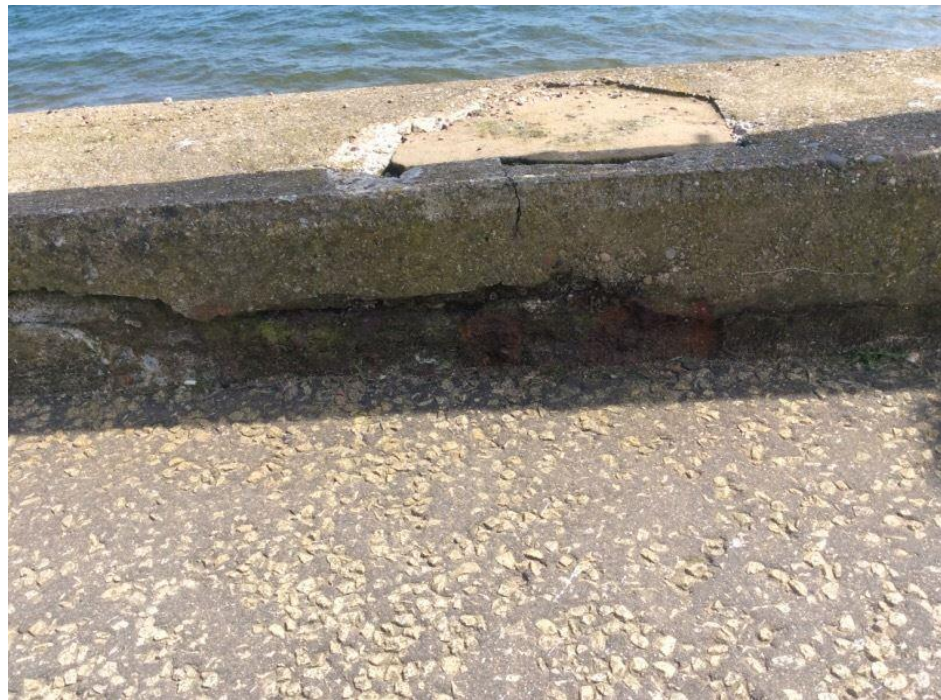
**Section C**  
**Splash wall**  
**Defect Ref: D43**  
**Description: D43 -**  
Cover loss and corroding  
reinforcement  
**Photo number: 90**

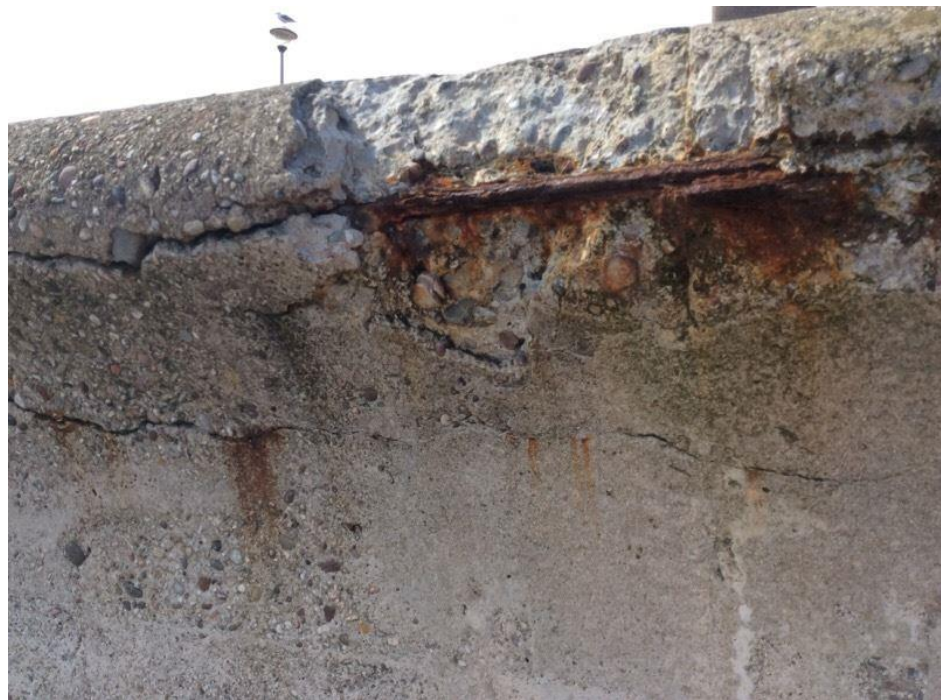
**Section C**  
**Splash wall**  
**Defect Ref: D44**  
**Description: D44 -**  
Crack exposing  
corroding reinforcement  
**Photo number: 91**

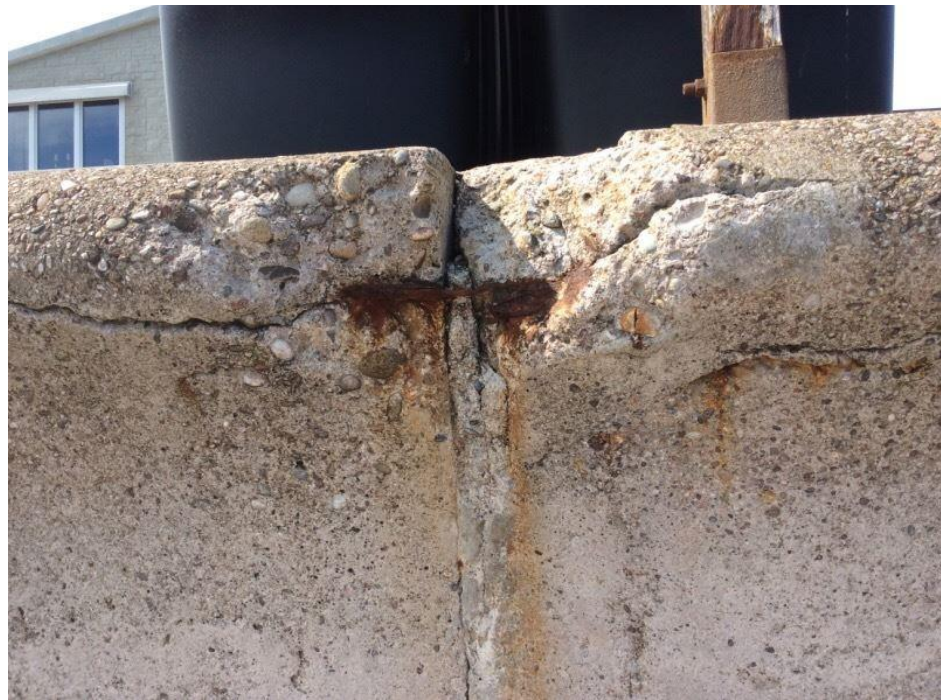
**Section C**  
**Splash wall**  
**Defect Ref: D45**  
**Description: D45 -**  
Chipped concrete  
exposing reinforcement  
**Photo number: 92**

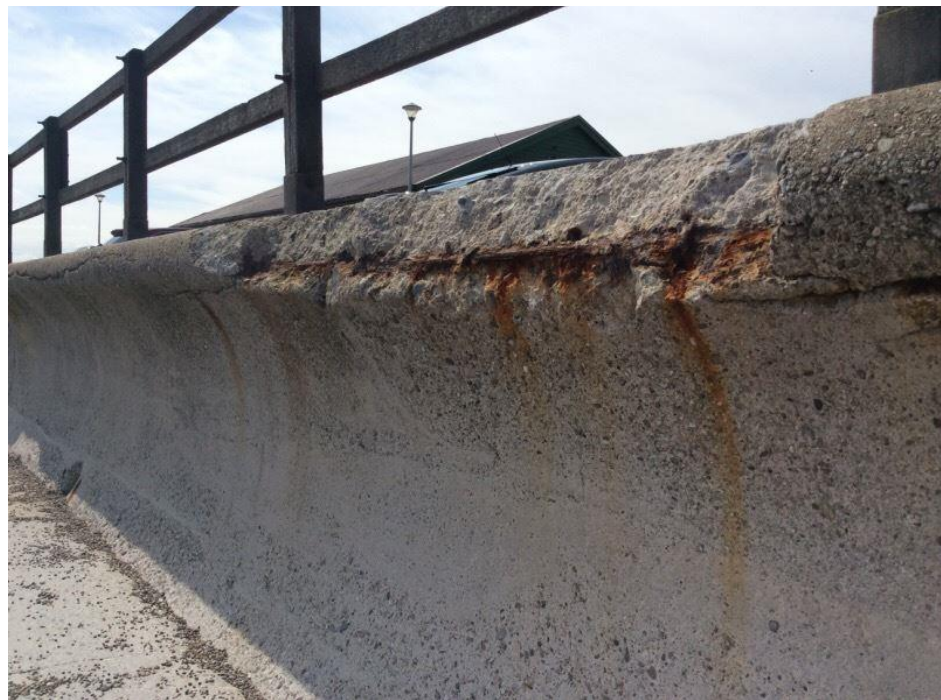
**Section C**  
**Splash wall**  
**Defect Ref: D46**  
**Description: D46 -**  
Chipped concrete  
exposing reinforcement  
**Photo number: 93**

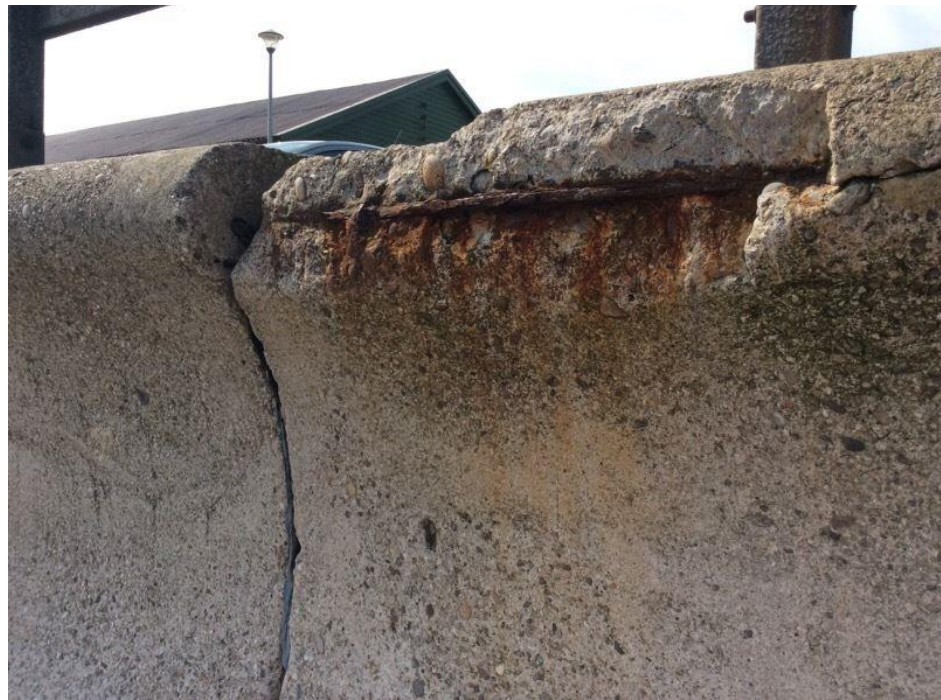
**Section C**  
**Splash wall**  
**Defect Ref: D47**  
**Description: D47 -**  
Chipped concrete  
exposing reinforcement  
**Photo number: 94**

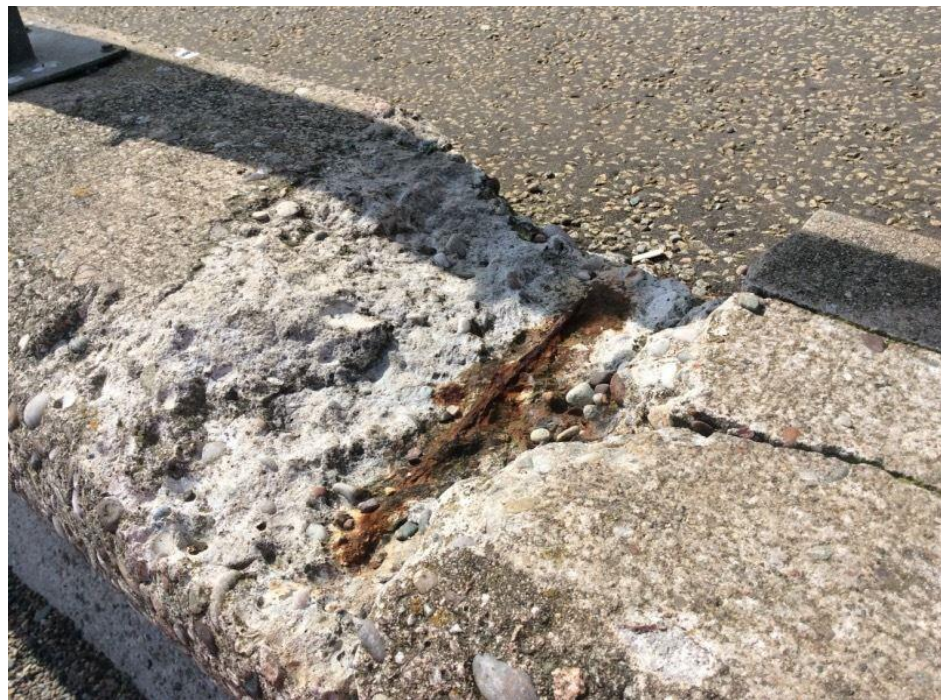
**Section C**  
**Splash wall**  
**Defect Ref: D48**  
**Description: D48 -**  
Chipped concrete  
exposing reinforcement  
**Photo number: 95**
