## 1. General information

Location Plan:		Stonehaven coastal defences Assessment Date: 14/05/2018

# COASTAL ASSET CONDITION SURVEY REPORT

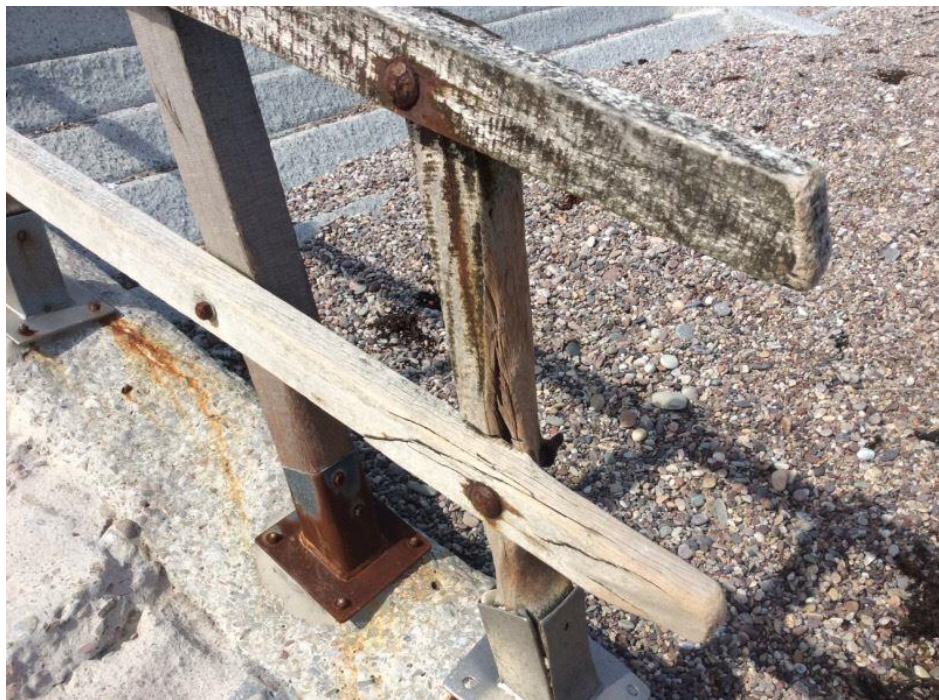
**Section C**  
**Splash wall**  
**Defect Ref: D52**  
**Description:** D52 - Signs of rot on timber handrailing  
**Photo number: 99**

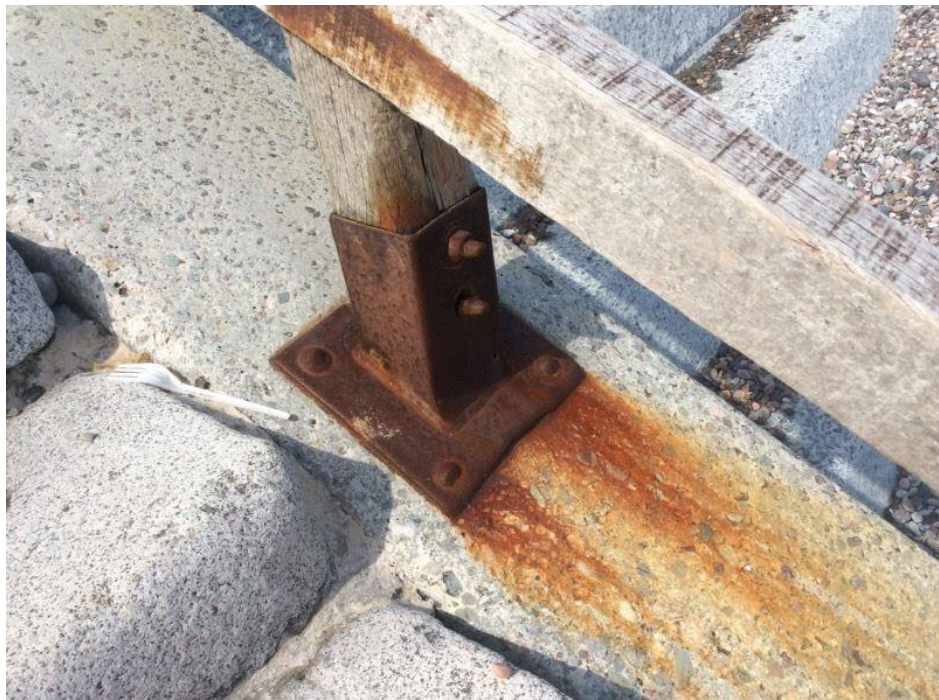
**Section C**  
**Splash wall**  
**Defect Ref: D53**  
**Description: D53 -**  
Corroded handrail  
supports  
**Photo number: 100**

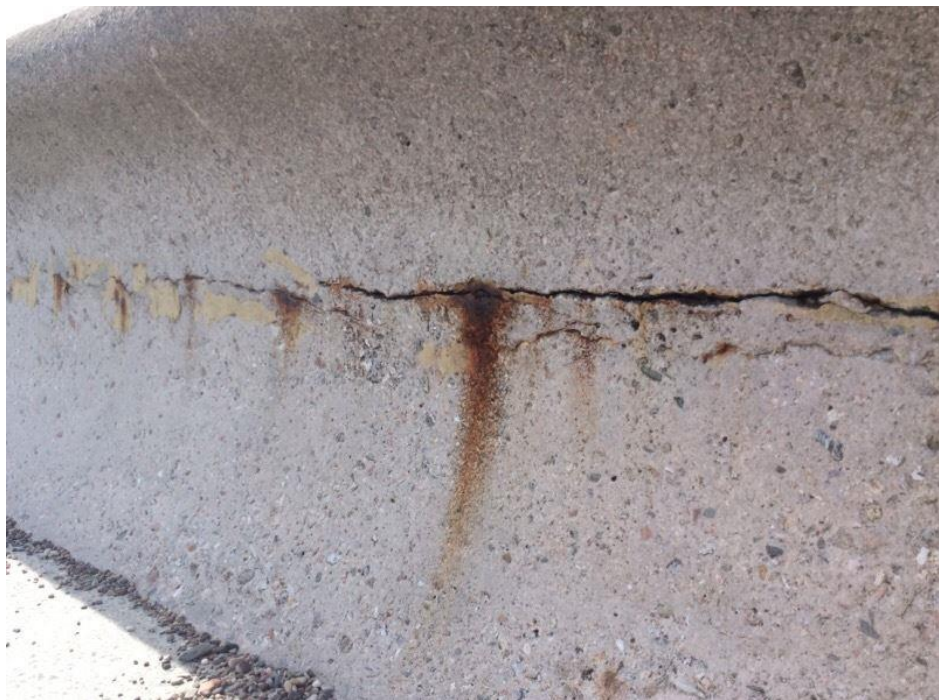
**Section C**  
**Splash wall**  
**Defect Ref: D54**  
**Description: D54 -**  
Horizontal crack in sea  
wall  
**Photo number: 101**

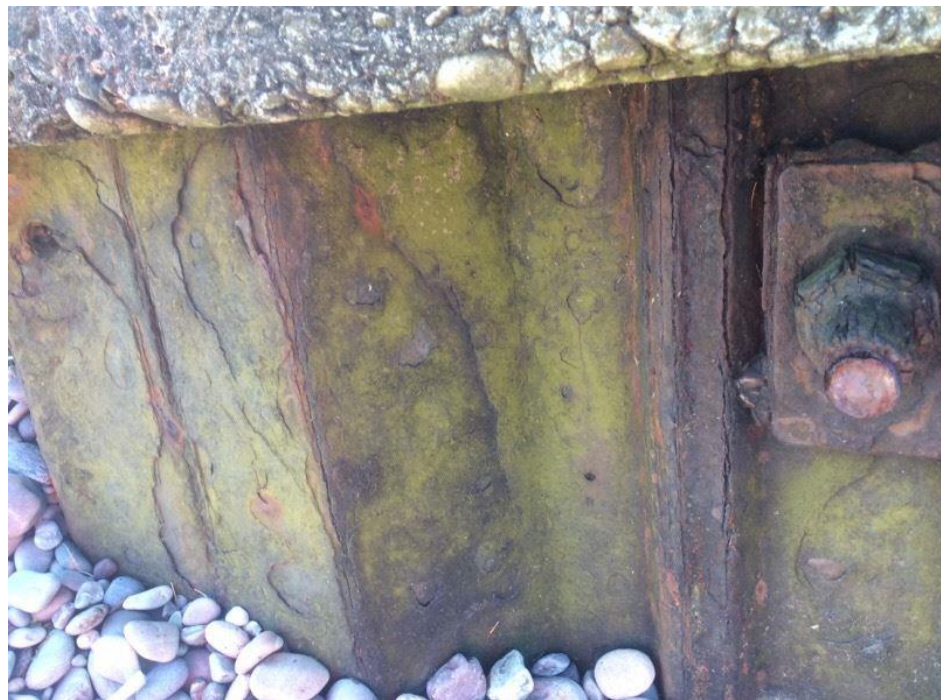
**Section D**  
**Piling**  
**Defect Ref: D58**  
**Description: D58 -**  
**Corrosion of piles**  
**Photo number: 105**

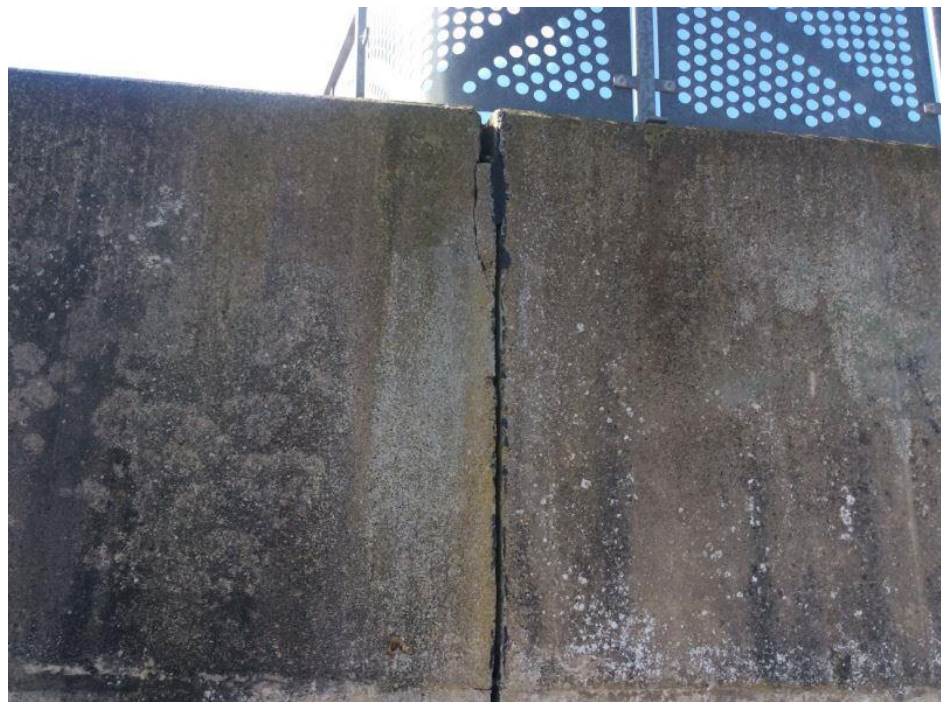
**Section D**  
**Exposed face**  
**Defect Ref: D66**  
**Description: D65 -**  
Cracked and broken  
concrete approximately  
0.5m  
**Photo number: 112**

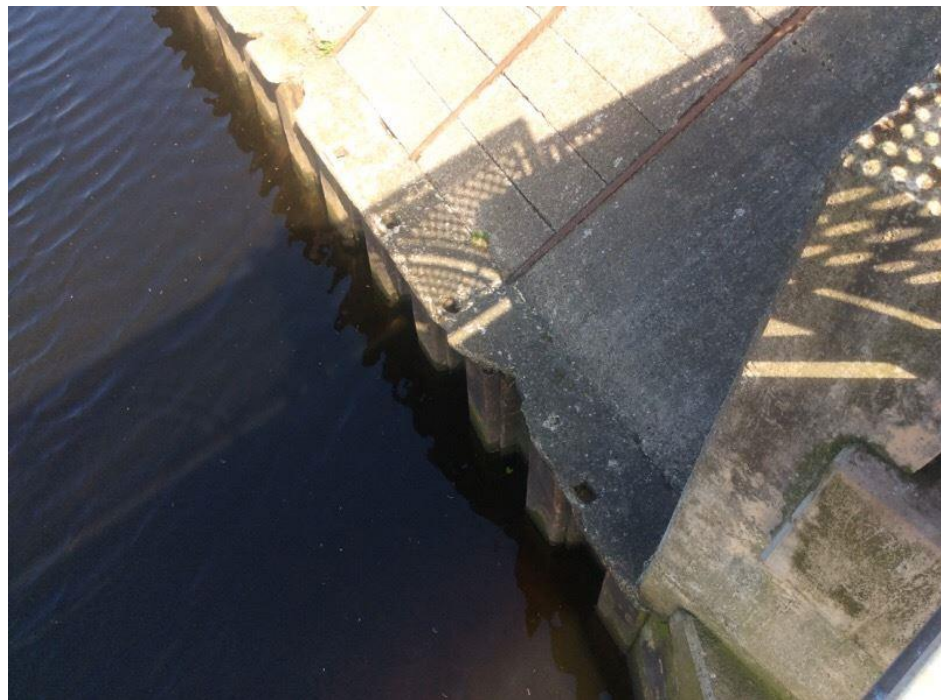
**Section D**  
**Piling**  
**Defect Ref: D67**  
**Description: D67 -**  
Chipped capping beam  
**Photo number: 113**

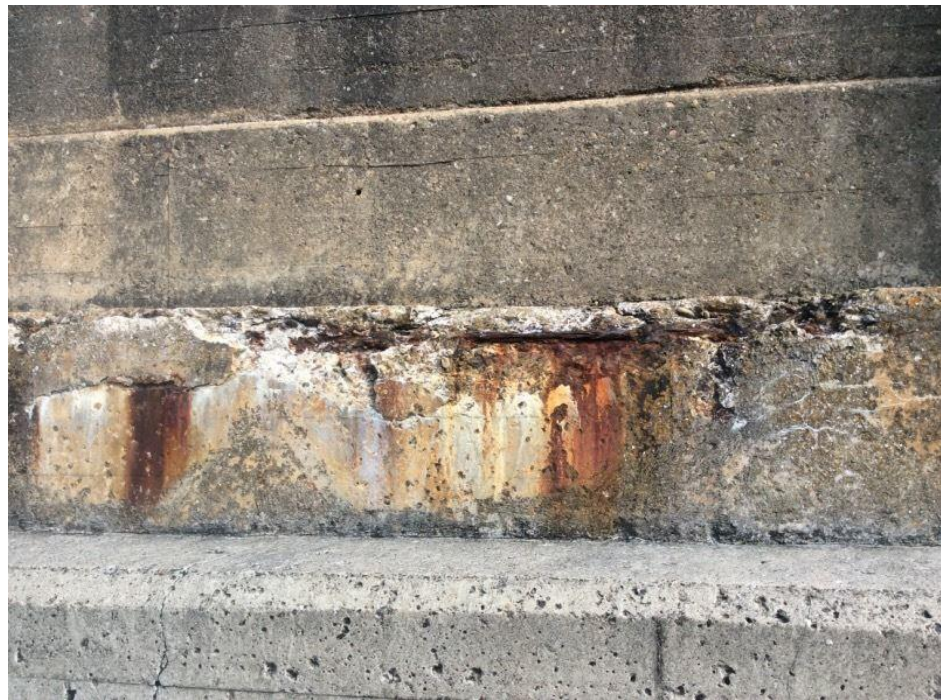
**Section D**  
**Exposed face**  
**Defect Ref: D70**  
**Description:** D70 -  
Damaged concrete  
approximately 1.5m long,  
exposing heavily  
corroded reinforcement  
**Photo number: 116**

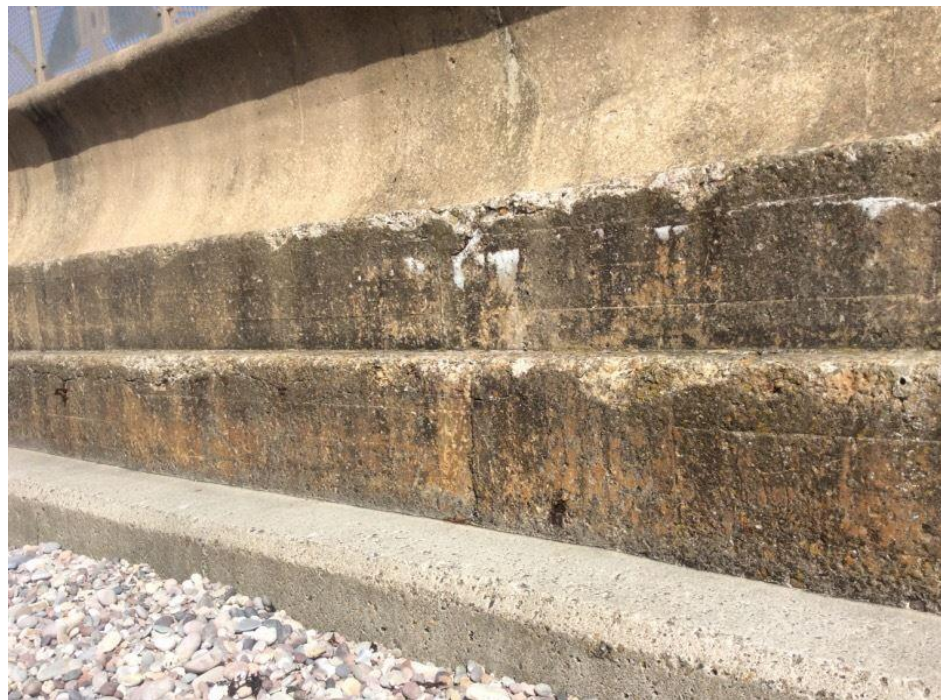
**Section D**  
**Exposed face**  
**Defect Ref: D71**  
**Description:** D71 -  
Chipping concrete and  
cracks along the river  
face of the wall  
**Photo number: 117**

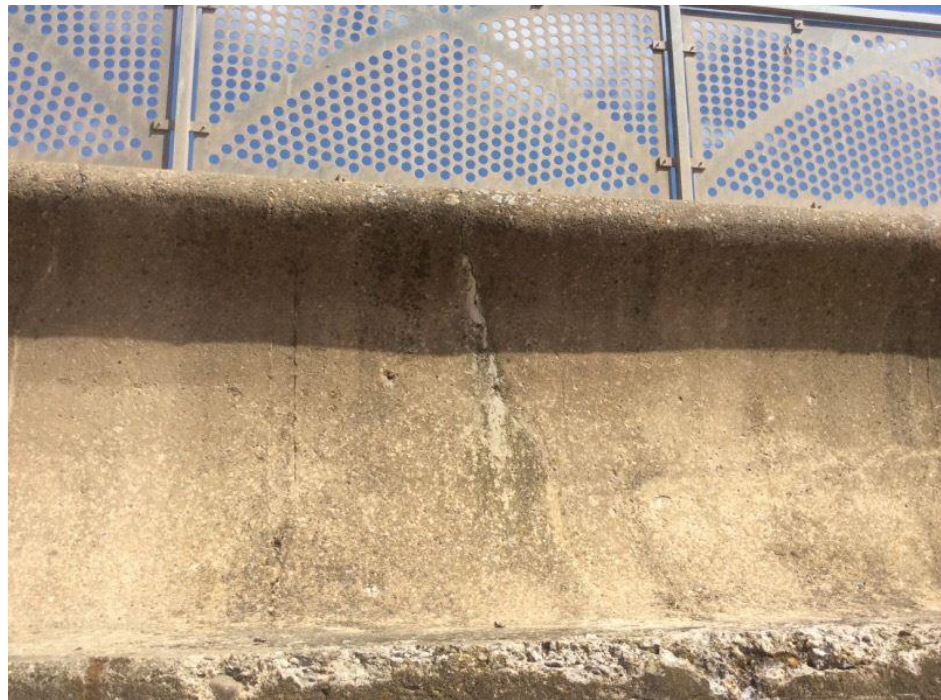
**Section D**  
**Exposed face**  
**Defect Ref: D72**  
**Description:** D72 -  
Vertical crack on recurve  
approximately 1m long  
**Photo number: 118**

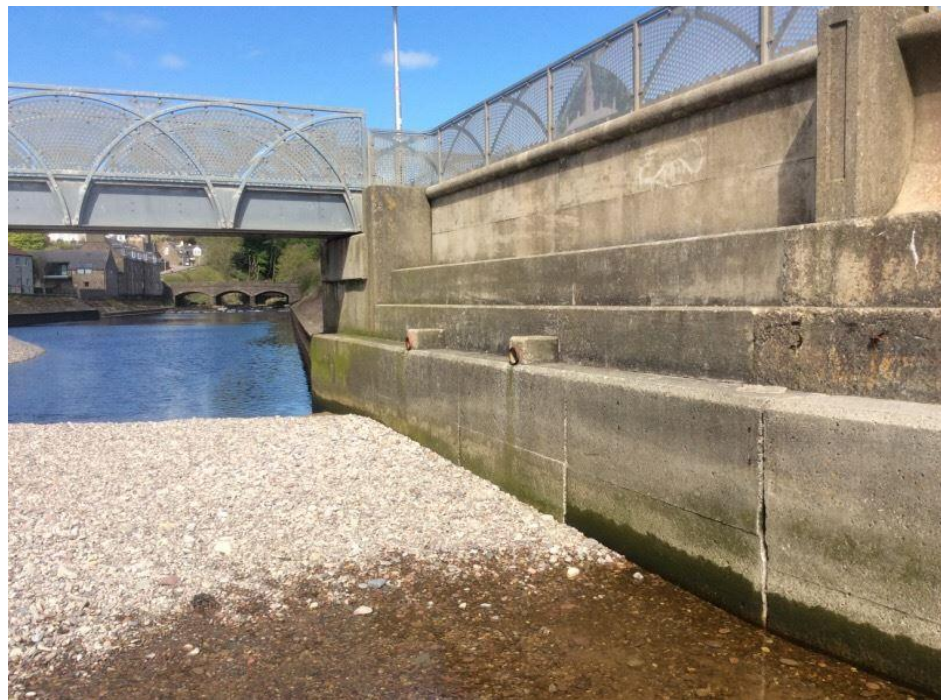
**Section D**  
**Exposed face**  
**Defect Ref: D73**  
**Description:** D73 -Flap  
valves missing  
**Photo number: 119**

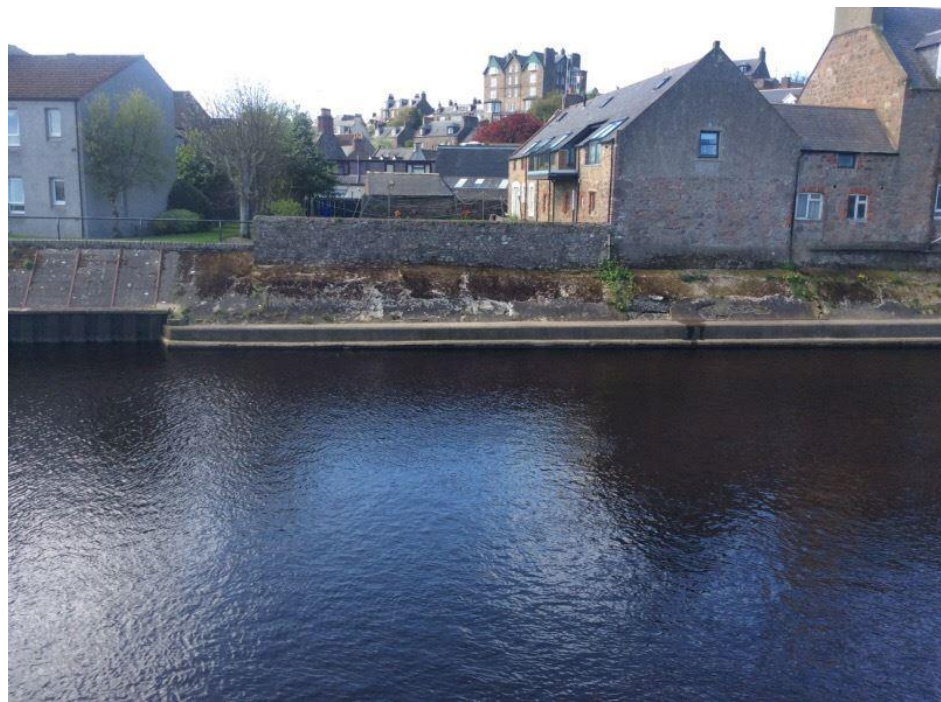
**Section D**  
**Channel side**  
**Defect Ref: D74**  
**Description:** D74 -  
Delaminating concrete  
repairs  
**Photo number: 120**

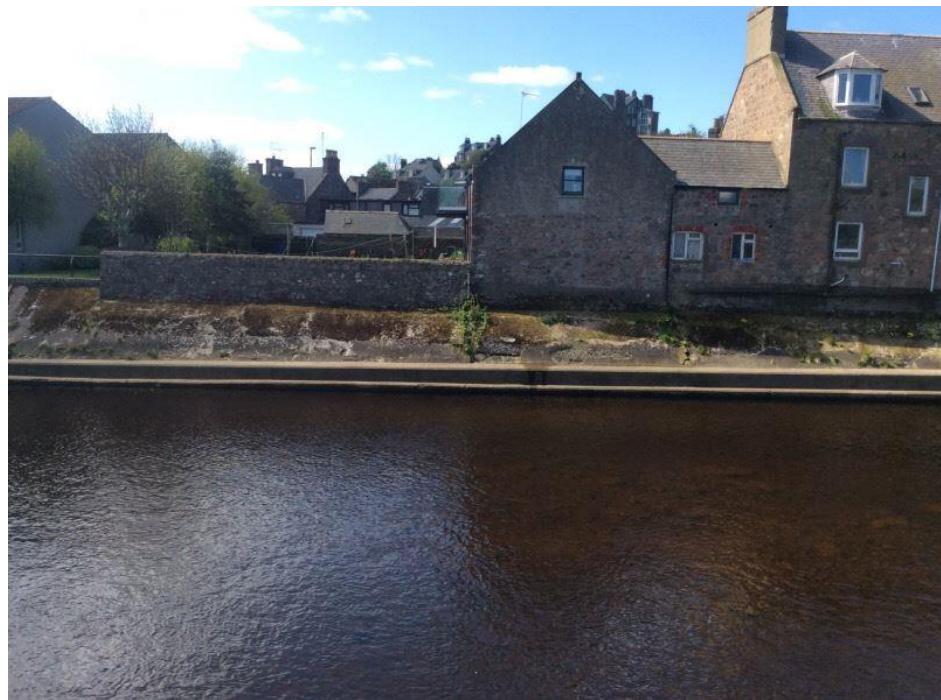
**Section D**  
**Channel side**  
**Defect Ref: D75**  
**Description:** D75 -  
Horizontal crack - poor  
protection of upper  
concrete slope  
**Photo number: 121**

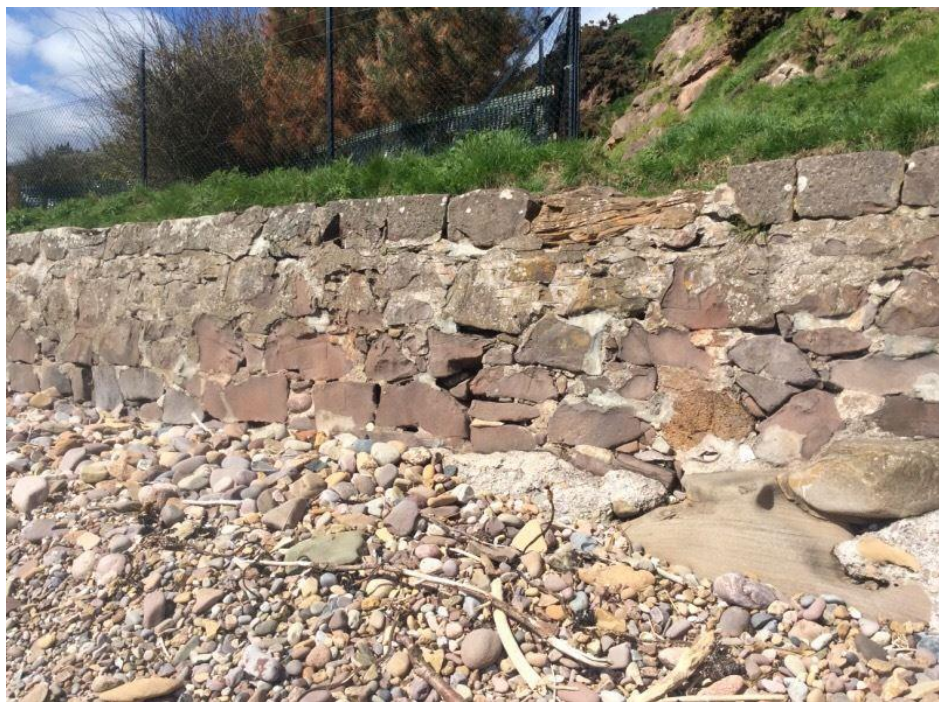
**Section A**  
**Exposed face**  
**Defect Ref: D78**  
**Description: D78 - Open joints**  
**Photo number: 125**

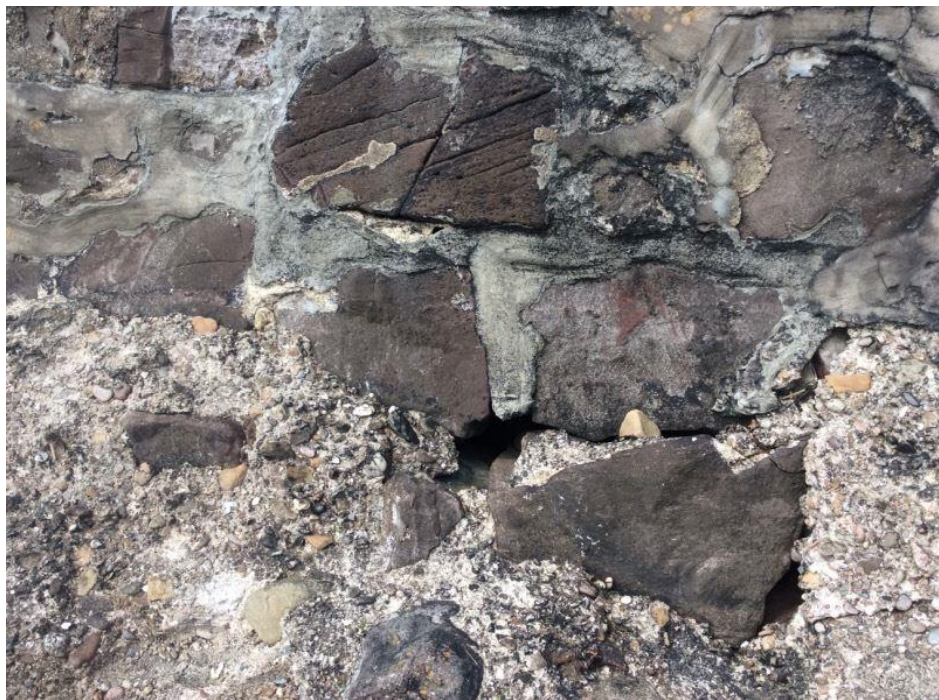
**Section A**  
**Exposed face**  
**Defect Ref: D79**  
**Description: Voiding behind blockwork.**  
**Photo number: 126**

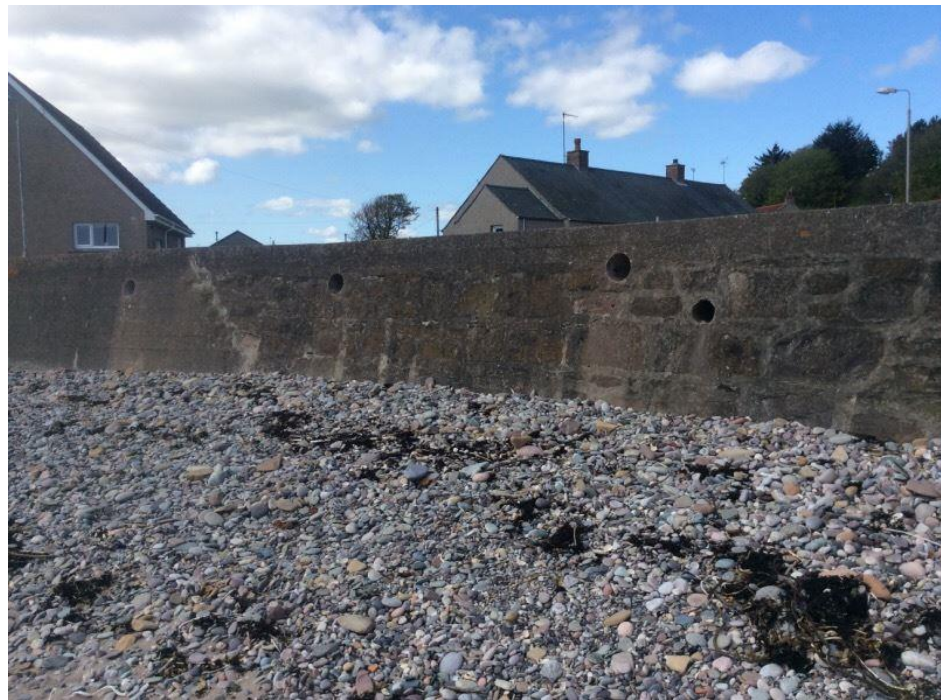
**Section A**  
**Exposed face**  
**Defect Ref: D82**  
**Description: D82 -**  
**Missing flap valves**  
**Photo number: 129**

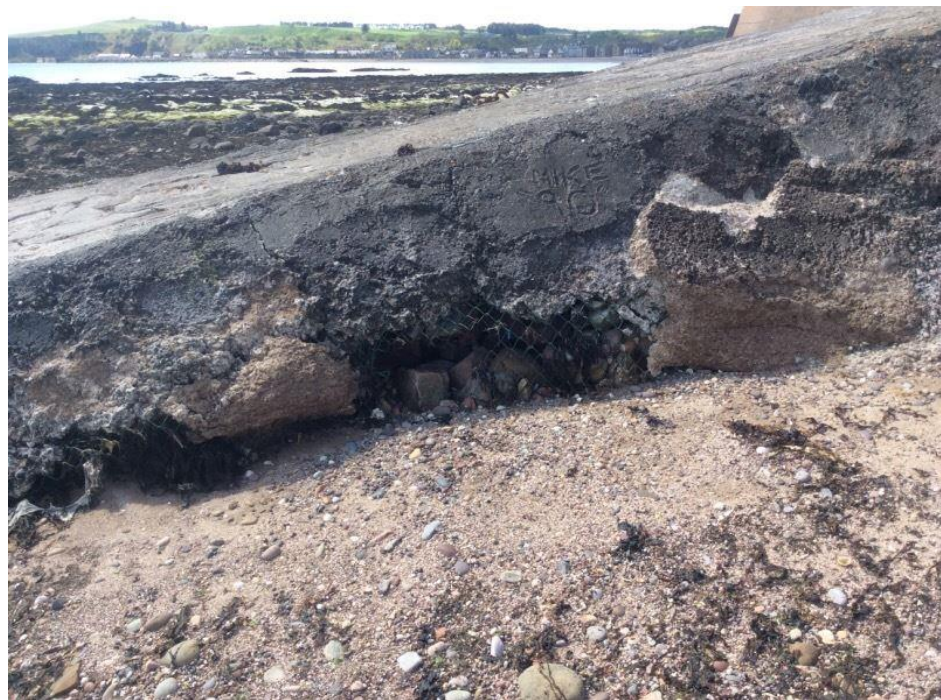
**Section A**  
**Access strip**  
**Defect Ref: D83**  
**Description: D84 -**  
**Undermined slipway**  
**Photo number: 130**

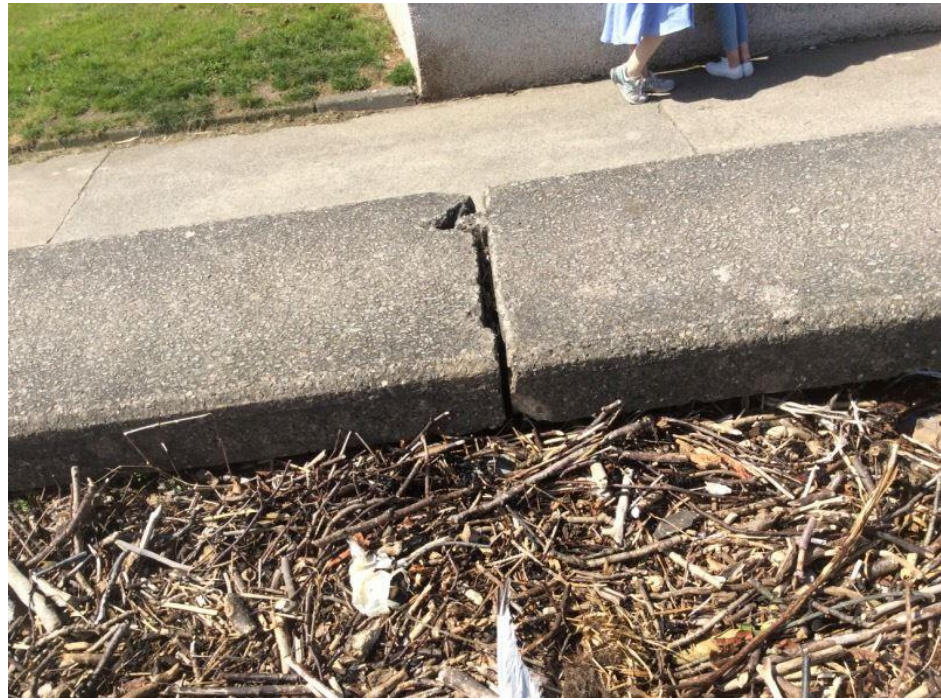
**Section E**  
**Exposed face**  
**Defect Ref: D88**  
**Description: D88 - Open joints**  
**Photo number: 158**

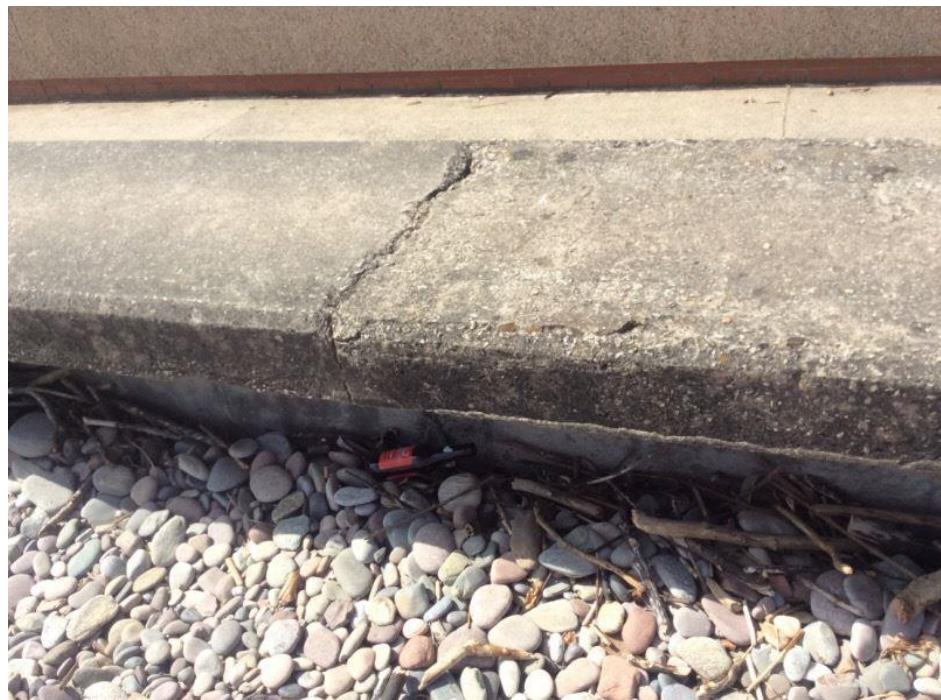
**Section E**  
**Exposed face**  
**Defect Ref: D89**  
**Description:** D89 -  
Chipped concrete by  
expansion joint with  
exposure of  
reinforcement  
**Photo number: 164**

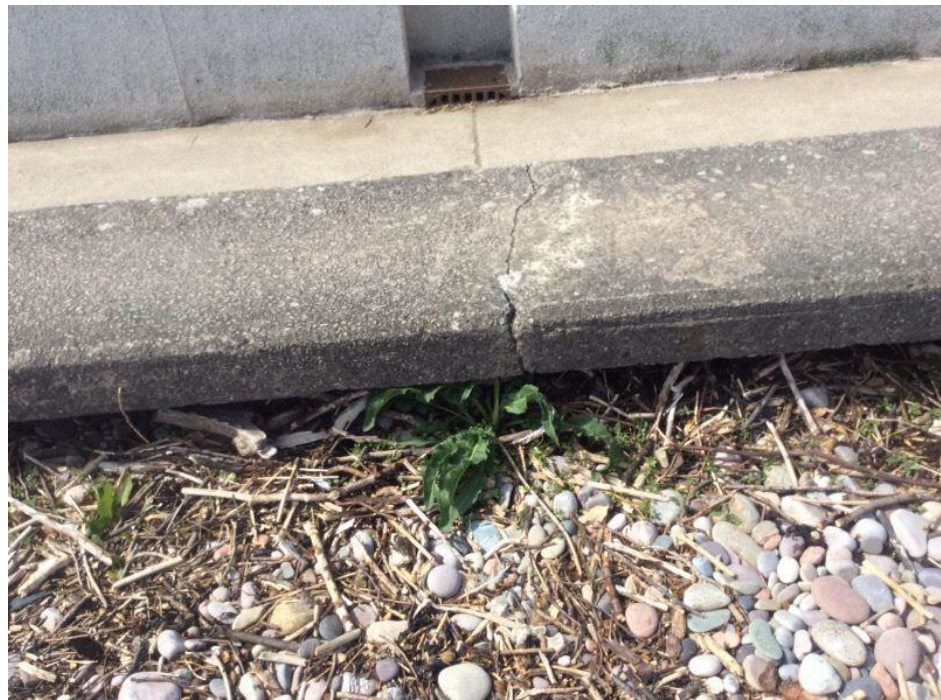
**Section E**  
**Exposed face**  
**Defect Ref: D89**  
**Description:** D89 -  
Chipped concrete by  
expansion joint with  
exposure of  
reinforcement  
**Photo number: 166**

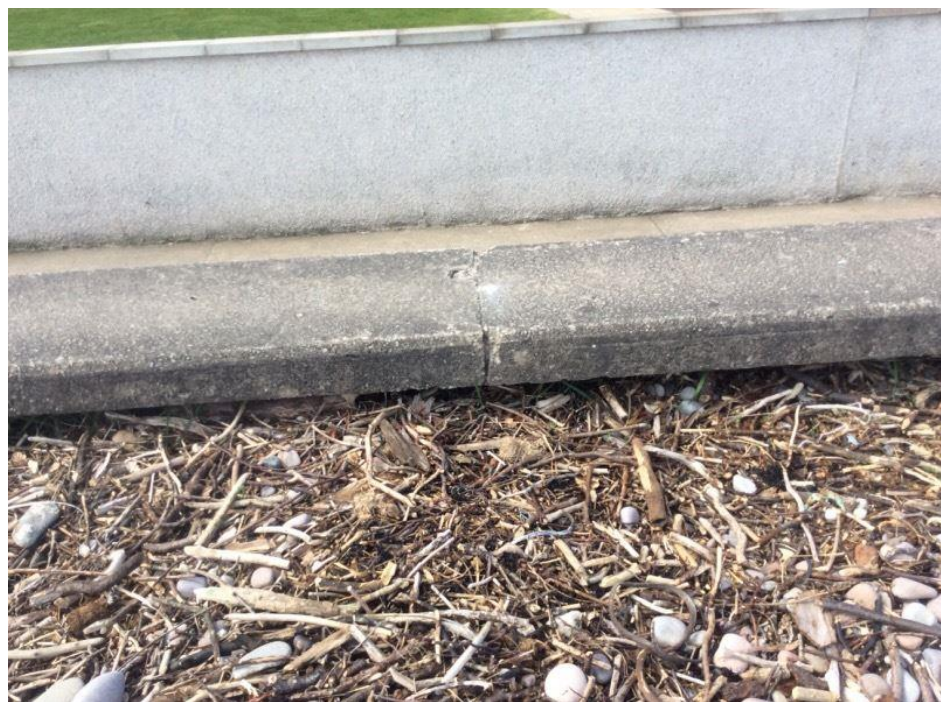
**Section E**  
**Exposed face**  
**Defect Ref: D89**  
**Description:** D89 -  
Chipped concrete by  
expansion joint with  
exposure of  
reinforcement  
**Photo number: 169**

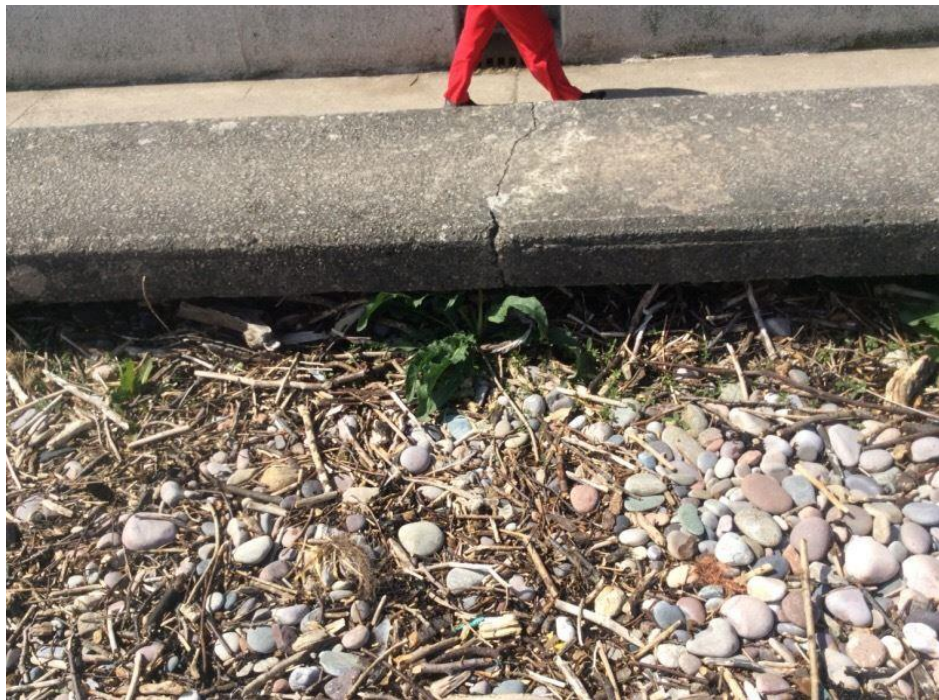
**Section E**  
**Exposed face**  
**Defect Ref: D89**  
**Description:** D89 -  
Chipped concrete by  
expansion joint with  
exposure of  
reinforcement  
**Photo number: 170**

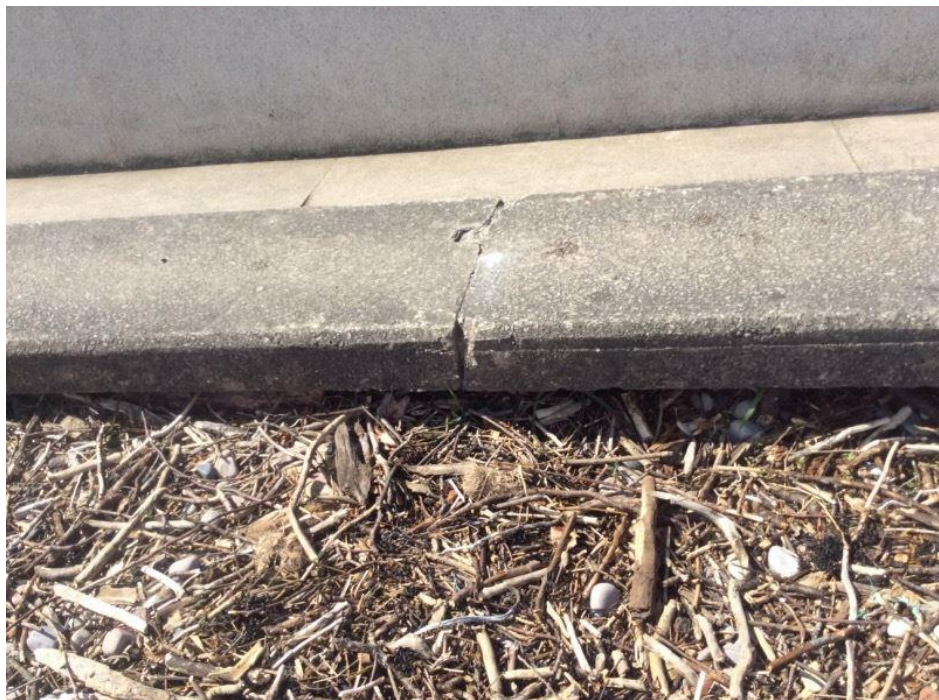
**Section E**  
**Exposed face**  
**Defect Ref: D89**  
**Description:** D89 -  
Chipped concrete by  
expansion joint with  
exposure of  
reinforcement  
**Photo number: 171**

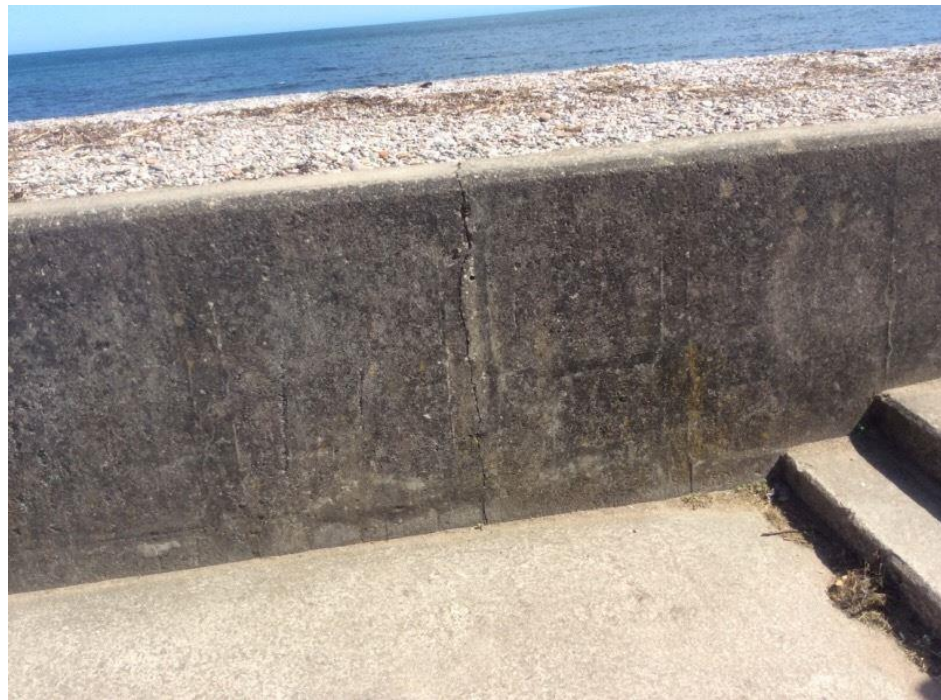
**Section E**  
**Exposed face**  
**Defect Ref: D89**  
**Description:** D89 -  
Chipped concrete by  
expansion joint with  
exposure of  
reinforcement  
**Photo number: 172**

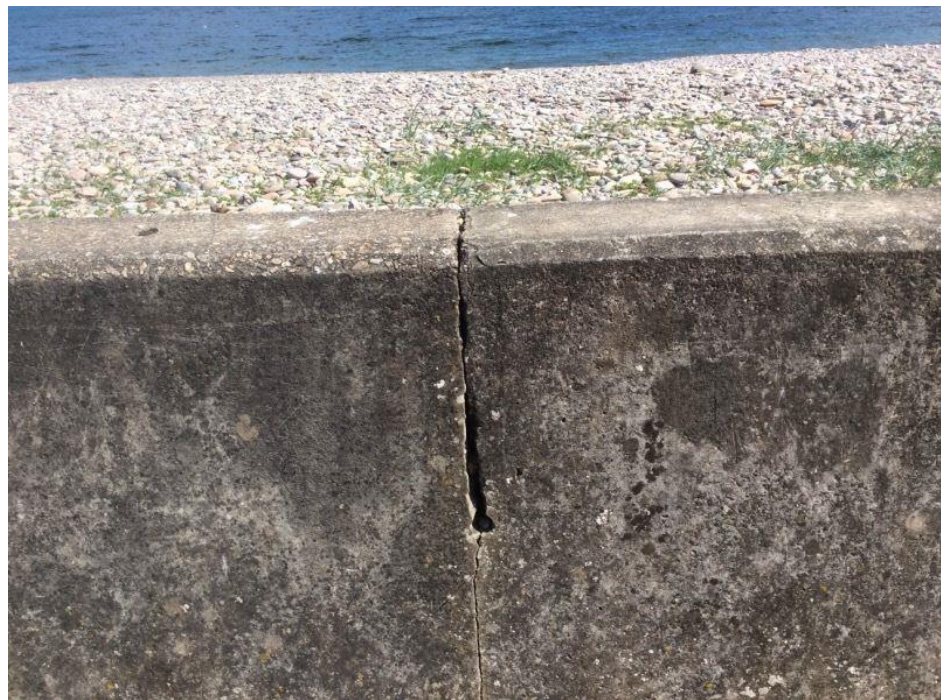
**Section E**  
**Exposed face**  
**Defect Ref: D89**  
**Description:** D89 -  
Chipped concrete by  
expansion joint with  
exposure of  
reinforcement  
**Photo number: 173**

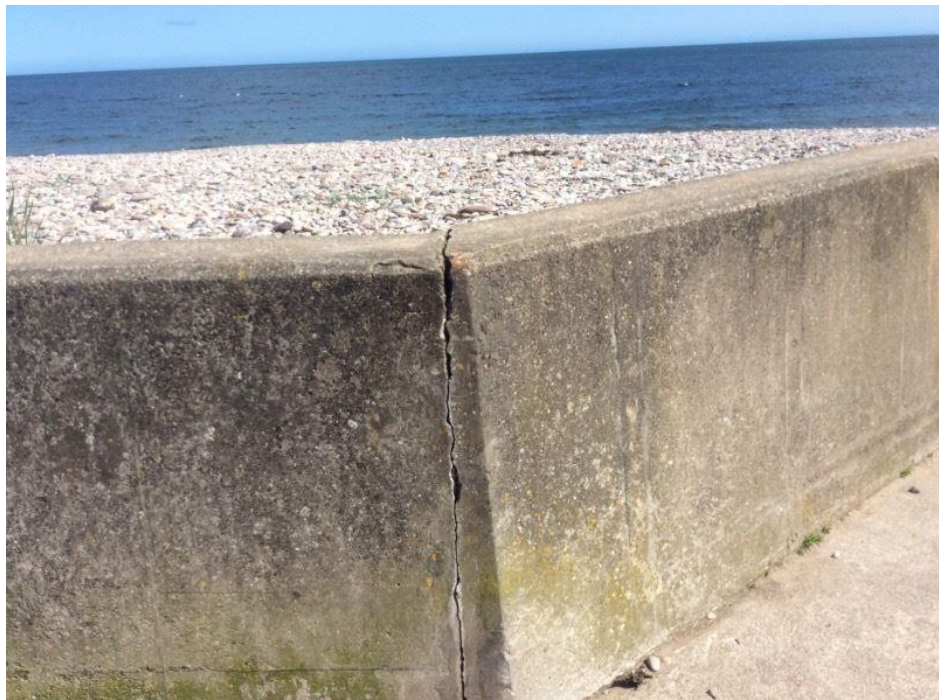
**Section E**  
**Exposed face**  
**Defect Ref: D89**  
**Description:** D89 -  
Chipped concrete by  
expansion joint with  
exposure of  
reinforcement  
**Photo number: 174**

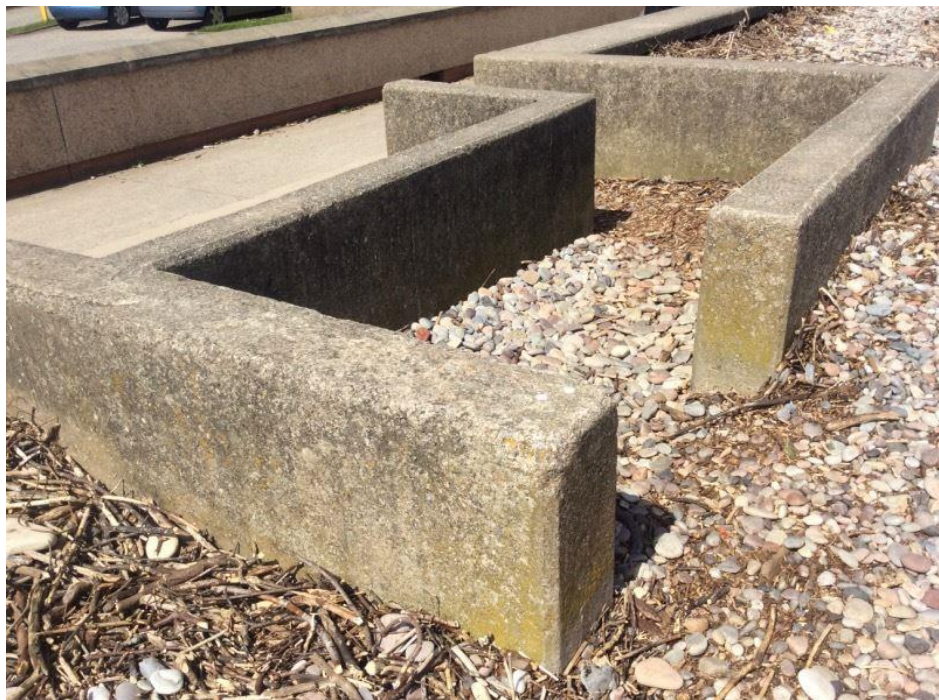
**Section E**  
**Exposed face**  
**Defect Ref: D90**  
**Description:** D90 -  
Flood gate possibly  
needed  
**Photo number: 134**

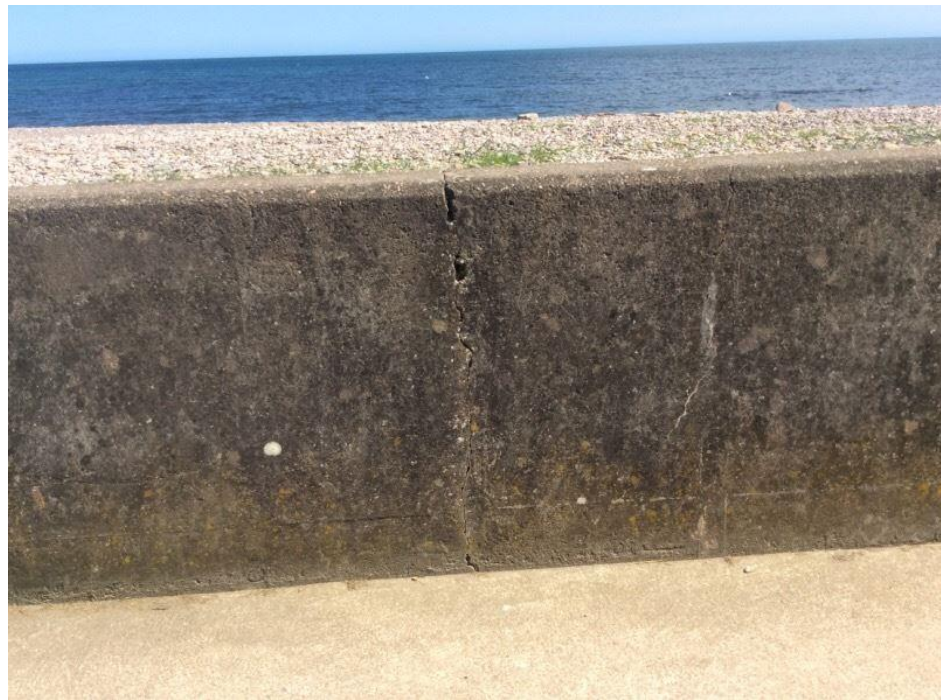
**Section E**  
**Exposed face**  
**Defect Ref: D91**  
**Description: D91 -**  
Distortion of parapet  
**Photo number: 135**

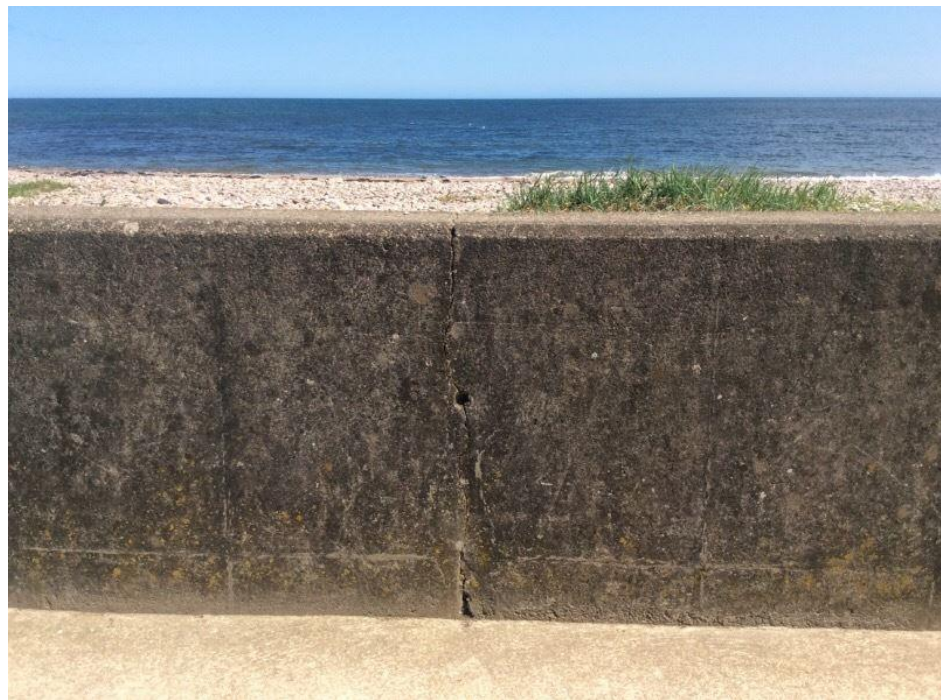
**Section E**  
**Exposed face**  
**Defect Ref: D93**  
**Description: D93 -**  
**Vertical crack in concrete**  
**Photo number: 147**

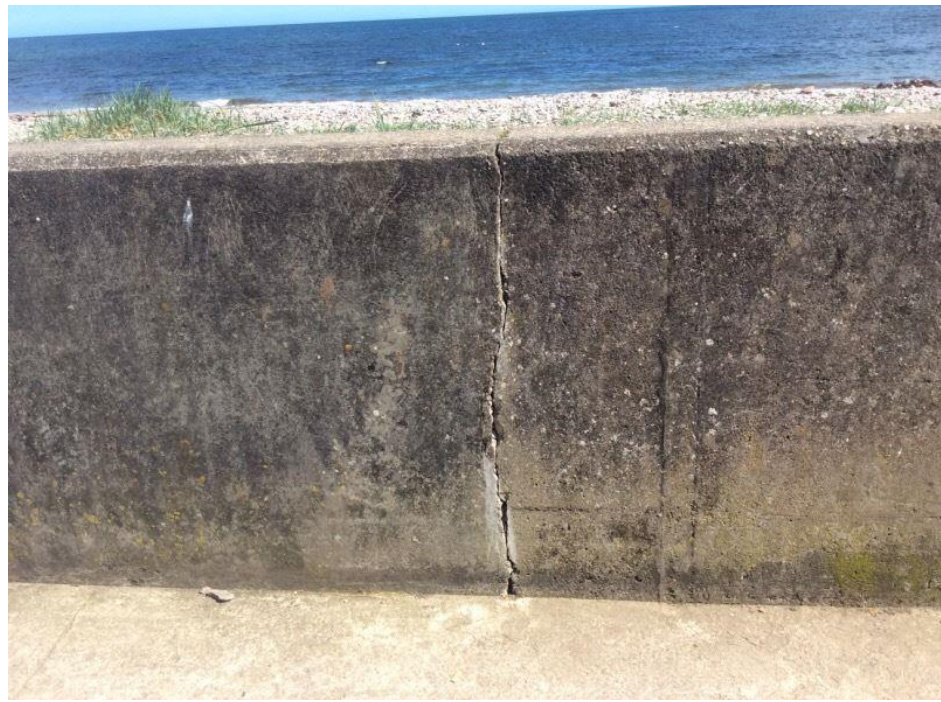
**Section E**  
**Exposed face**  
**Defect Ref: D93**  
**Description: D93 -**  
**Vertical crack in concrete**  
**Photo number: 151**

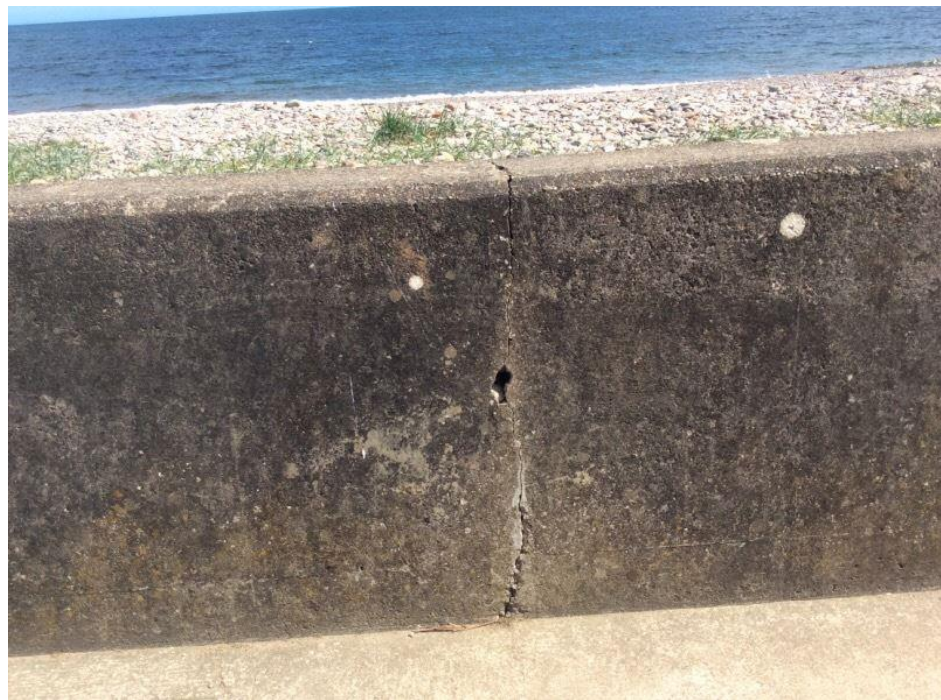
**Section E**  
**Exposed face**  
**Defect Ref: D93**  
**Description: D93 -**  
**Vertical crack in concrete**  
**Photo number: 155**

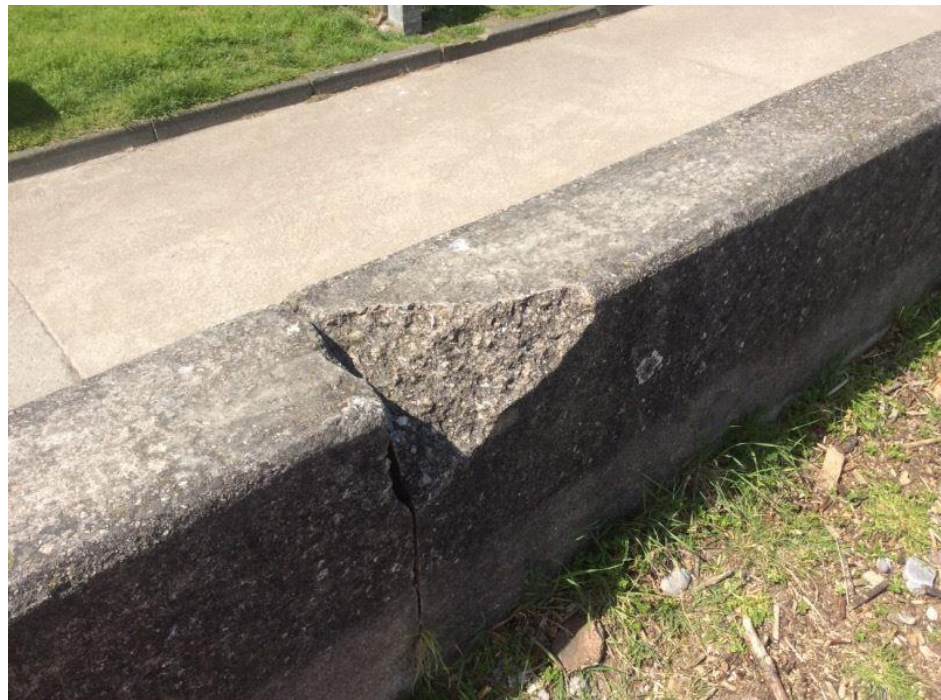
**Section E**  
**Exposed face**  
**Defect Ref: D94**  
**Description: D94 -**  
**Damaged concrete**  
**Photo number: 138**

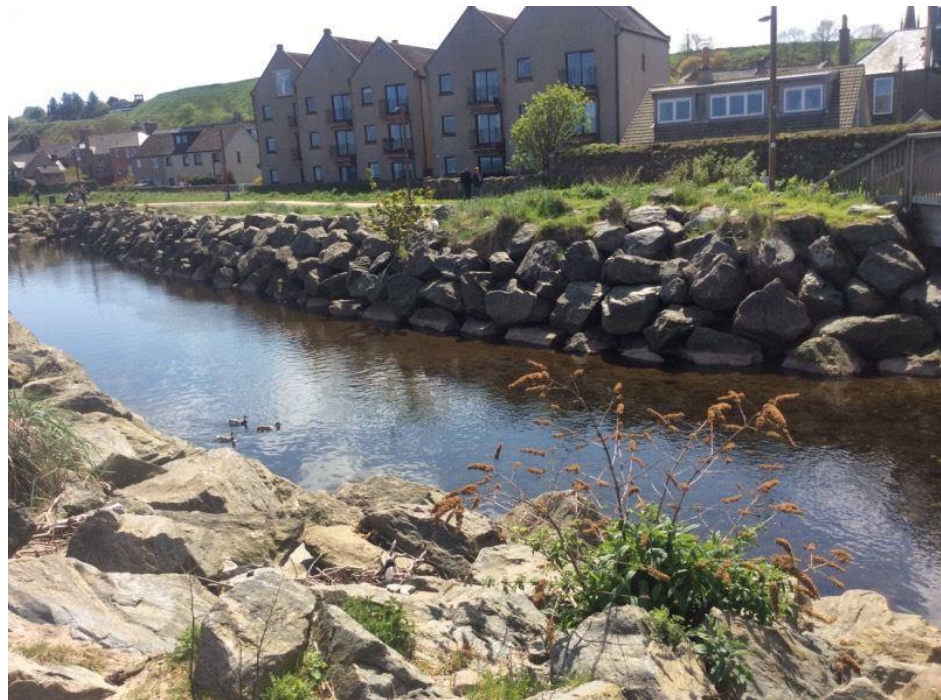
**Section F**  
**Rock armour**  
**Defect Ref: D95**  
**Description: D95 -**  
**Overly steep rock armour**  
**profile**  
**Photo number: 139**

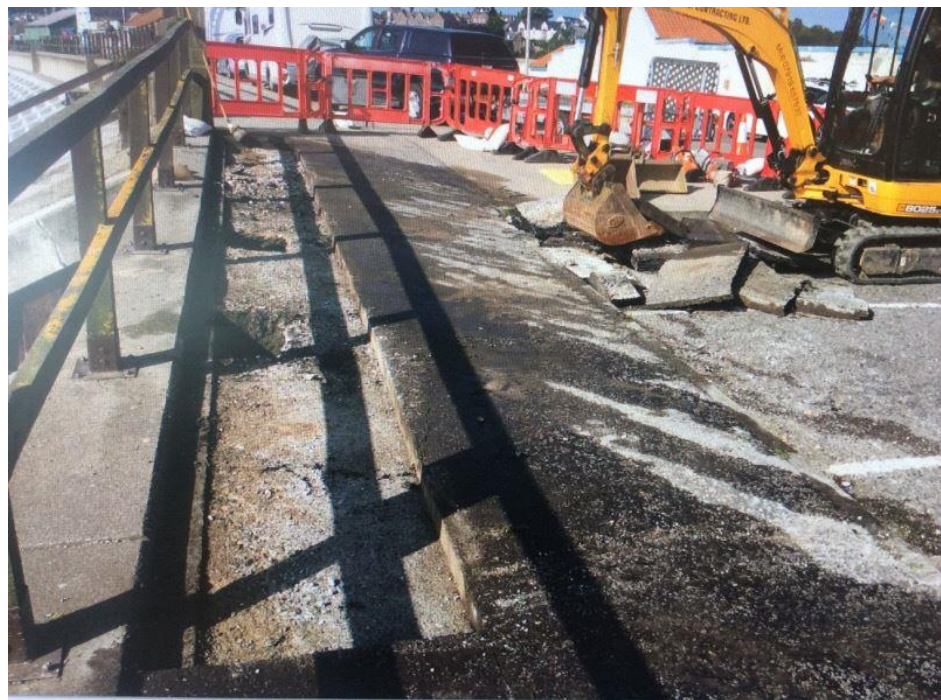
**Section B**  
**Crest**  
**Defect Ref: D98**  
**Description:** Sinkhole in crest (observed following initial inspection)  
**Photo number: 156**
