Location Plan:		Stonehaven harbour Assessment Date: 15/05/2018

Exam Type:	Detailed	
	Complete Survey:	Yes	
	Structure Ref:	1	
	OS Ref:	387867 , 785378	
	Survey Unit:	N/A	
	Governing SMP2:	N/A	
	SMP2 Policy Unit:	N/A	
	SMP2 Policy:	N/A	
<p>NOTE: This document has been prepared as an Asset Condition Survey Report for Aberdeenshire Council. JBA Consulting accepts no responsibility or liability for any use that is made of this document other than by the Client for the purposes for which it was originally commissioned and prepared.</p>

COASTAL ASSET CONDITION SURVEY REPORT

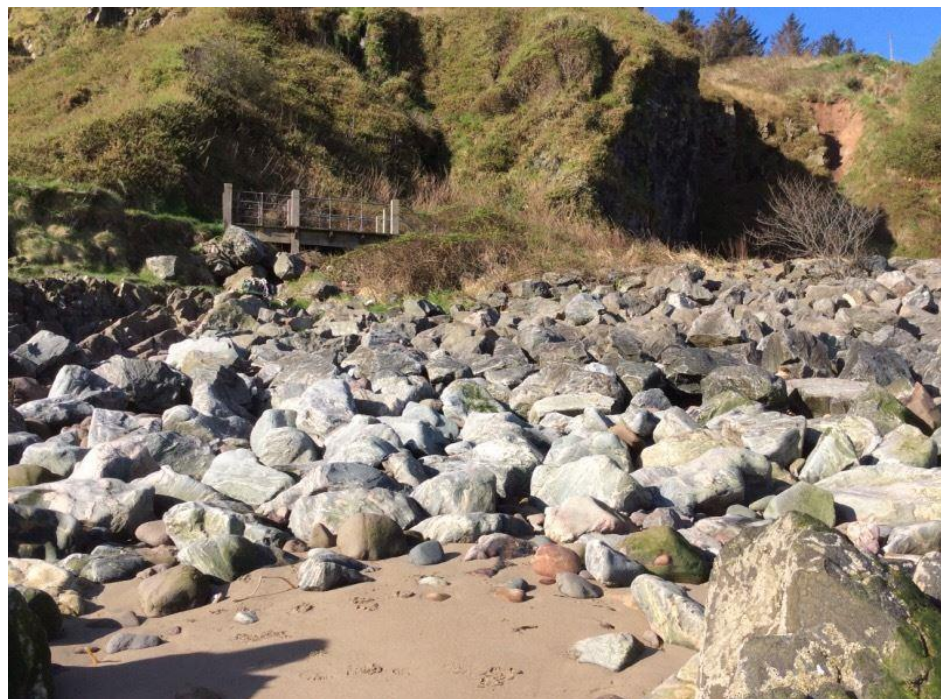
Section A
Rock armour
Defect Ref: D1
Description: D1 -
Nonuniform rock armour
profile, insufficient
protection to timber
footbridge.
Photo number: 102

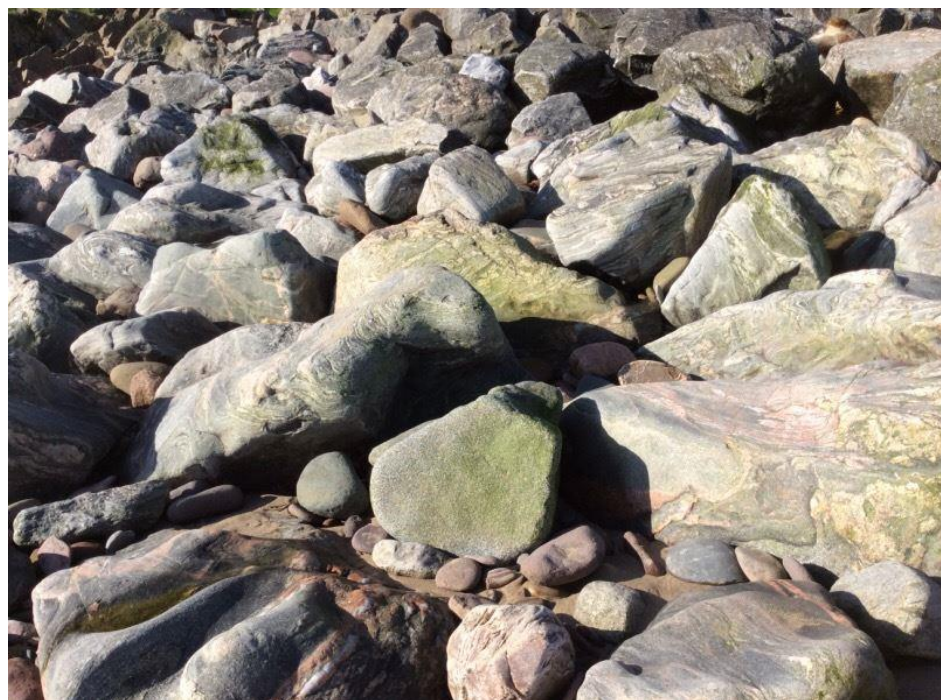
Section A
Rock armour
Defect Ref: D2
Description: D2 -
Undersized rock armour.
Photo number: 103

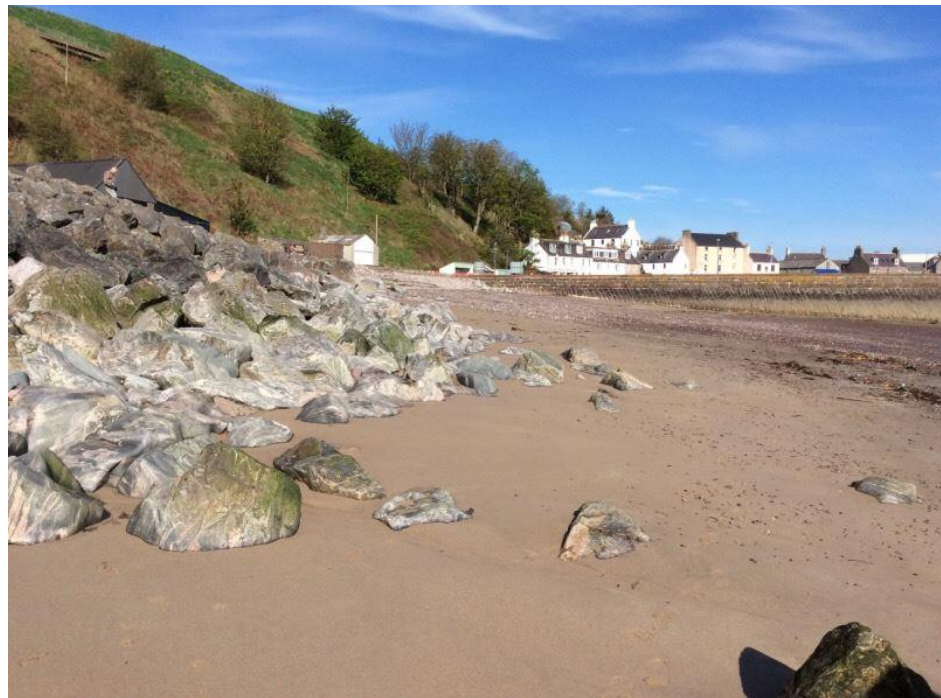
Section A
Rock armour
Defect Ref: D3
Description: D3 -
Expelled rock armour,
also present on slipway
blocking access.
Photo number: 104

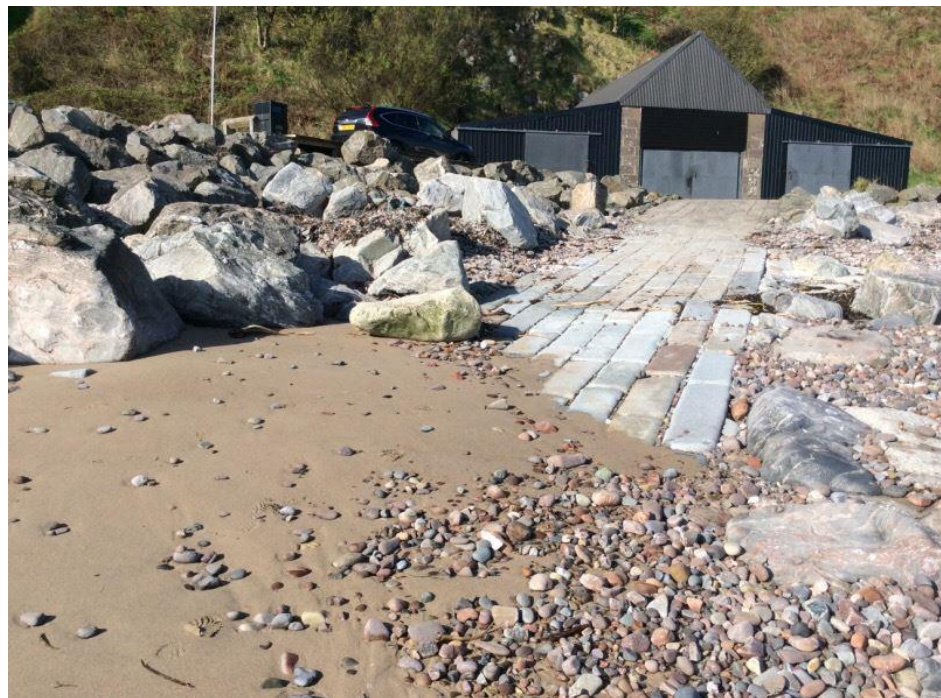
Section A
Rock armour
Defect Ref: D3
Description: D3 -
Expelled rock armour,
also present on slipway
blocking access.
Photo number: 187

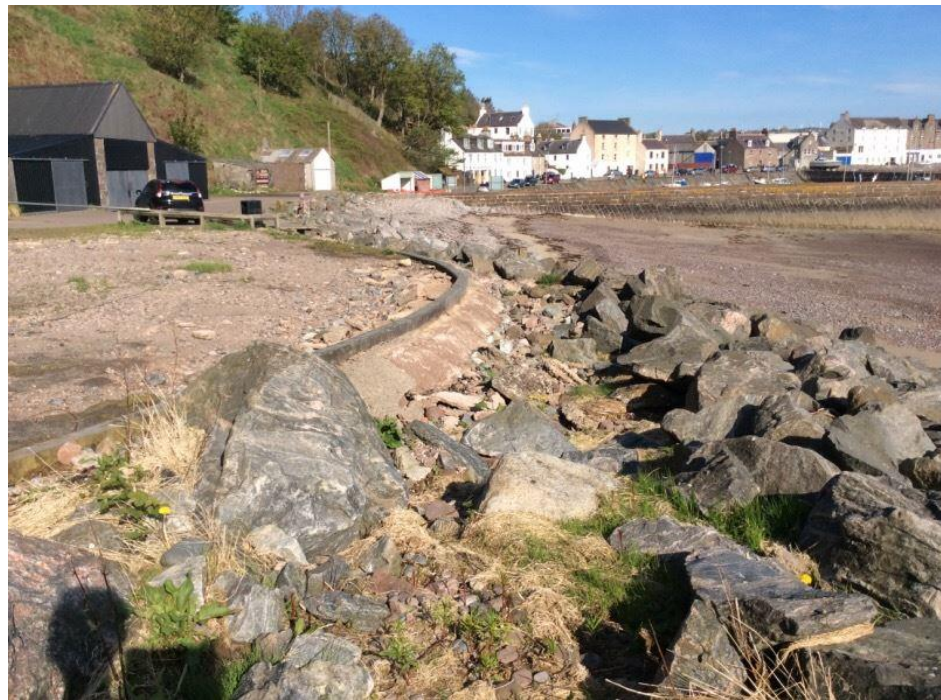
Section A
Rock armour
Defect Ref: D6
Description: D6 - Poor condition of rock armour crest, too narrow under design guidance and provides insufficient protection to the timber walkway.
Photo number: 107

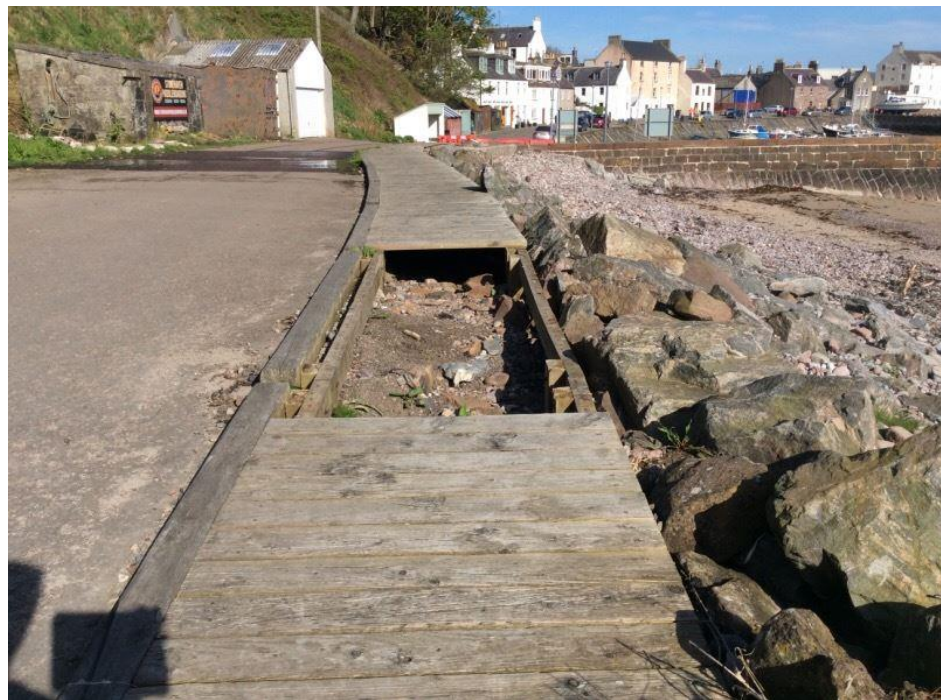
Section A
Access strip
Defect Ref: D7
Description: D7 - H&S uneven and damaged access path, with missing planking.
Photo number: 108

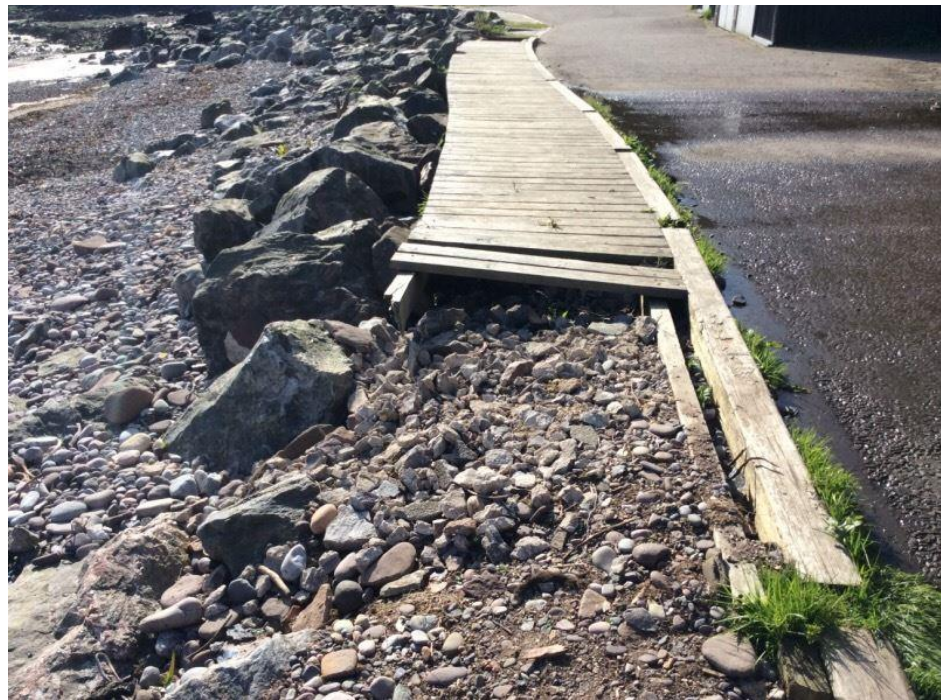
Section A
Access strip
Defect Ref: D7
Description: D7 - H&S uneven and damaged access path, with missing planking.
Photo number: 188

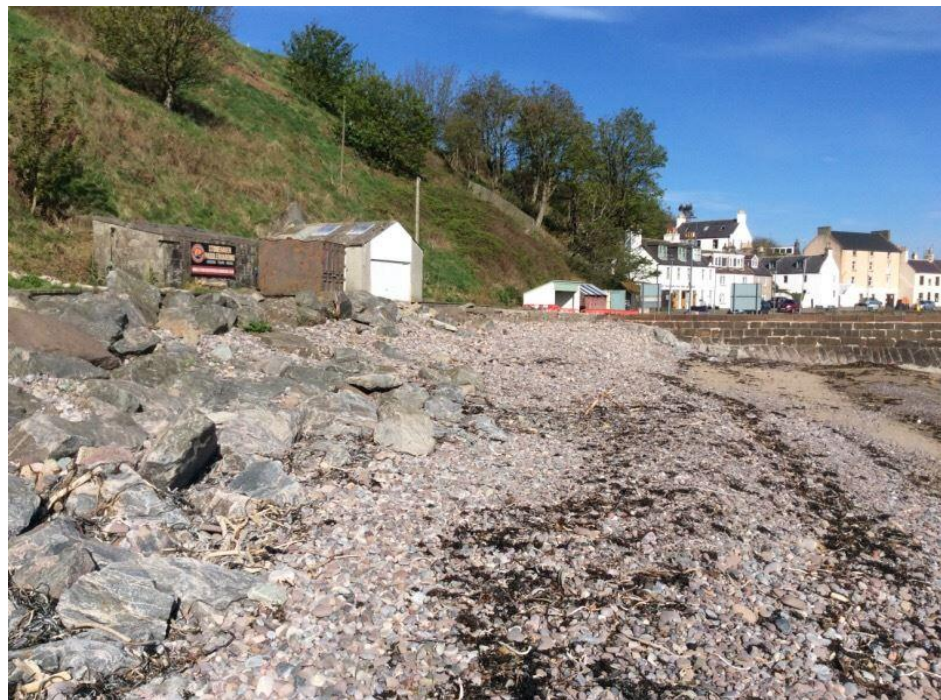
Section A
Rock armour
Defect Ref: D8
Description: D8 - Insufficient rock armour protection at tie-in with harbour arm.
Photo number: 109

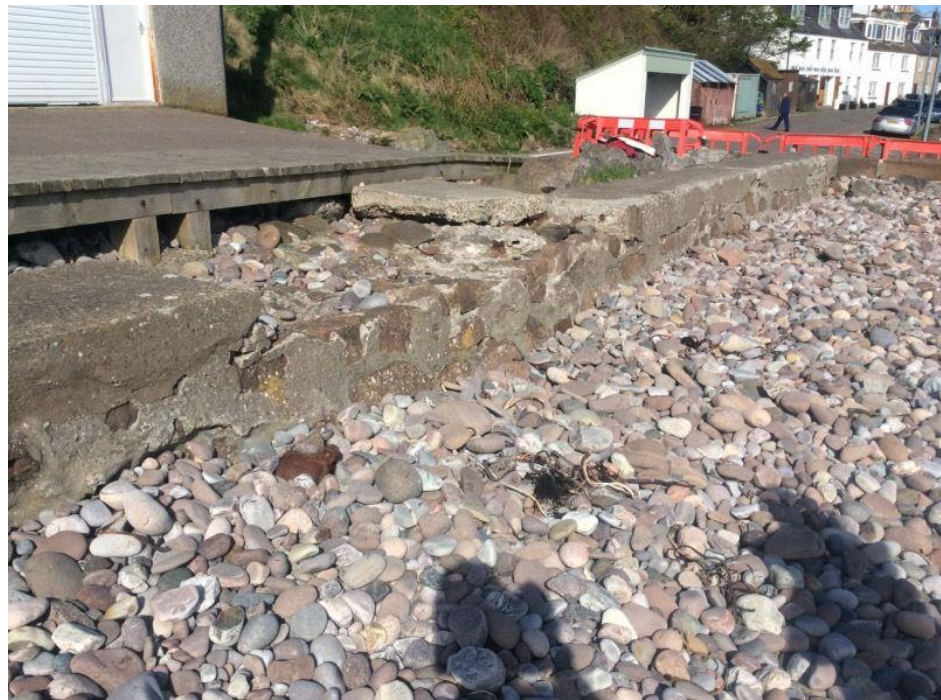
Section A
Splash wall
Defect Ref: D9
Description: D9 -
General dilapidation and
damaged capping repairs
Photo number: 110

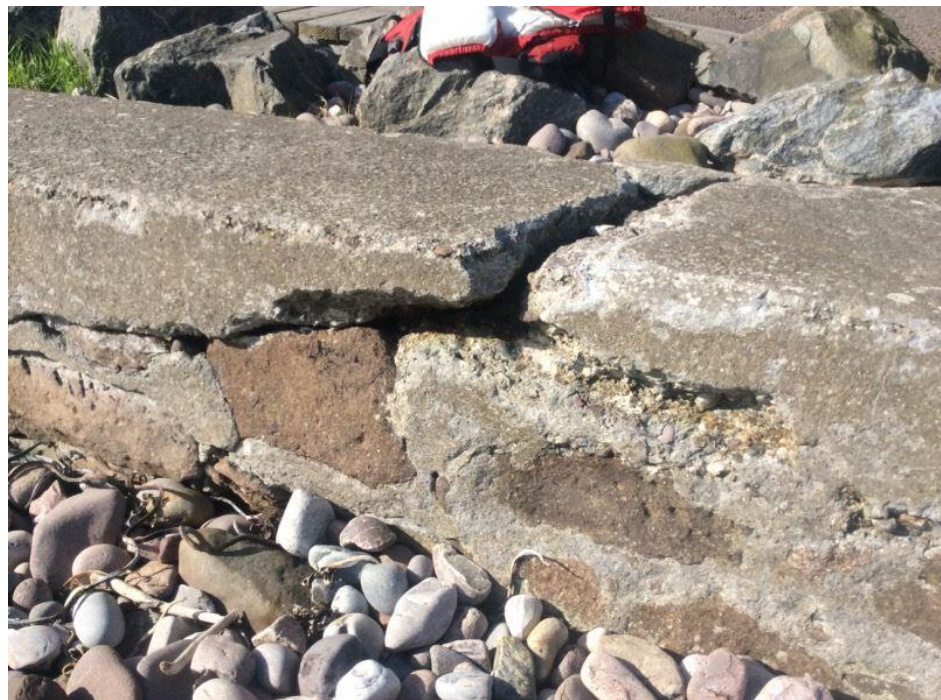
Section A
Splash wall
Defect Ref: D9
Description: D9 -
General dilapidation and
damaged capping repairs
Photo number: 189

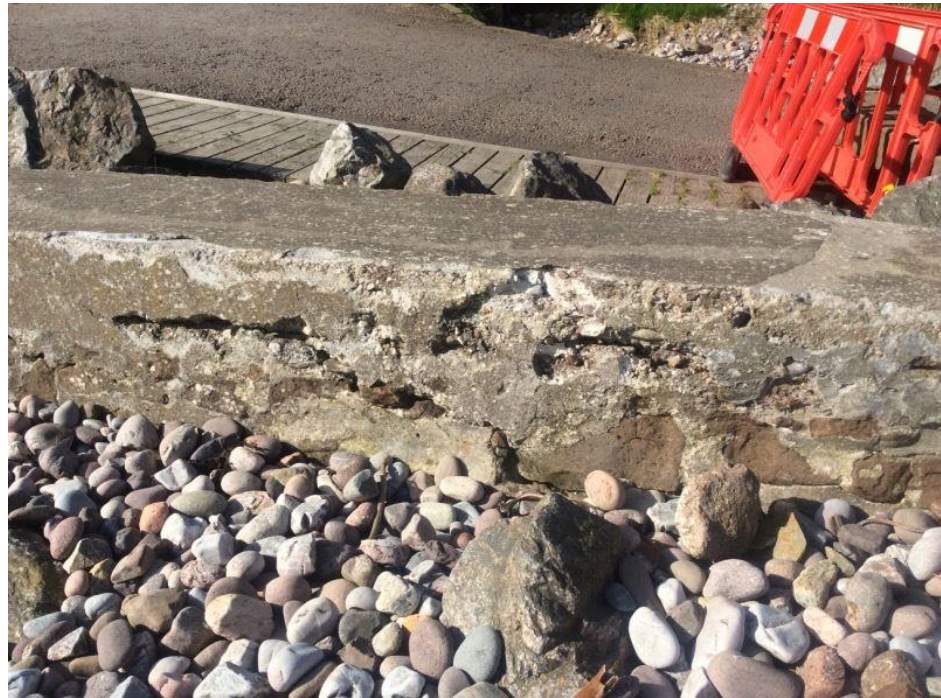
Section A
Splash wall
Defect Ref: D9
Description: D9 -
General dilapidation and
damaged capping repairs
Photo number: 221

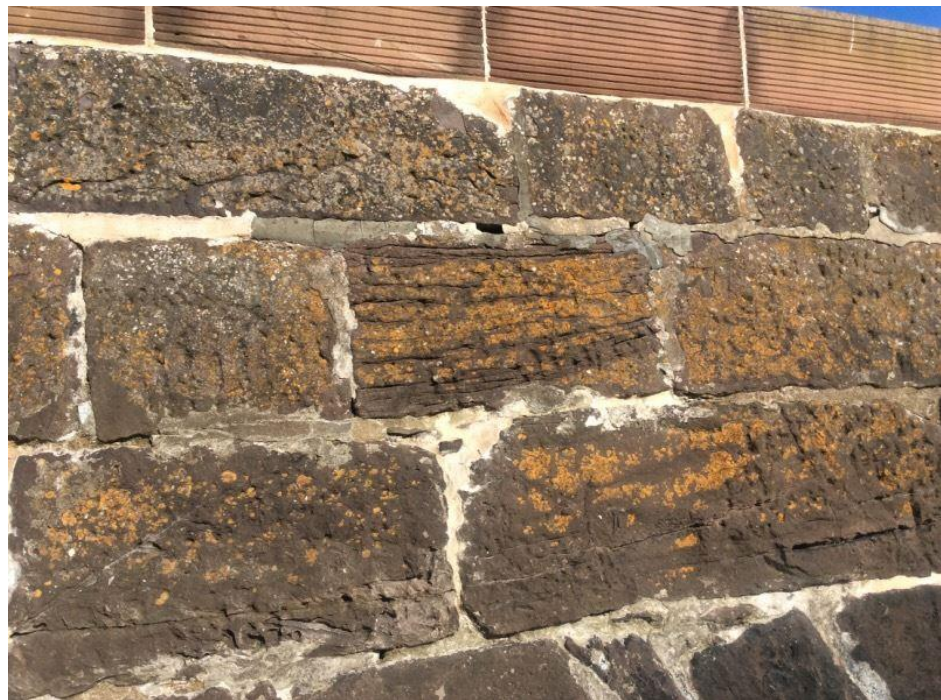
Section B
Seaward face
Defect Ref: D10
Description: D10 - Open
joints.
Photo number: 111

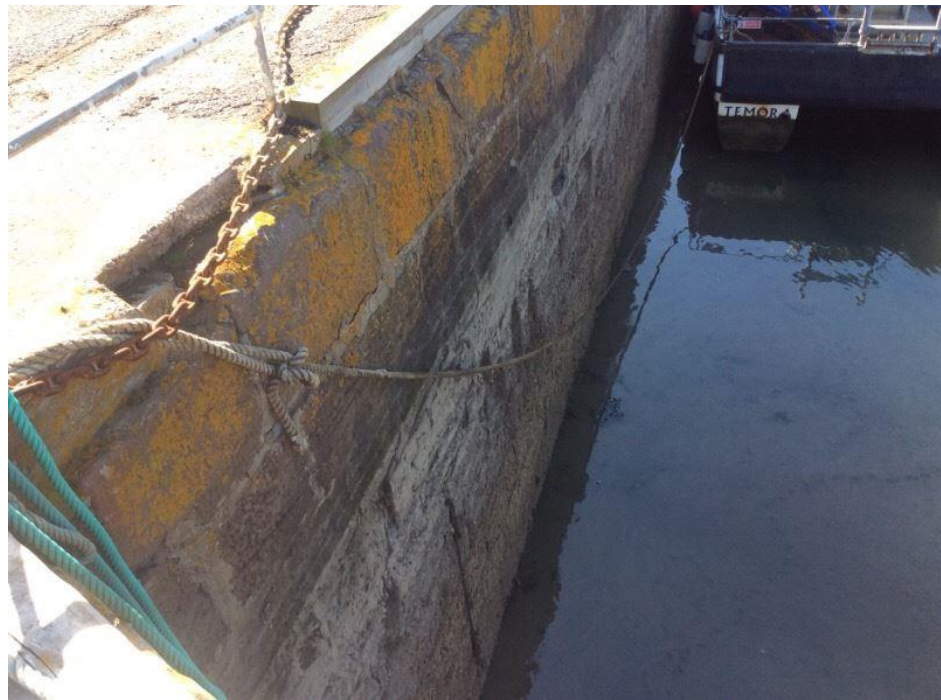
Section B
Quay face
Defect Ref: D13
Description: D13 -
Small cracks of masonry
blocks.
Photo number: 224

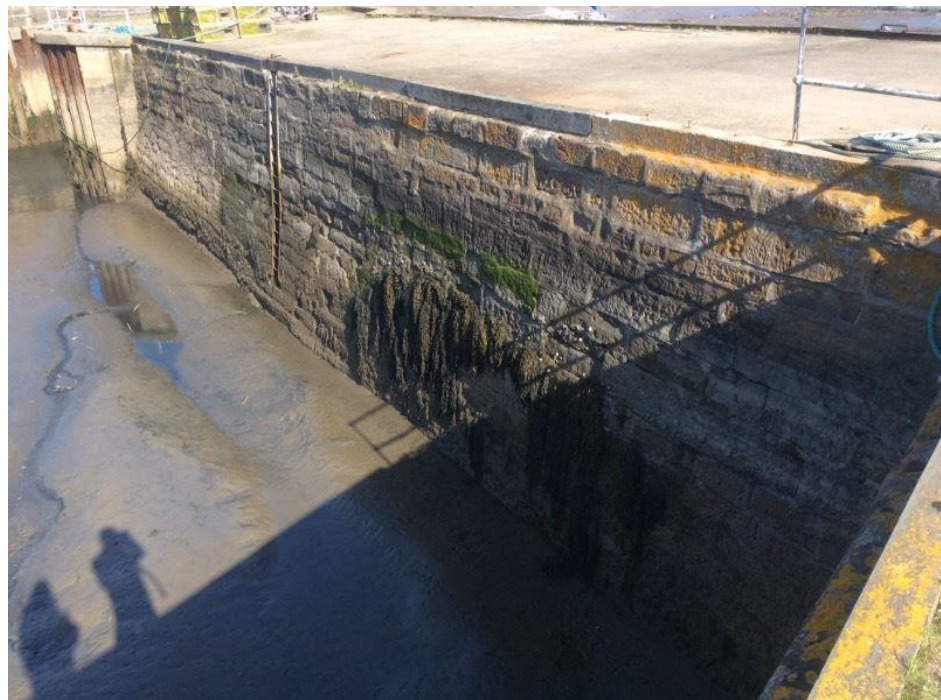
Section B
Quay face
Defect Ref: D14
Description: D14 - Open
joints.
Photo number: 168

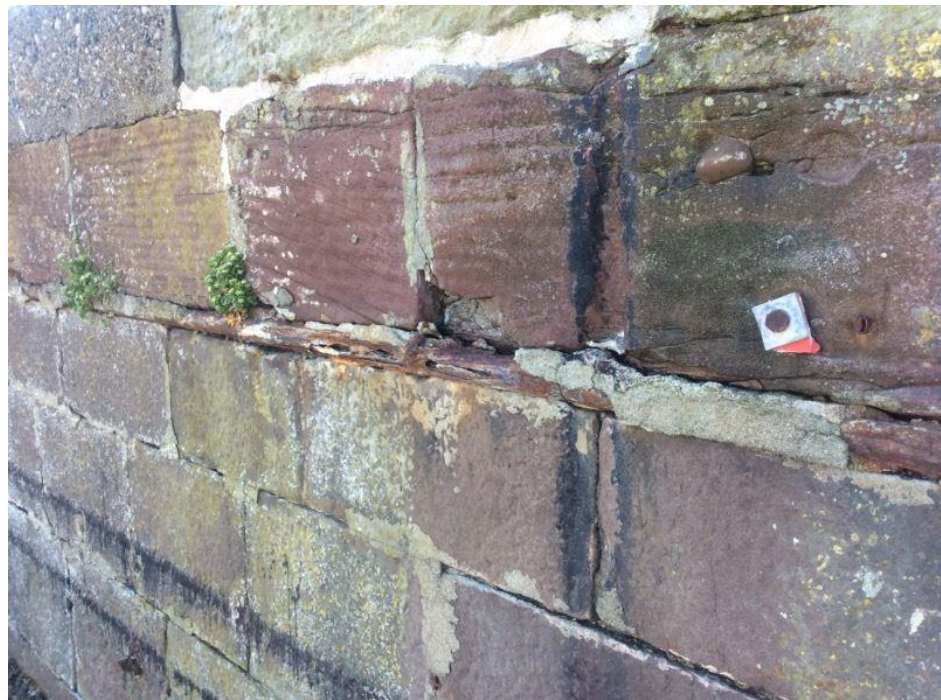
Section B
Capping
Defect Ref: D17
Description: D17 -
Corroding piping joints.
Photo number: 117

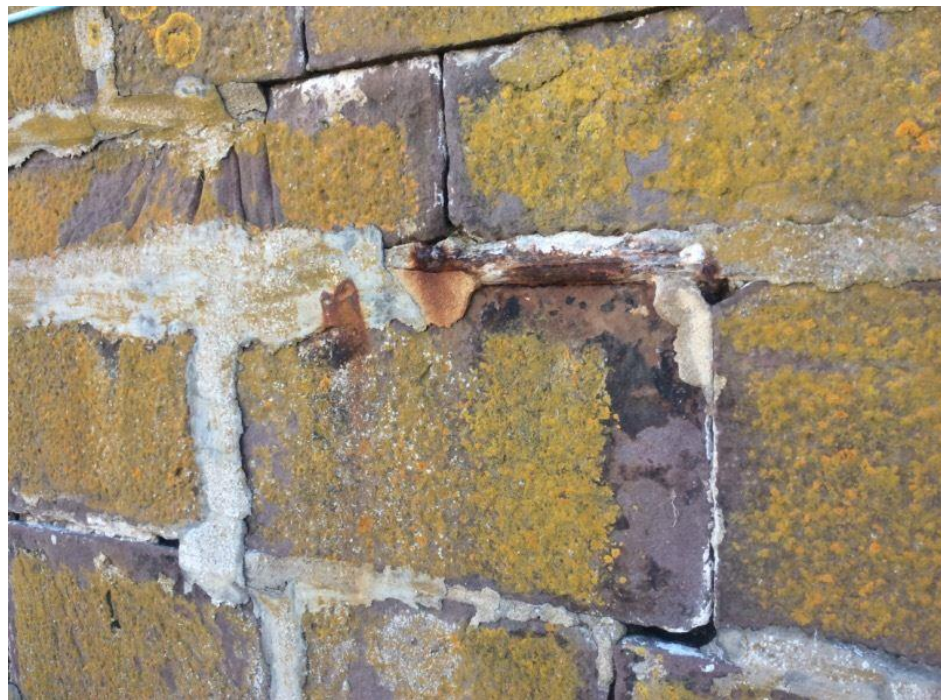
Section B
Capping
Defect Ref: D17
Description: D17 -
Corroding piping joints.
Photo number: 194

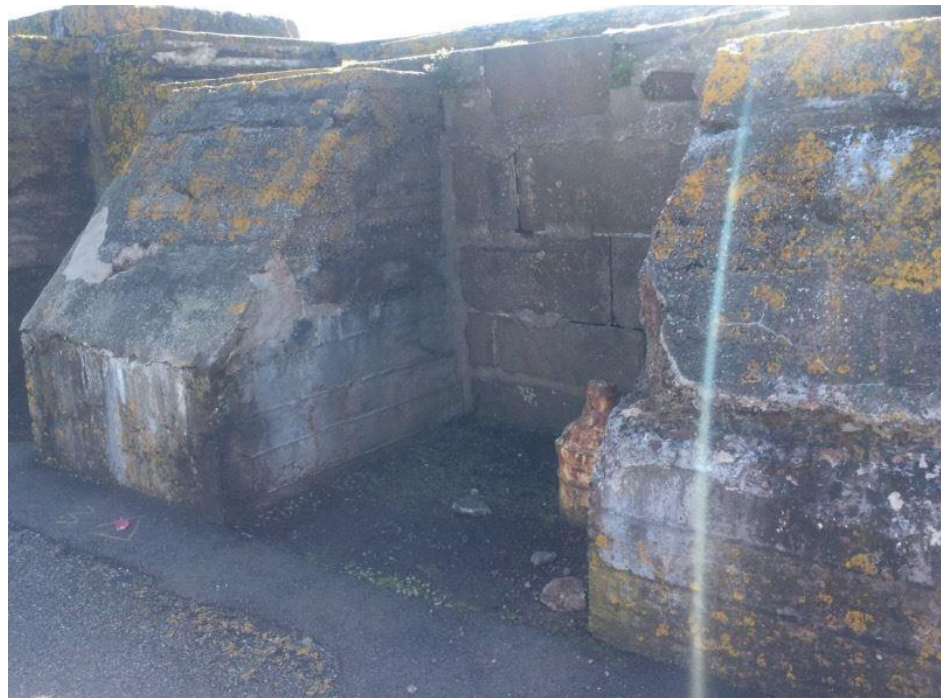
Section B
Capping
Defect Ref: D19
Description: D19 - Spalling, cracking and honeycombing of buttress elements of the wall.
Photo number: 119

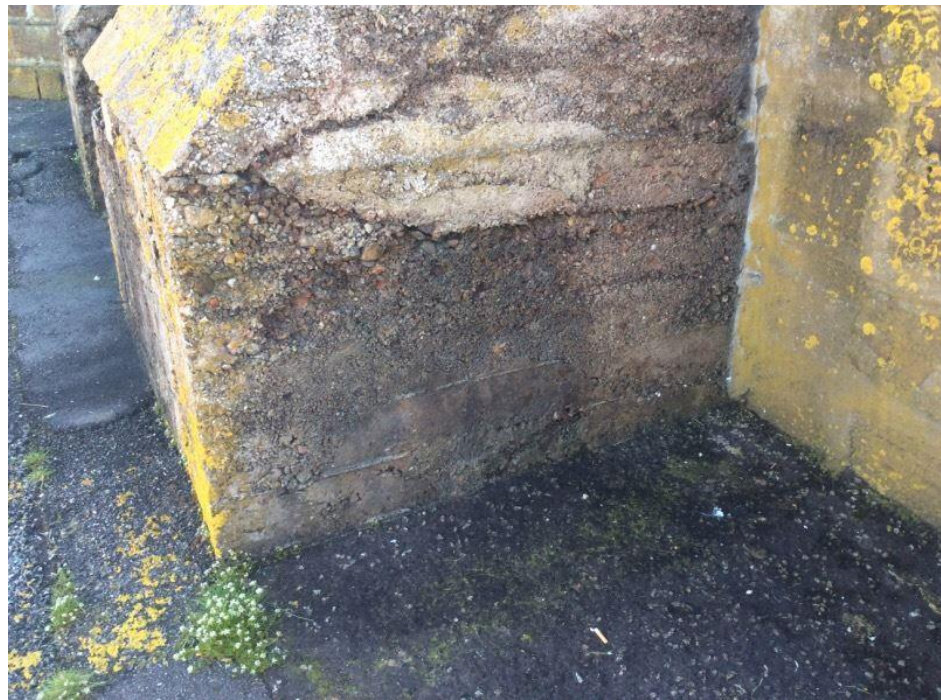
Section B
Capping
Defect Ref: D19
Description: D19 - Spalling, cracking and honeycombing of buttress elements of the wall.
Photo number: 222

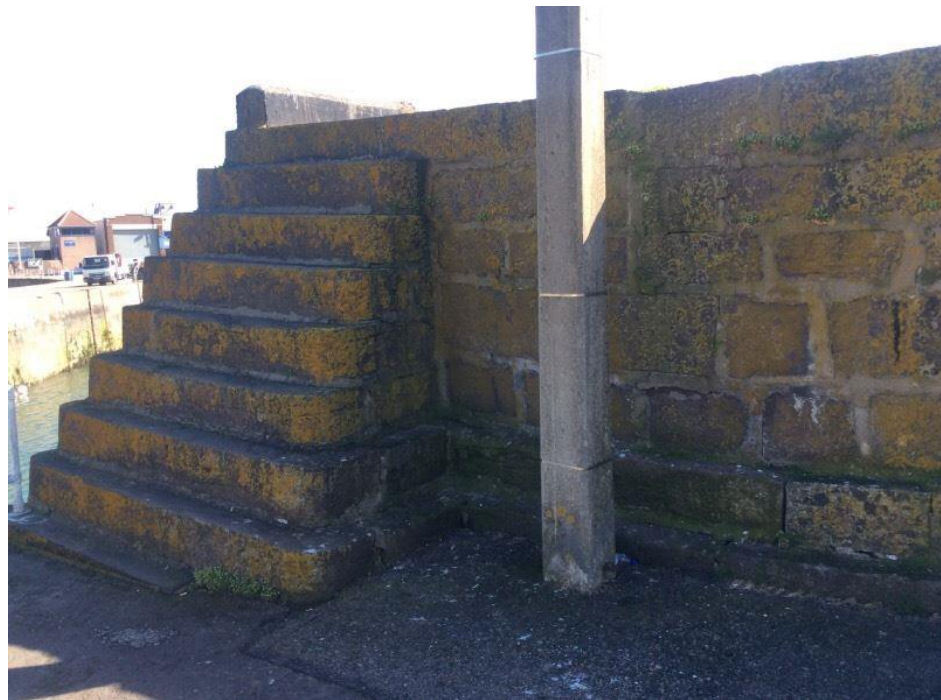
Section B
Capping
Defect Ref: D20
Description: D20 - Settlement of the wall.
Photo number: 120

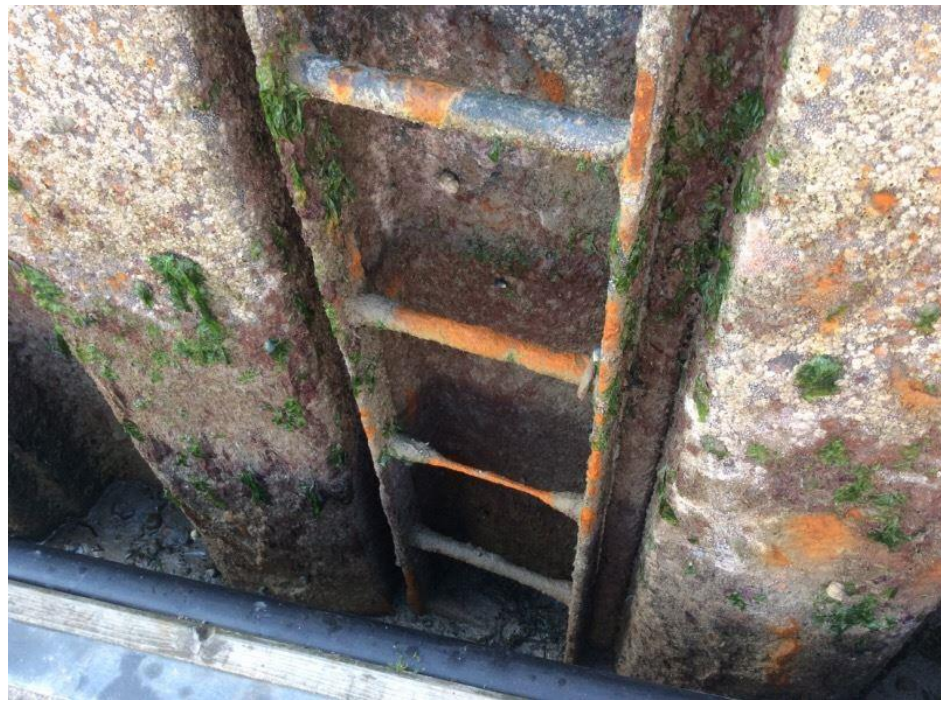
Section D
Sheet piling
Defect Ref: D22
Description: D22 -
Health and Safety -
Heavily corroded ladder.
Photo number: 216

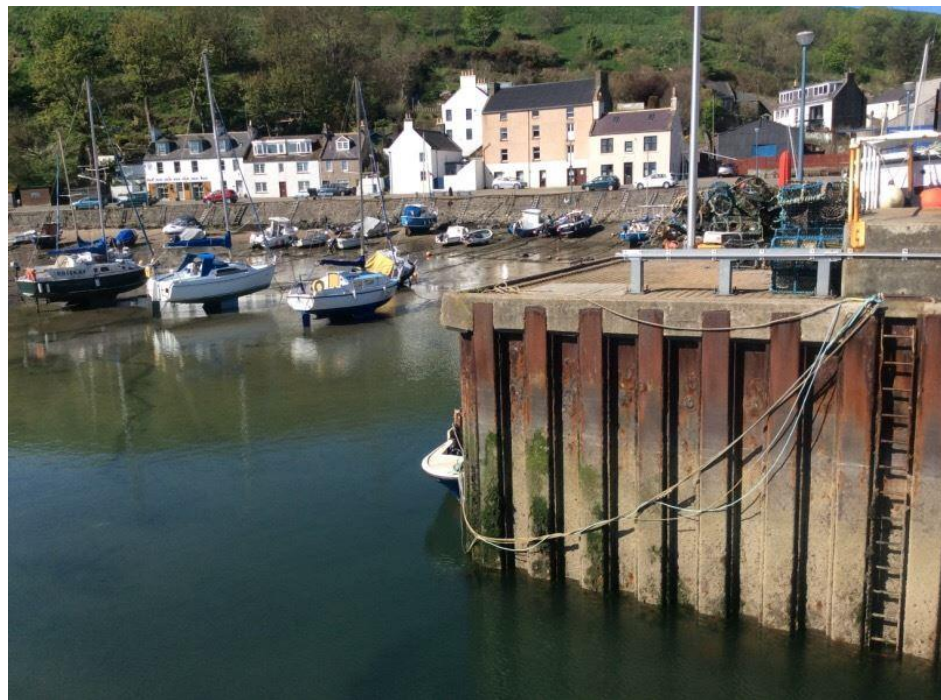
Section D
Sheet piling
Defect Ref: D23
Description: D23 -
Capping beam cracked.
Photo number: 123

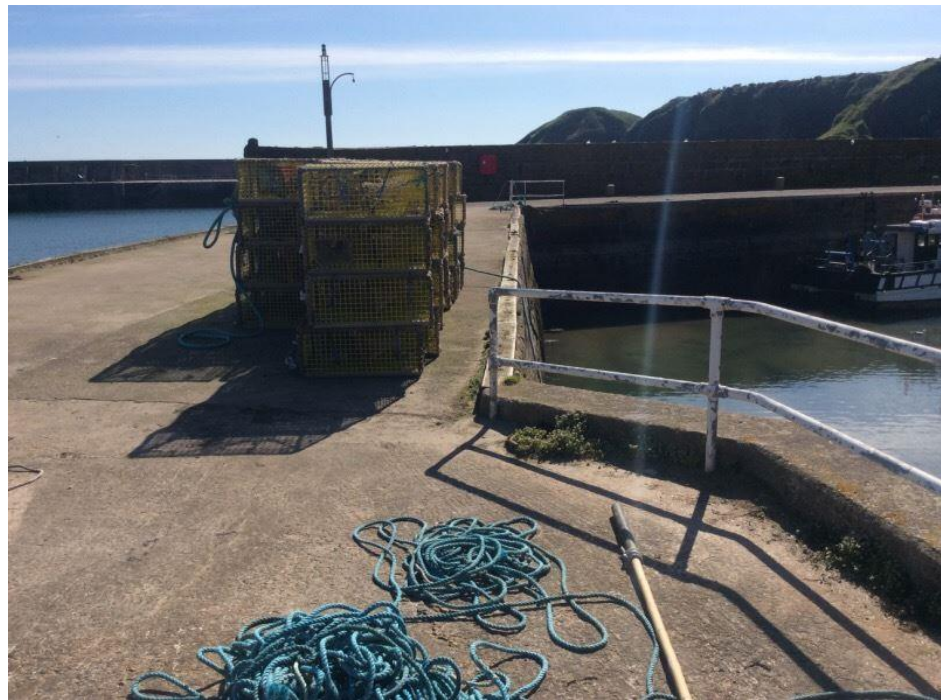
Section B
Deck
Defect Ref: D24
Description: D24 -
Insufficient hand railing
Photo number: 124

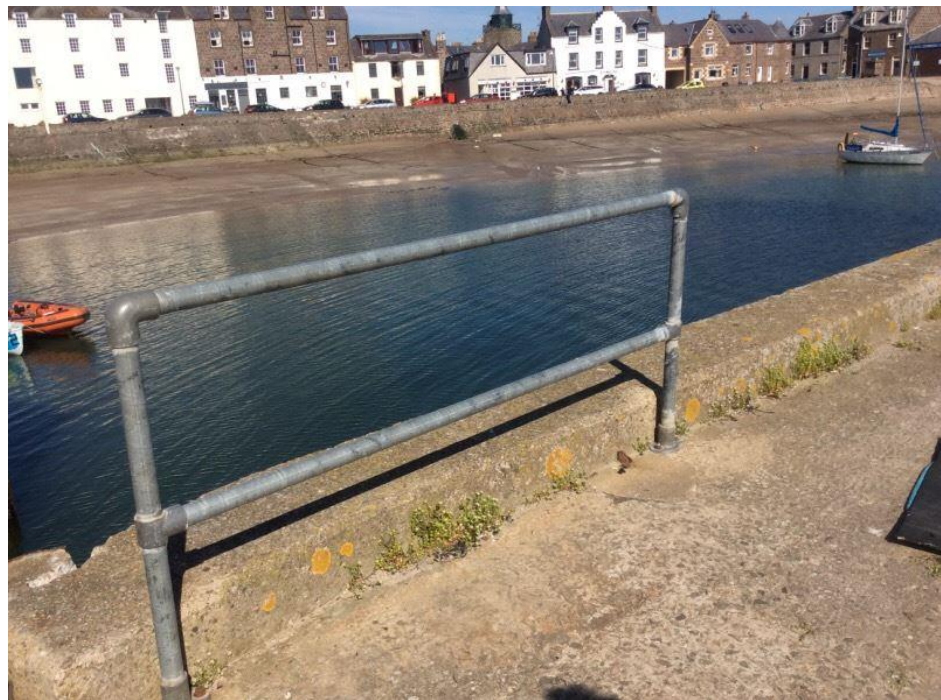
Section B
Deck
Defect Ref: D25
Description: D25 -
Loose handrailing
Photo number: 125

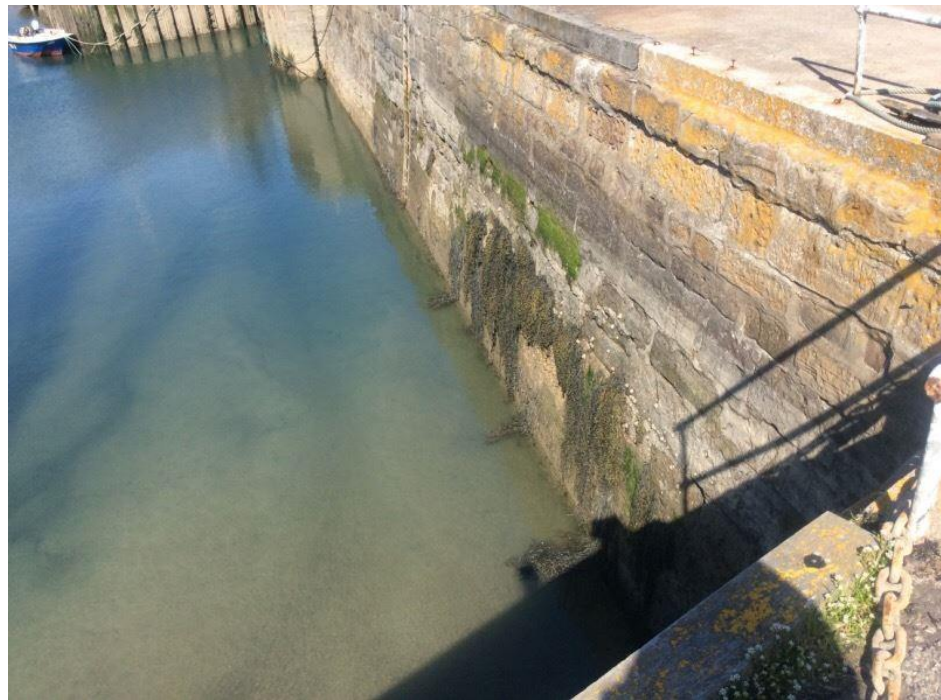
Section B
Quay face
Defect Ref: D26
Description: D26 -
Weathering of blockwork.
Photo number: 126

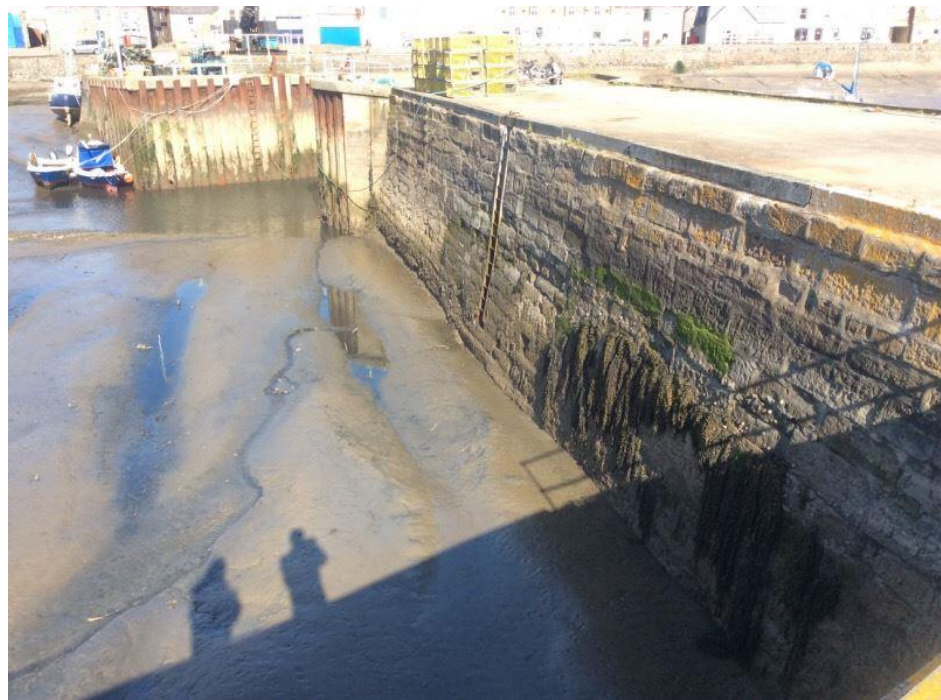
Section B
Quay face
Defect Ref: D26
Description: D26 -
Weathering of blockwork.
Photo number: 213

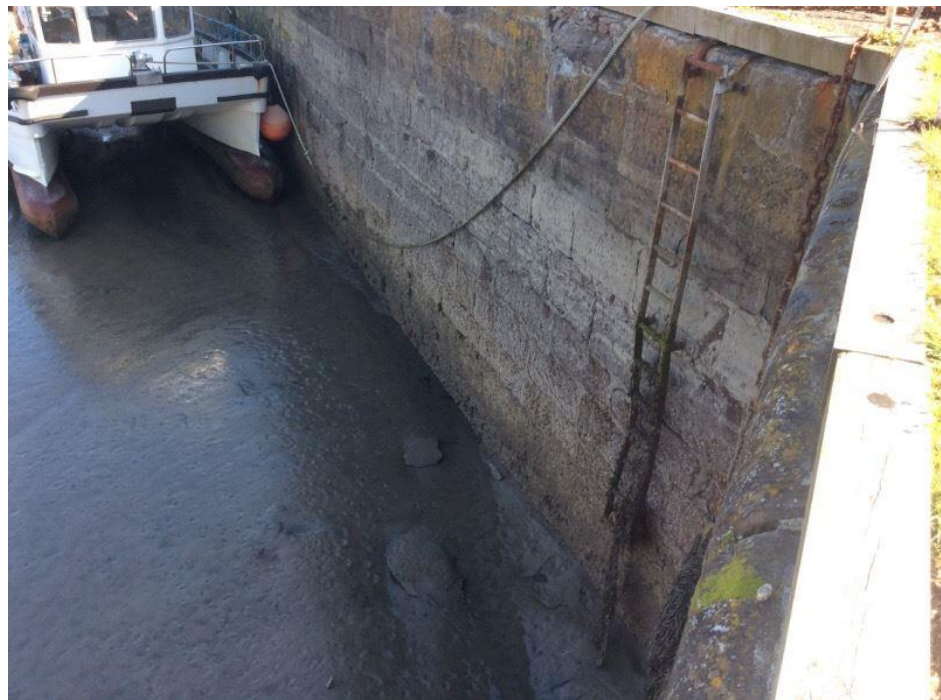
Section B
Quay face
Defect Ref: D27
Description: D27 -
Corroded ladder
Photo number: 212

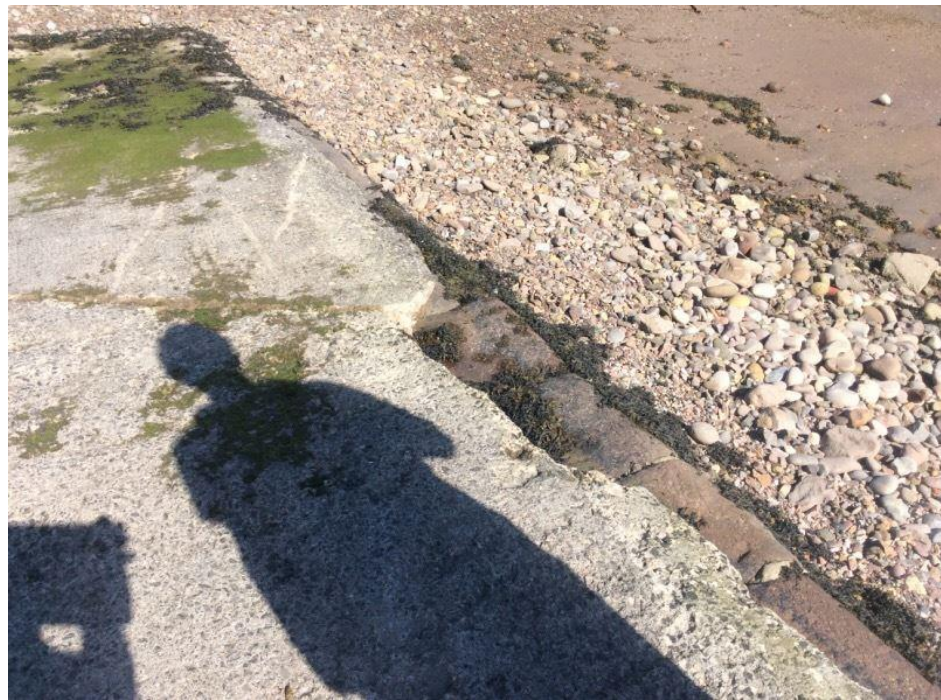
Section C
Access strip
Defect Ref: D28
Description: D28 -
Cracking and loss of
concrete on the slipway
Photo number: 128

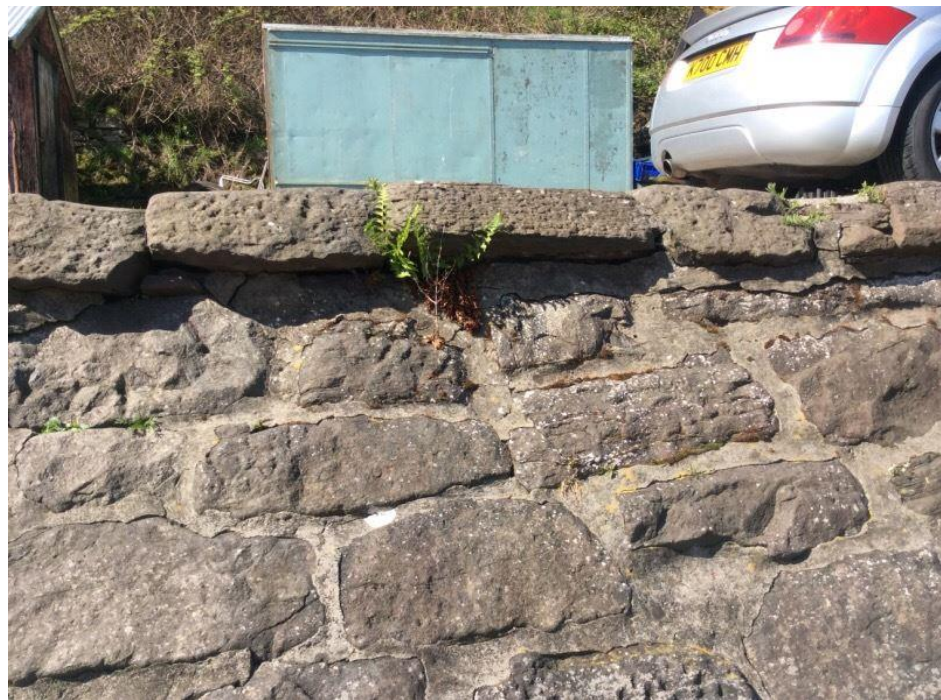
Section C
Exposed face
Defect Ref: D29
Description: D29 -
Cracking of pointing
along the entire length
and loose blockwork.
Photo number: 129

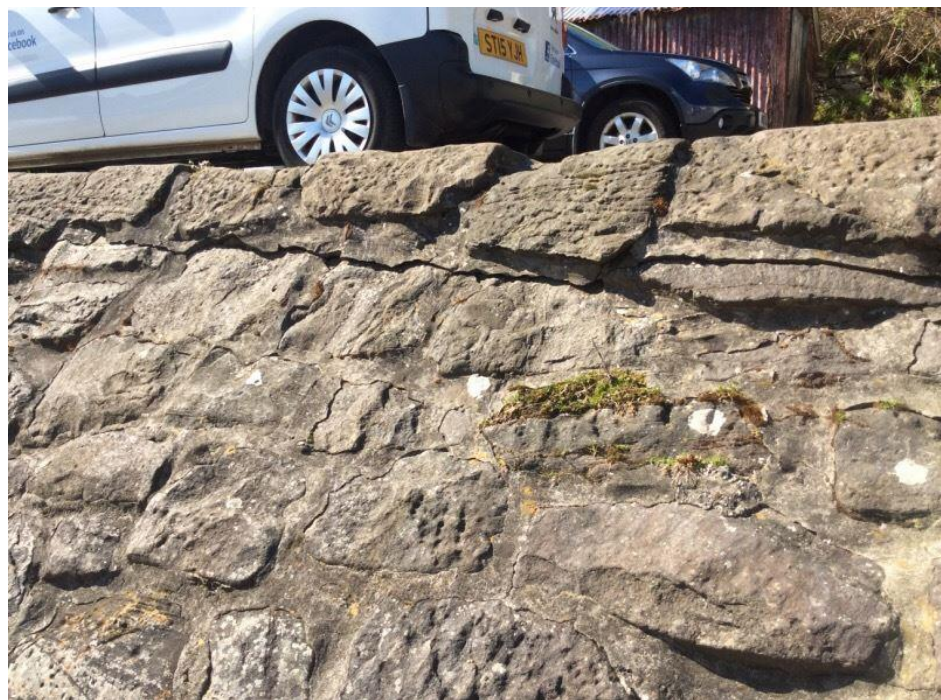
Section C
Exposed face
Defect Ref: D29
Description: D29 -
Cracking of pointing
along the entire length
and loose blockwork.
Photo number: 195

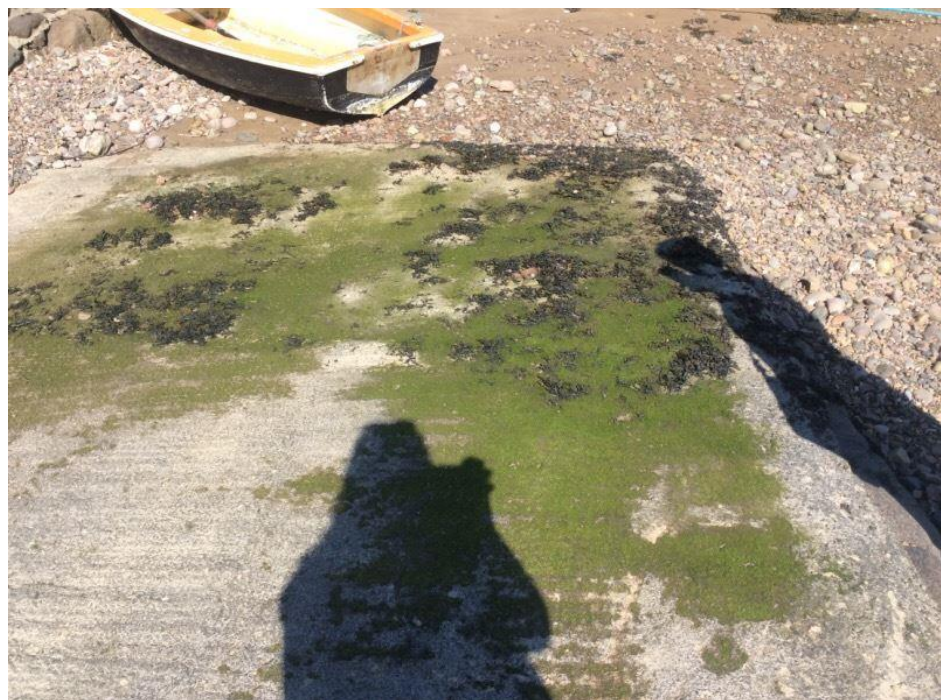
Section C
Access strip
Defect Ref: D30
Description: D30 -
Algae growth on slipway
Photo number: 130

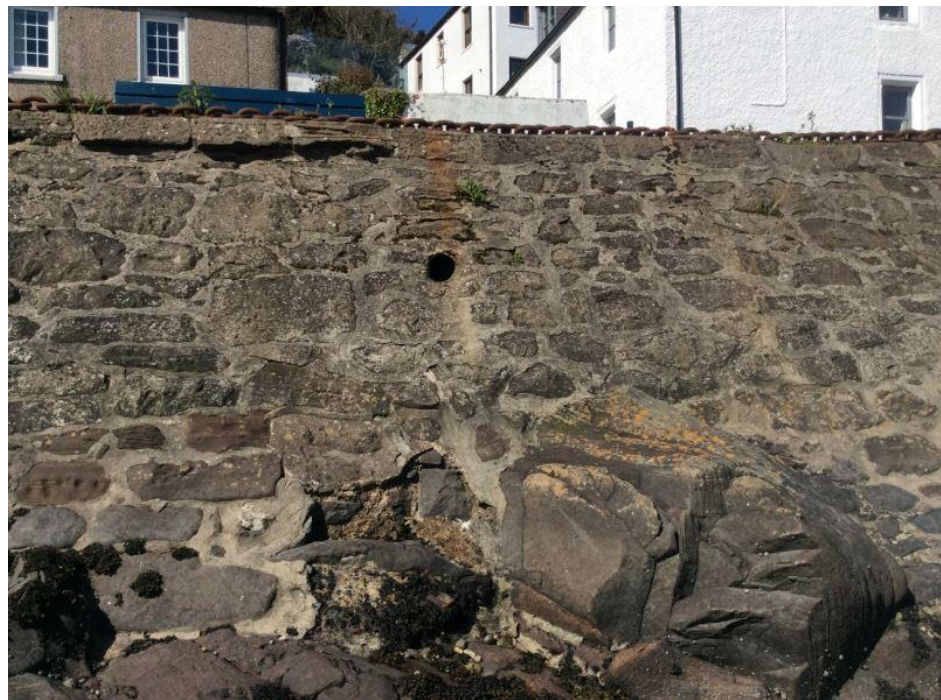
Section C
Exposed face
Defect Ref: D31
Description: D31 -
Missing flap valve
Photo number: 197

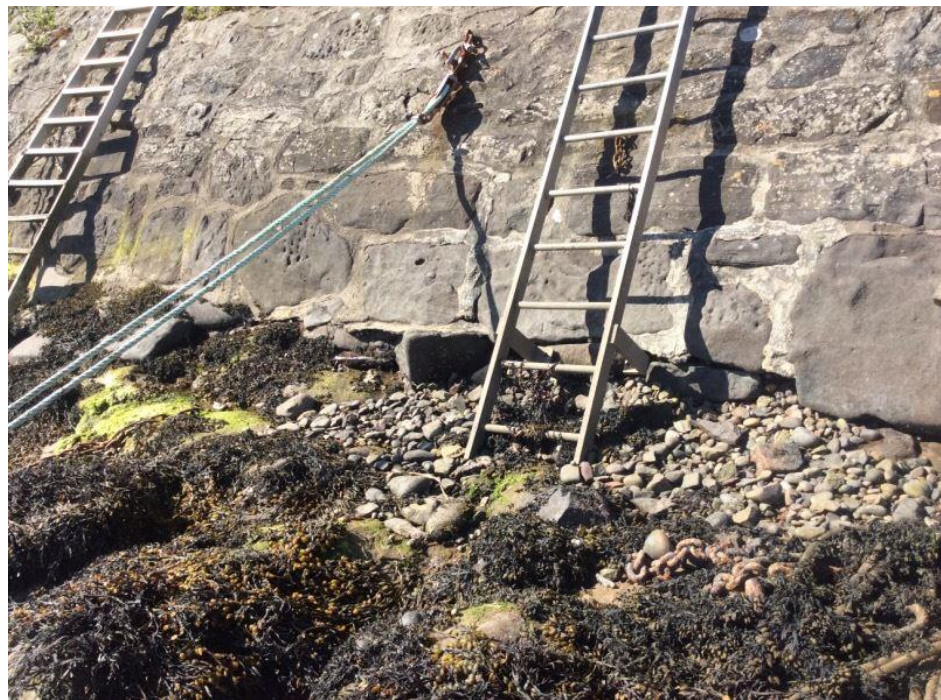
Section C
Exposed face
Defect Ref: D32
Description: D32 -
Undermining scour of
exposed face
approximately 10m
Photo number: 225

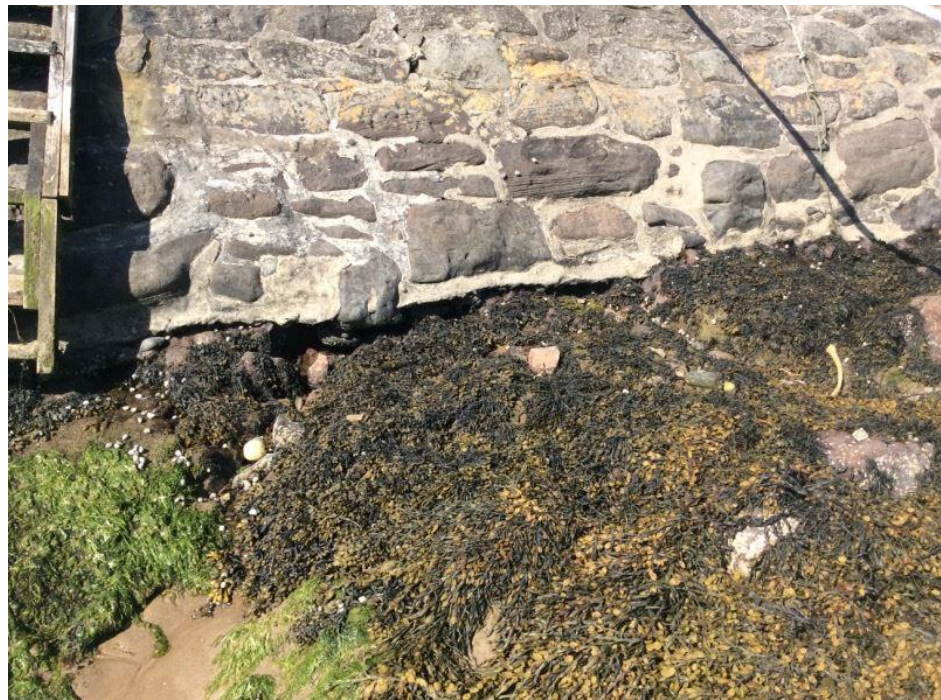
Section C
Exposed face
Defect Ref: D32
Description: D32 -
Undermining scour of
exposed face
approximately 10m
Photo number: 233
