Location Plan:		Stonehaven harbour Assessment Date: 15/05/2018

Exam Type:	Detailed	
	Complete Survey:	Yes	
	Structure Ref:	1	
	OS Ref:	387867 , 785378	
	Survey Unit:	N/A	
	Governing SMP2:	N/A	
	SMP2 Policy Unit:	N/A	
	SMP2 Policy:	N/A	
<p>NOTE: This document has been prepared as an Asset Condition Survey Report for Aberdeenshire Council. JBA Consulting accepts no responsibility or liability for any use that is made of this document other than by the Client for the purposes for which it was originally commissioned and prepared.</p>

COASTAL ASSET CONDITION SURVEY REPORT

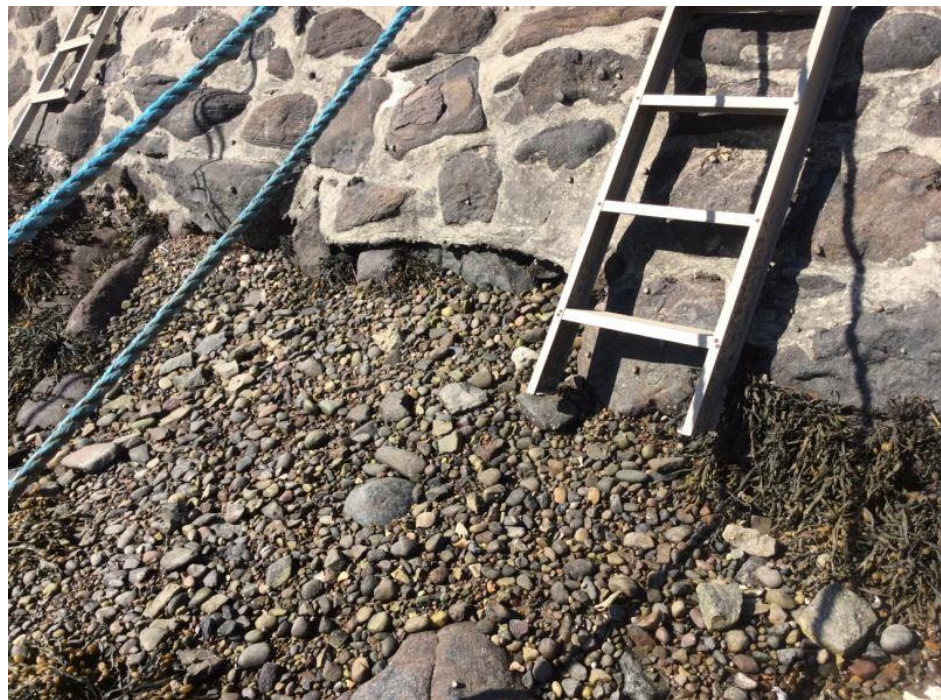
Section C
Exposed face
Defect Ref: D33
Description: D33 -
Undermining scour of
exposed face
approximately 2m long.
Photo number: 133

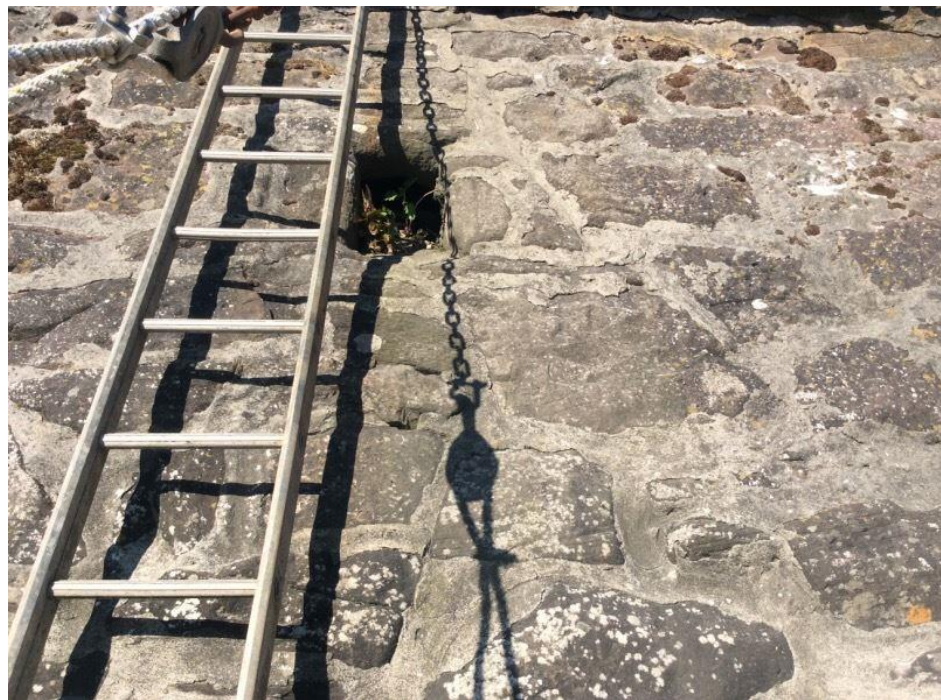
Section C
Exposed face
Defect Ref: D35
Description: D35 - Possibly blocked outfall.
Photo number: 135

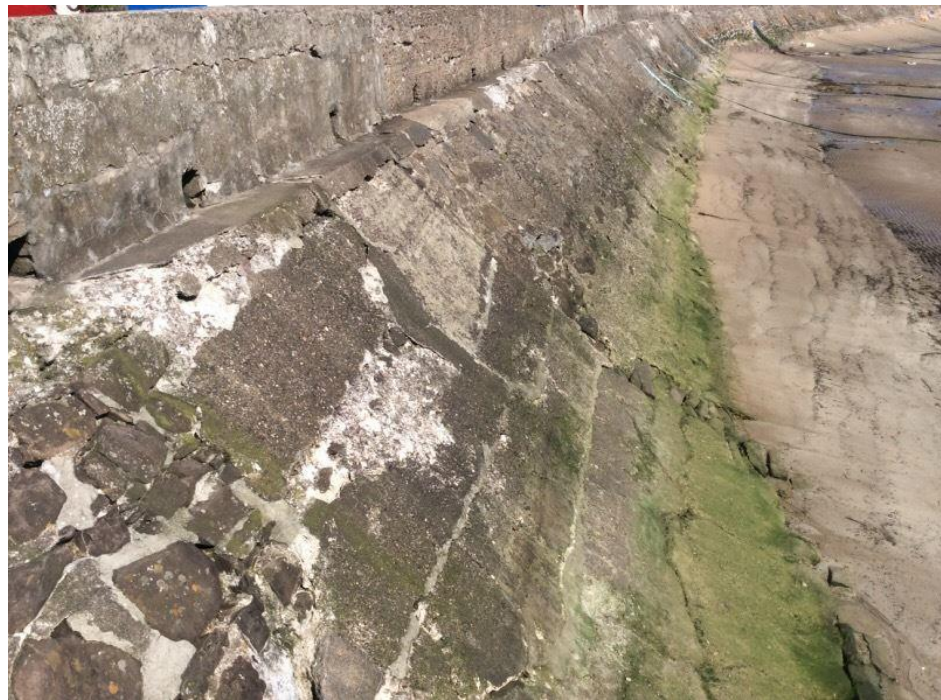
Section C
Exposed face
Defect Ref: D40
Description: D40 - Dilapidated concrete repairs exposing open joints in old masonry blockwork of the exposed face and the crest.
Photo number: 140

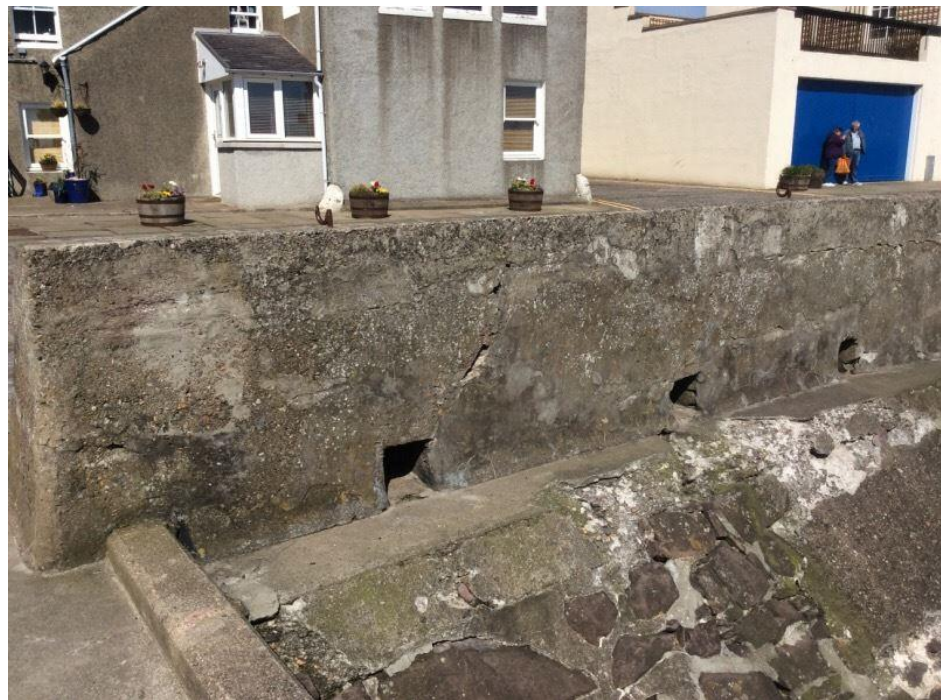
Section C
Capping wall
Defect Ref: D41
Description: D41 - Large horizontal cracks. Cracking also visible on landward side
Photo number: 141

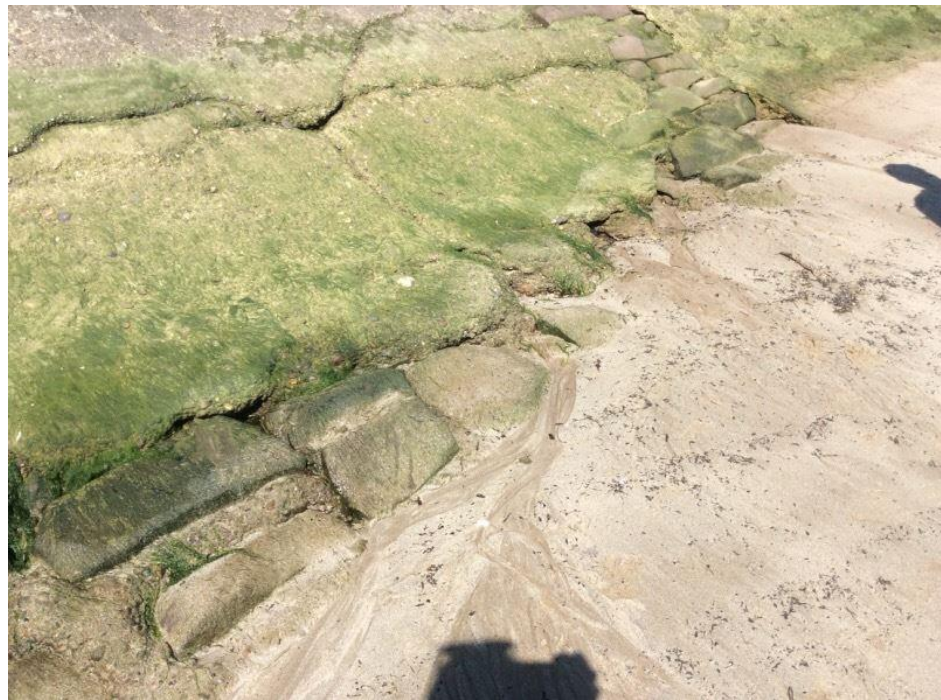
Section C
Exposed face
Defect Ref: D46
Description: D46 -
Delaminating repairs on
toe and potential for
undermining scour,
approximately 30m.
Photo number: 145

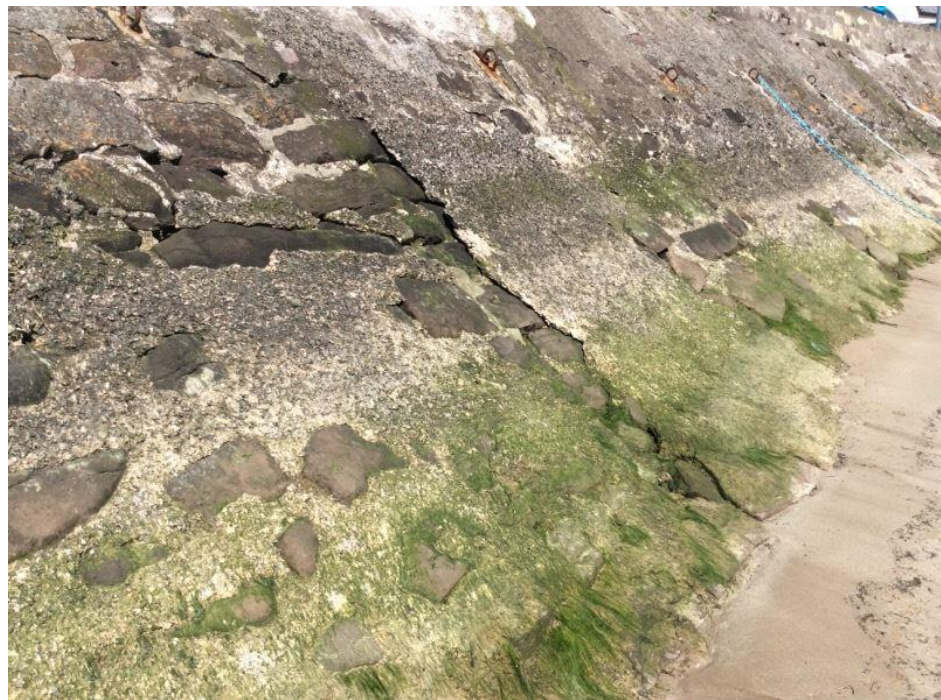
Section C
Exposed face
Defect Ref: D46
Description: D46 -
Delaminating repairs on
toe and potential for
undermining scour,
approximately 30m.
Photo number: 199

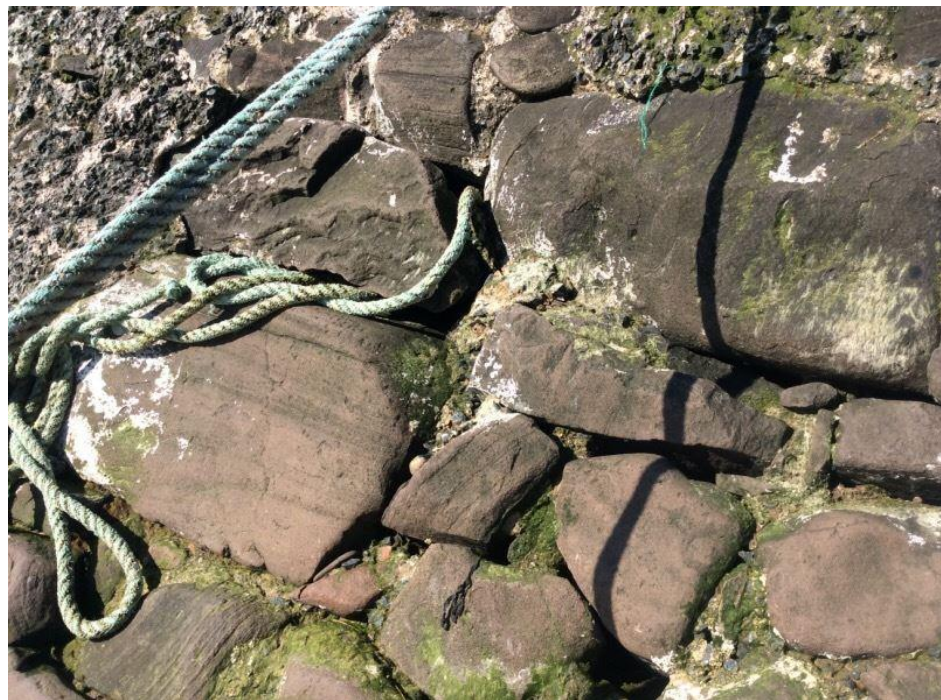
Section C
Exposed face
Defect Ref: D47
Description: D47 -
Voiding behind the
structure. Approximately
1m behind the structure
in 5 locations.
Photo number: 200

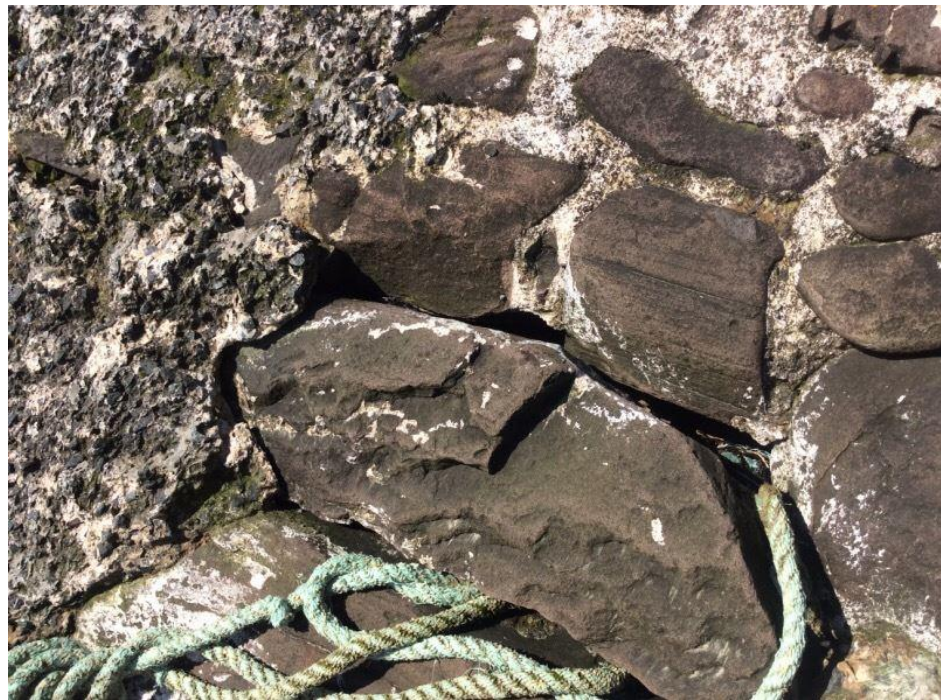
Section C
Exposed face
Defect Ref: D47
Description: D47 -
Voiding behind the
structure. Approximately
1m behind the structure
in 5 locations.
Photo number: 227

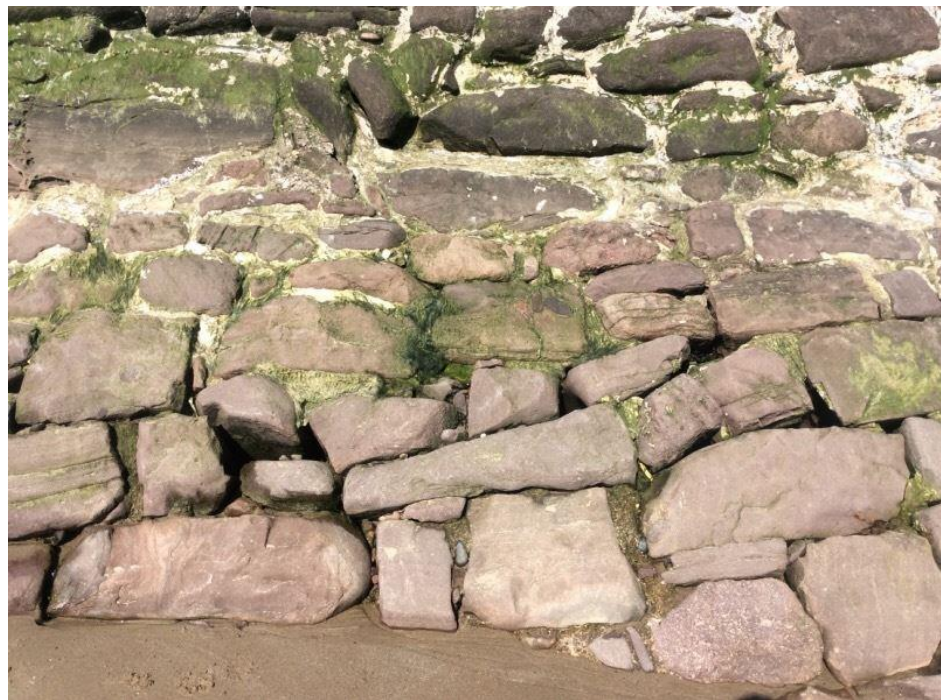
Section C
Exposed face
Defect Ref: D47
Description: D47 -
Voiding behind the
structure. Approximately
1m behind the structure
in 5 locations.
Photo number: 234

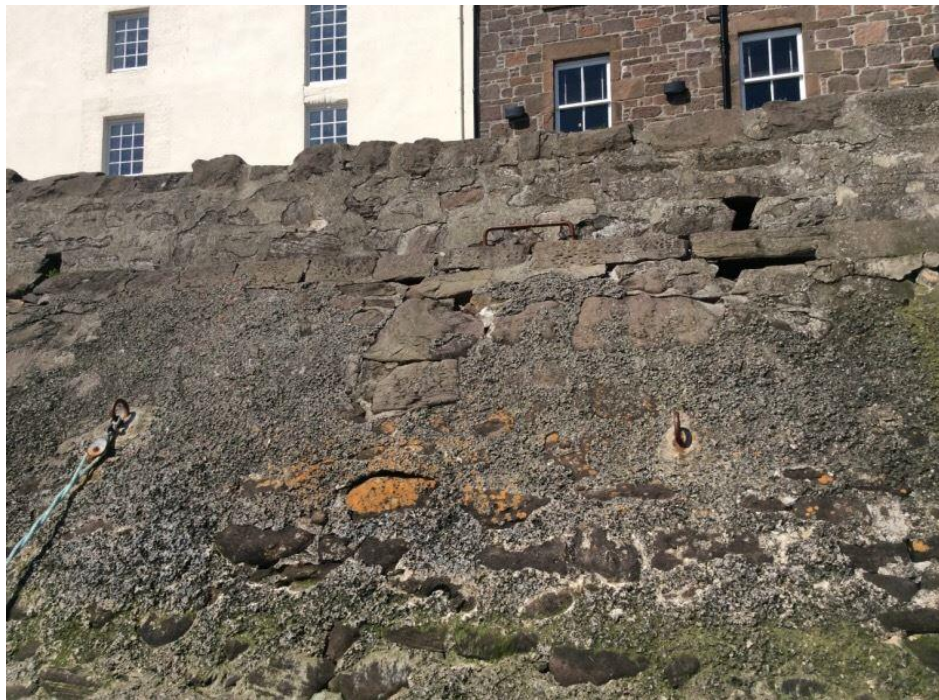
Section C
Capping wall
Defect Ref: D48
Description: D48 -
Drainage points on
capping wall may need
flap valves
Photo number: 147

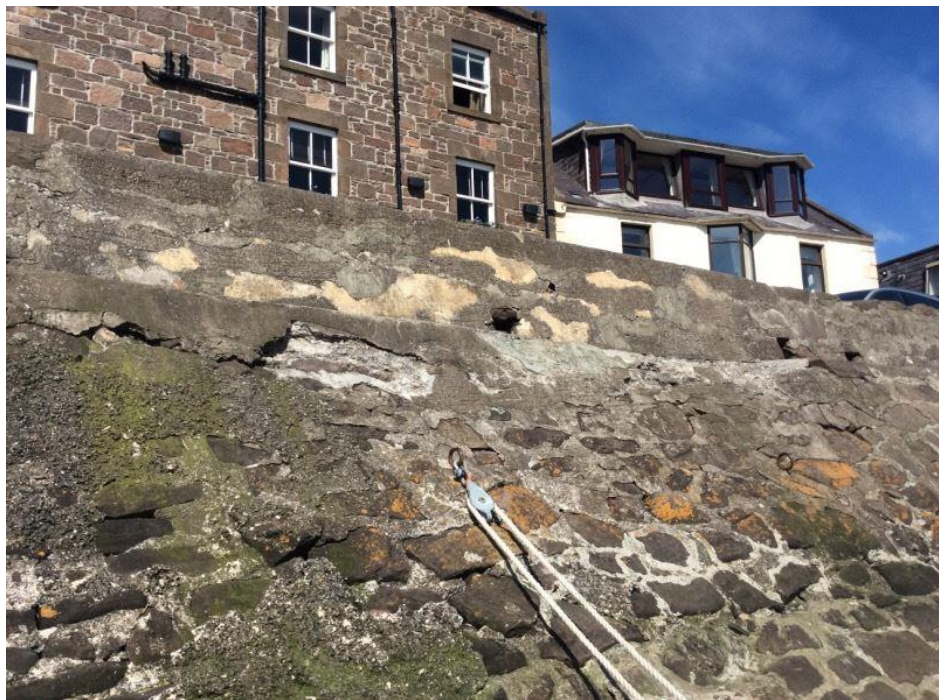
Section C
Capping wall
Defect Ref: D48
Description: D48 -
Drainage points on
capping wall may need
flap valves
Photo number: 201

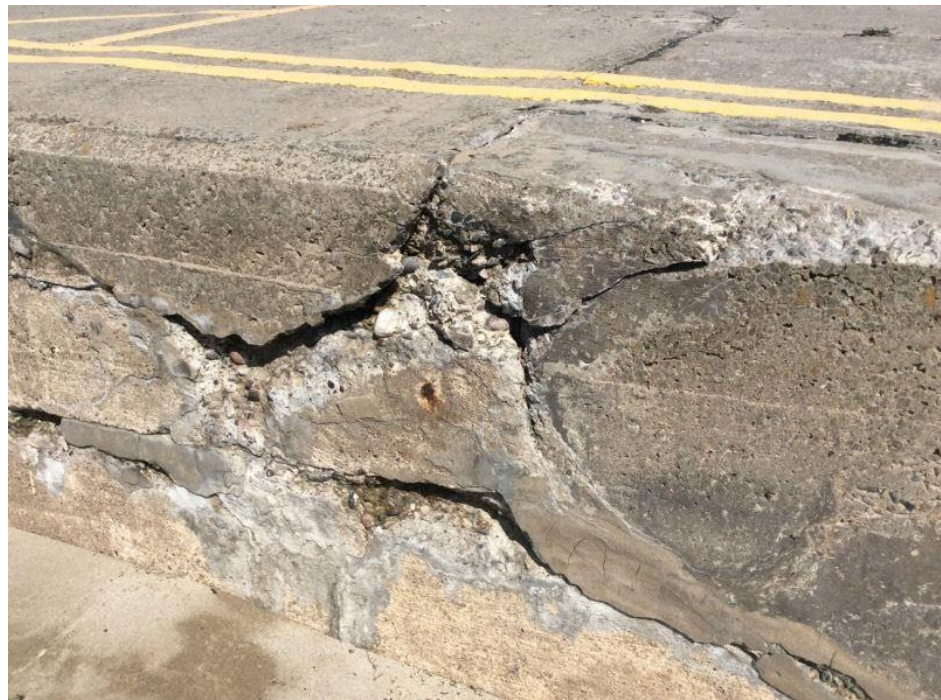
Section E
Access strip
Defect Ref: D51
Description: D51 -
Cracking on side of
slipway.
Photo number: 150

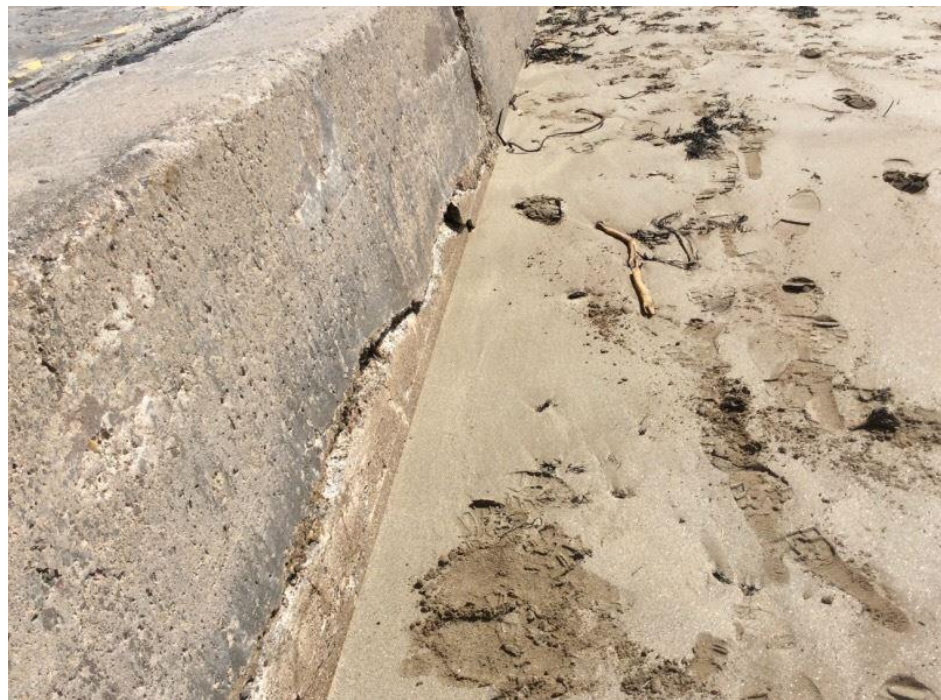
Section E
Access strip
Defect Ref: D51
Description: D51 -
Cracking on side of
slipway.
Photo number: 204

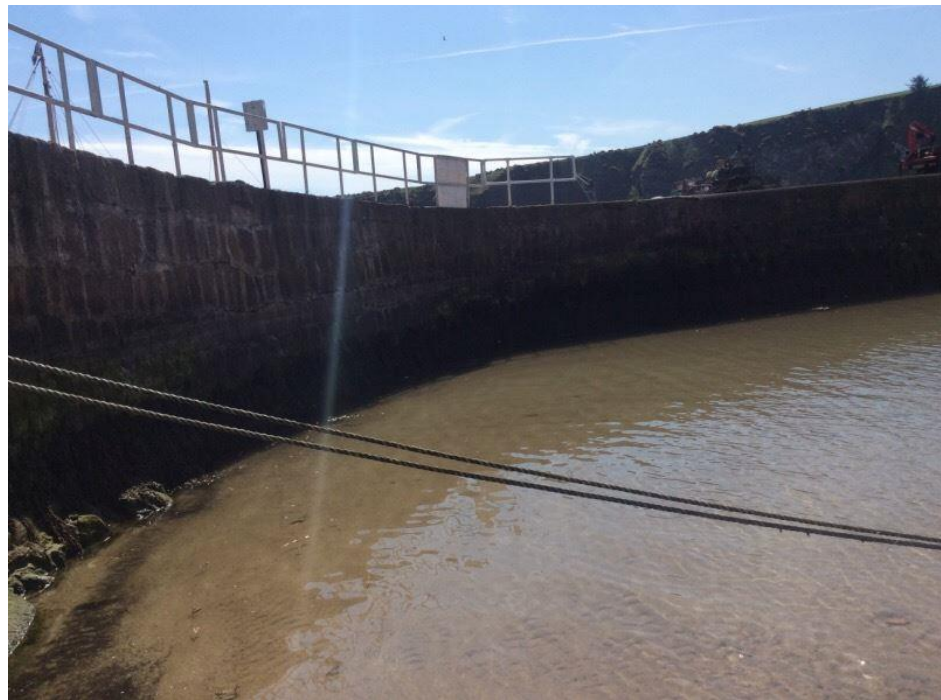
Section F
Quay face
Defect Ref: D52
Description: D52 -
Longitudinal cracks
approximately 8m.
Photo number: 151

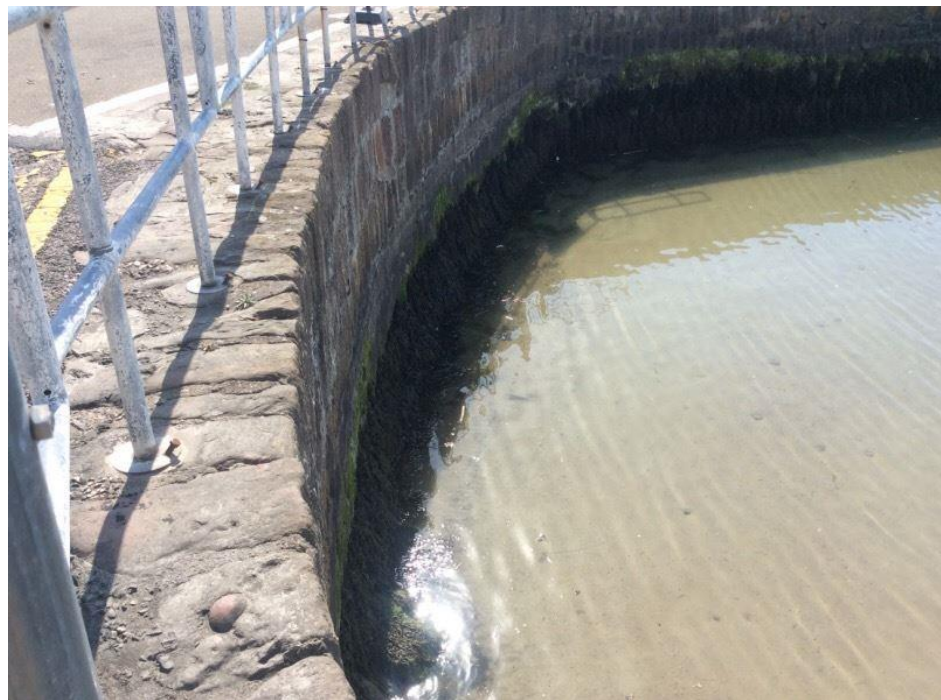
Section F
Quay face
Defect Ref: D52
Description: D52 -
Longitudinal cracks
approximately 8m.
Photo number: 205

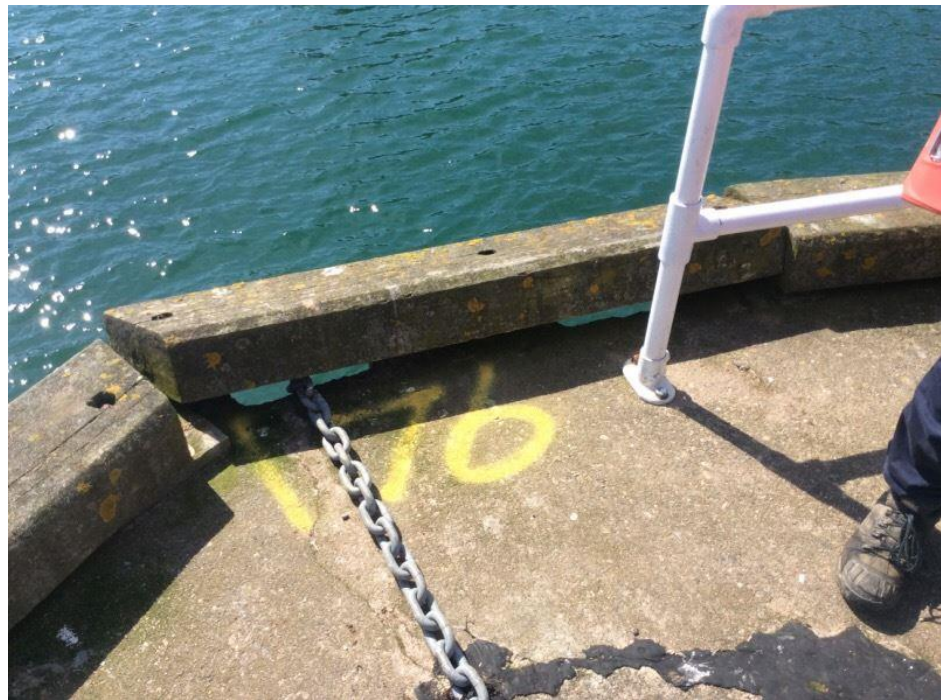
Section F
Deck
Defect Ref: D55
Description: D55 -
Displaced timber beam.
Photo number: 154

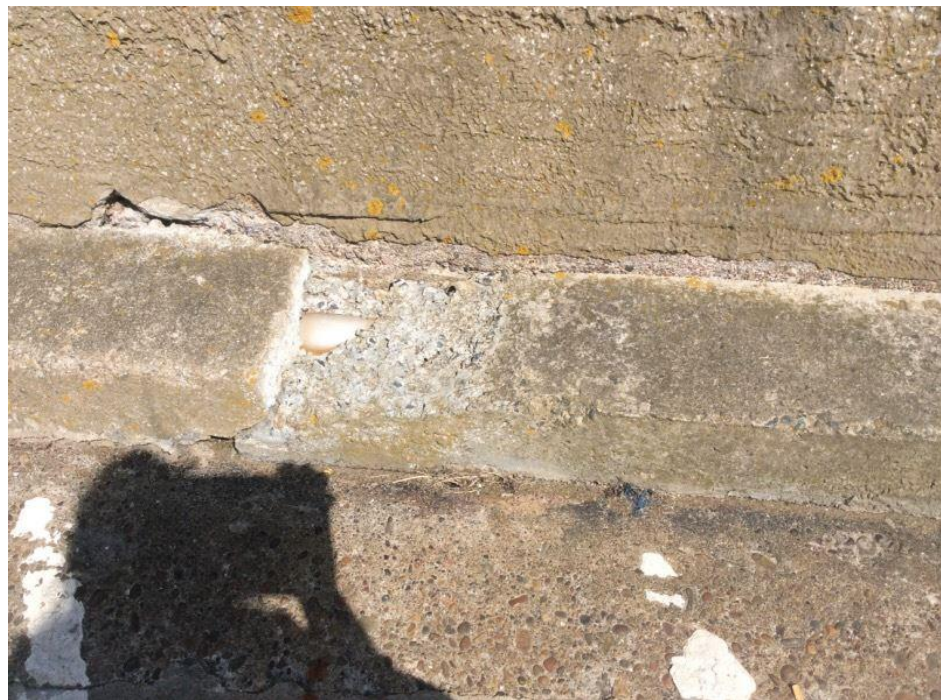
Section G
Capping
Defect Ref: D60
Description: D60 - Missing element, exposed pipe.
Photo number: 158

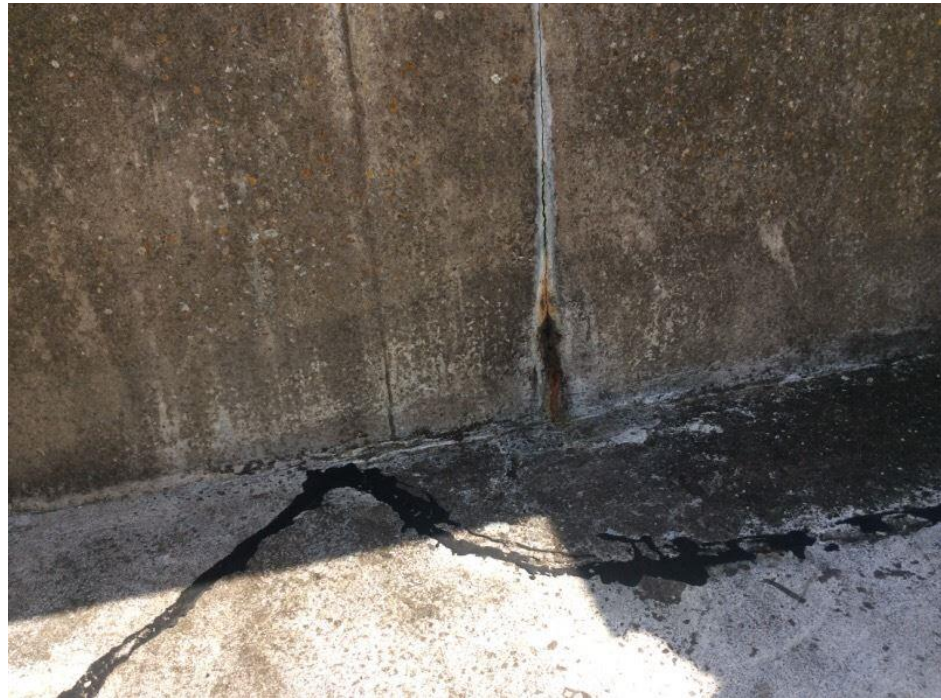
Section G
Seaward face
Defect Ref: D61
Description: D61 -
Stains of corroding
reinforcement.
Photo number: 159

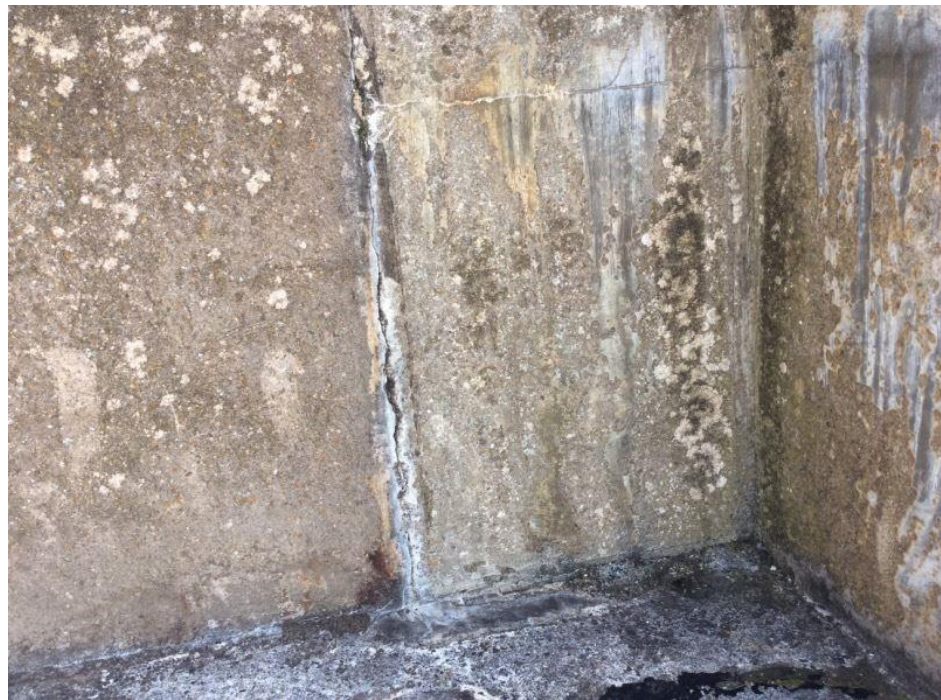
Section G
Seaward face
Defect Ref: D62
Description: D62 -
Cracking of concrete
Photo number: 228

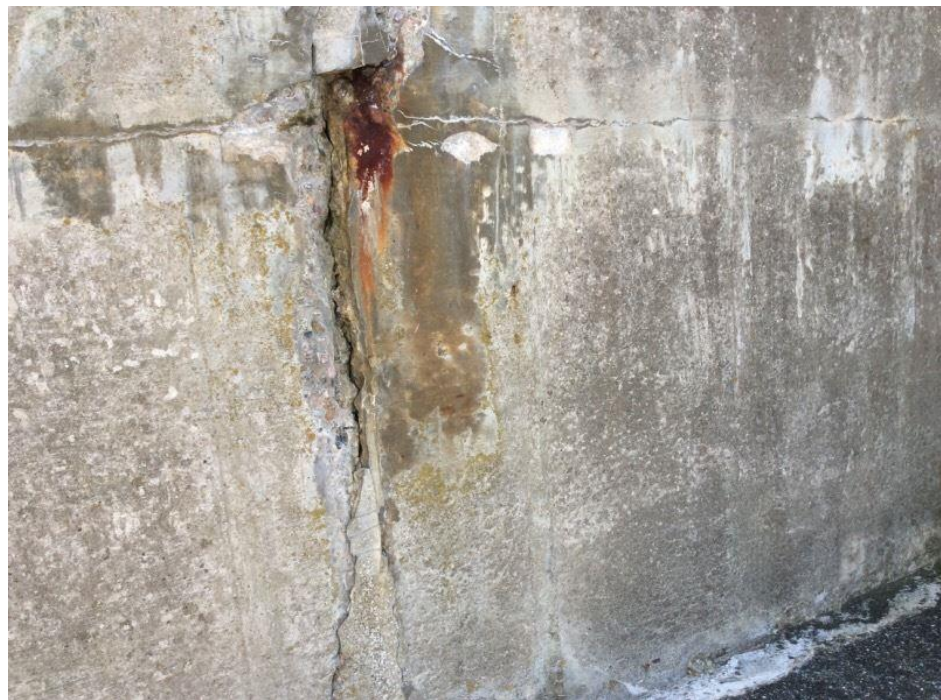
Section G
Seaward face
Defect Ref: D63
Description: D63 -
Cracking of walls.
Repairs coming off.
Photo number: 161

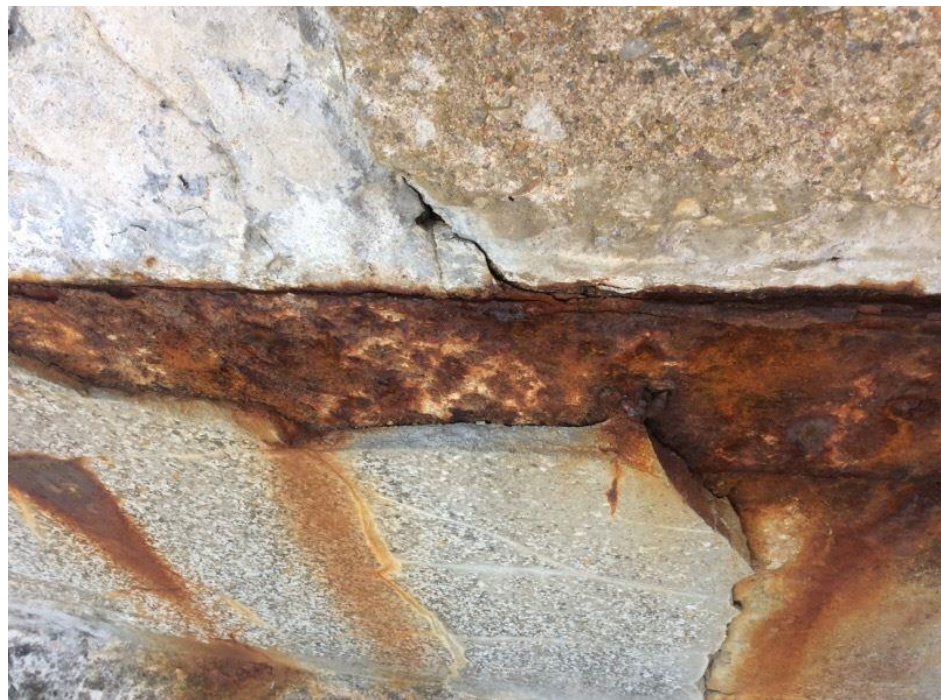
Section G
Seaward face
Defect Ref: D65
Description: D65 -
Exposed steel corroding.
Photo number: 209

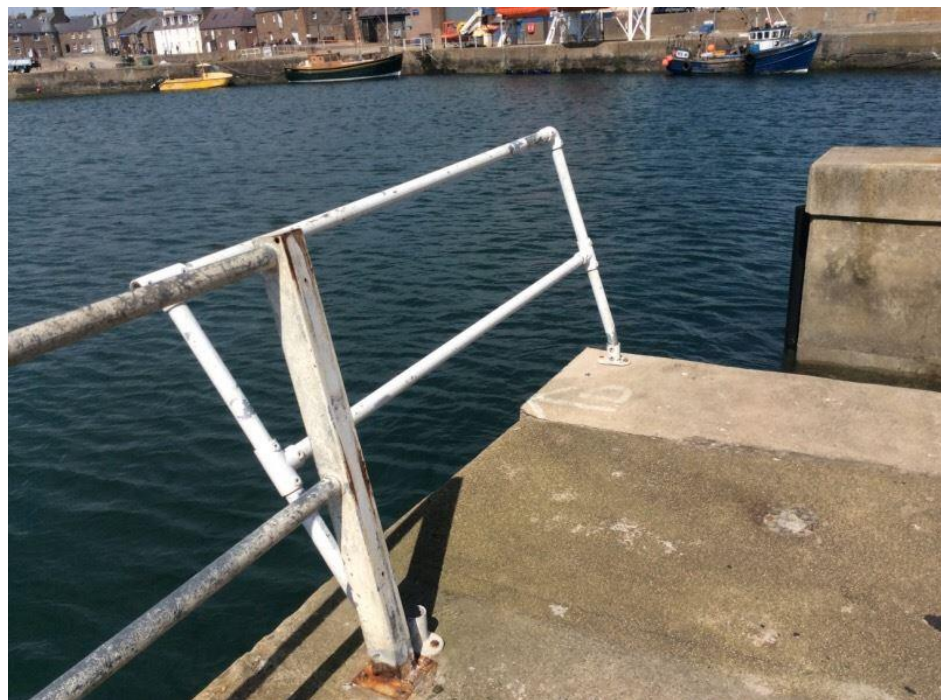
Section G
Seaward face
Defect Ref: D67
Description: D67 -
Health and Safety -
Damaged handrailing
around stepped access.
Photo number: 165

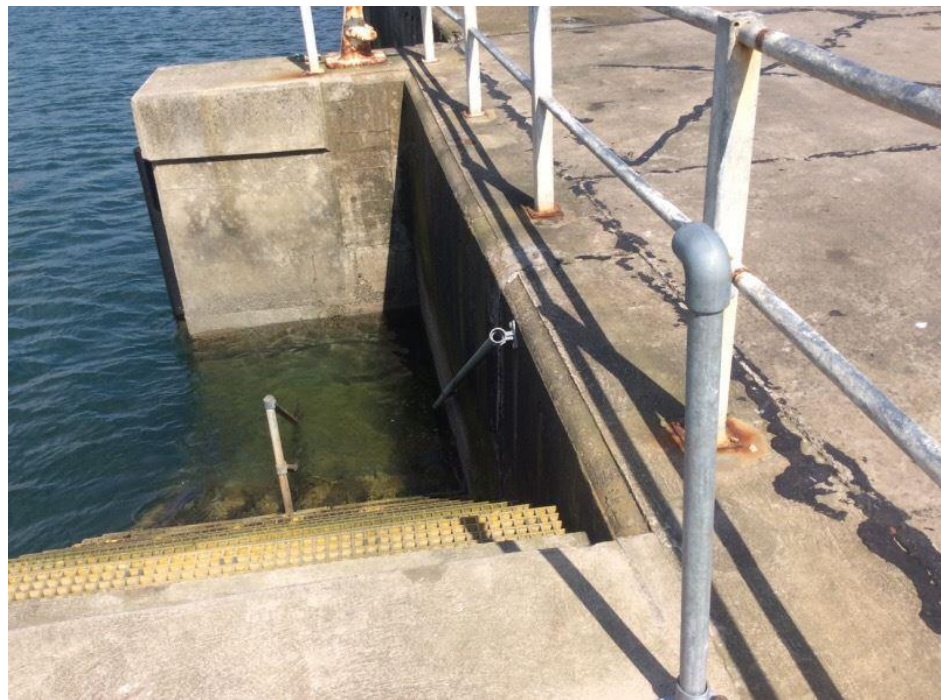
Section G
Seaward face
Defect Ref: D67
Description: D67 -
Health and Safety -
Damaged handrailing
around stepped access.
Photo number: 210

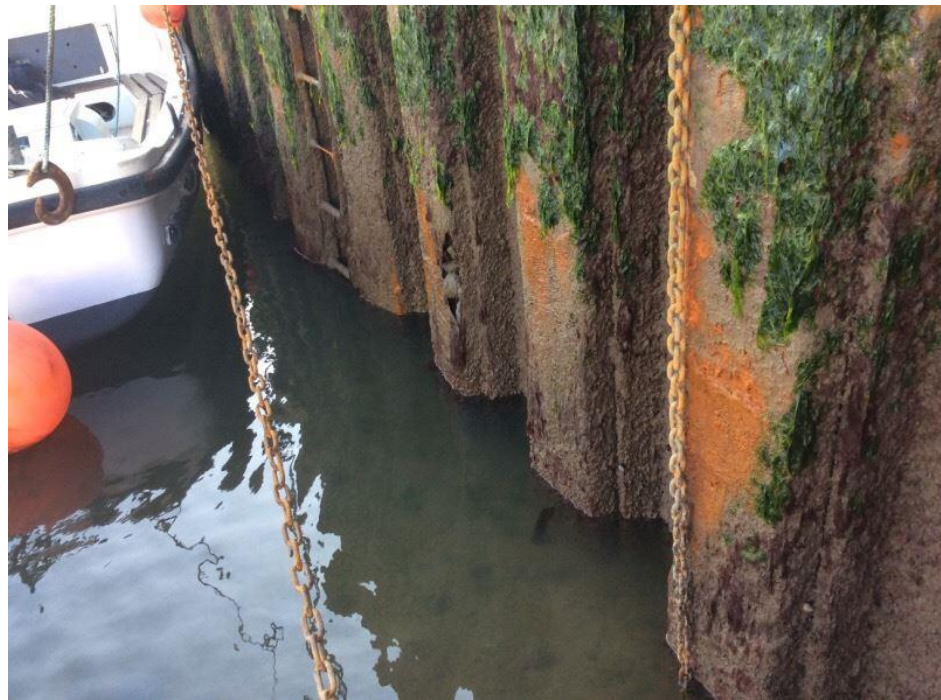
Section D
Sheet piling
Defect Ref: D72
Description: D72 - Two holes in piles, approximately 0.3x0.1m and 0.3x0.3
Photo number: 235

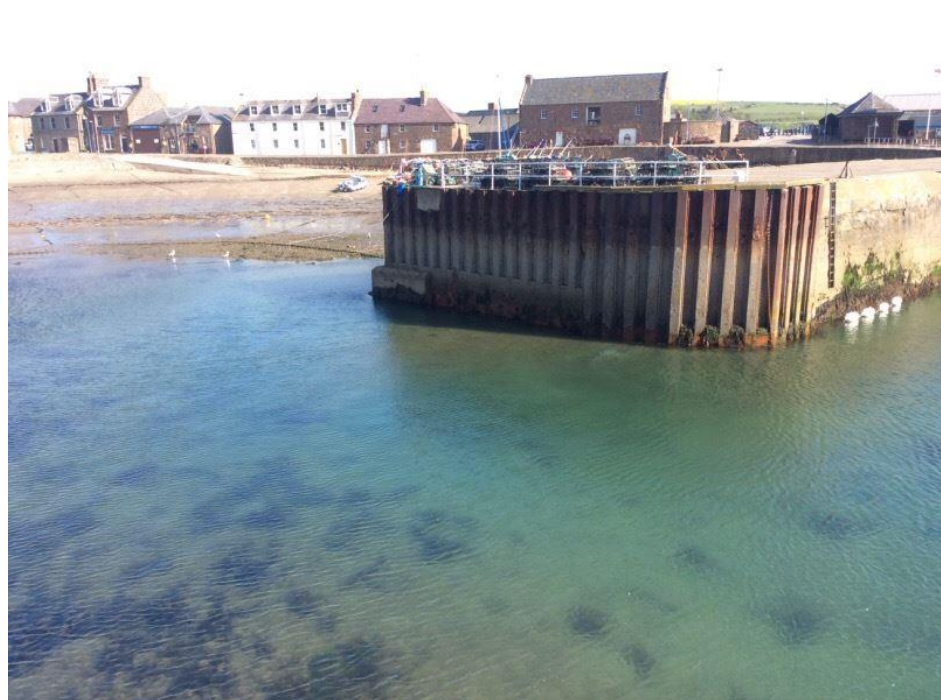
Section F
Sheet piling
Defect Ref: D73
Description: D73 - 6 no of holes corroded through piles.
Photo number: 170

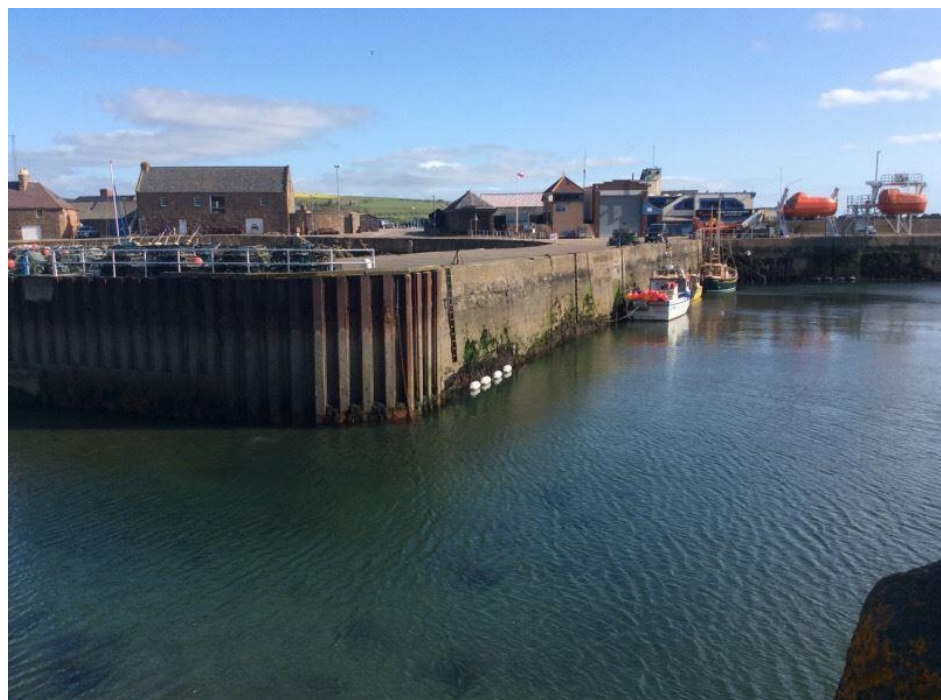
Section F
Quay face
Defect Ref: D76
Description: D76 -
Delaminating concrete
repairs
Photo number: 172

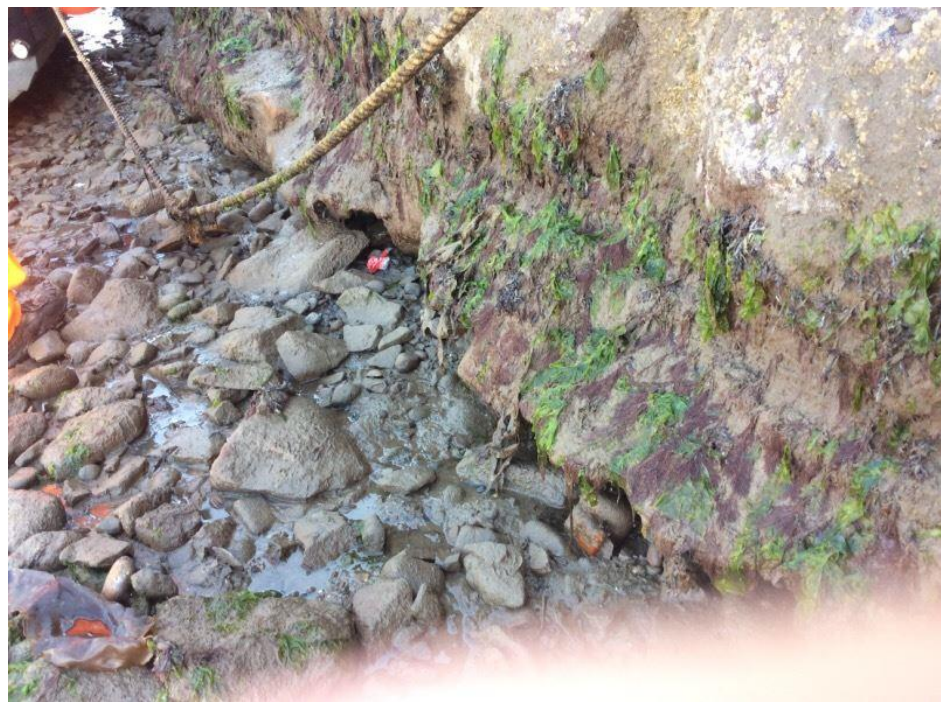
Section F
Quay face
Defect Ref: D77
Description: D77 -
Undermining scour on
toe of old concrete toe
repairs.
Photo number: 175

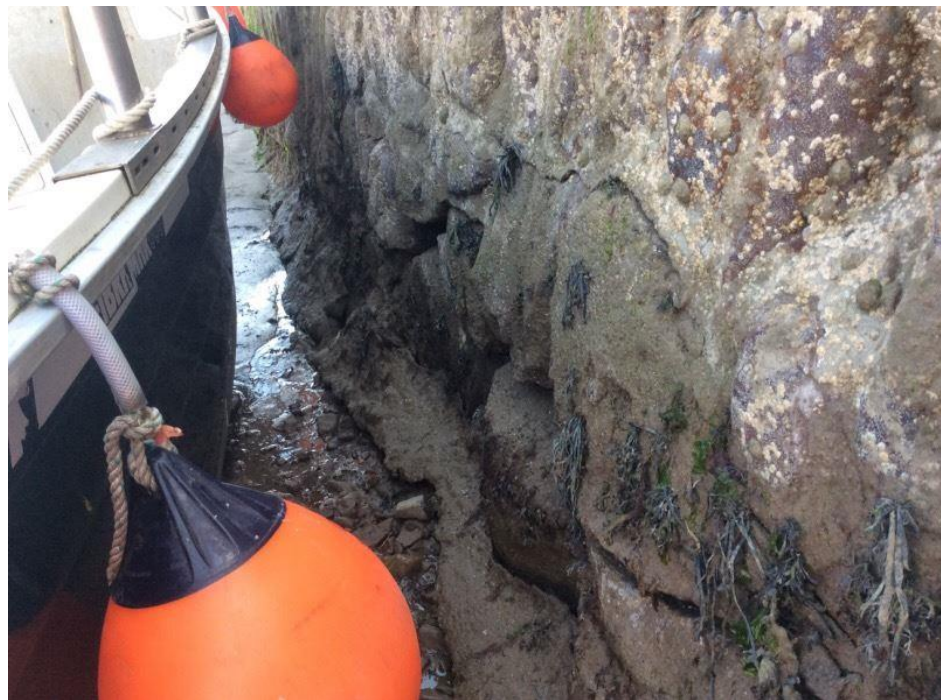
Section F
Quay face
Defect Ref: D77
Description: D77 -
Undermining scour on
toe of old concrete toe
repairs.
Photo number: 217

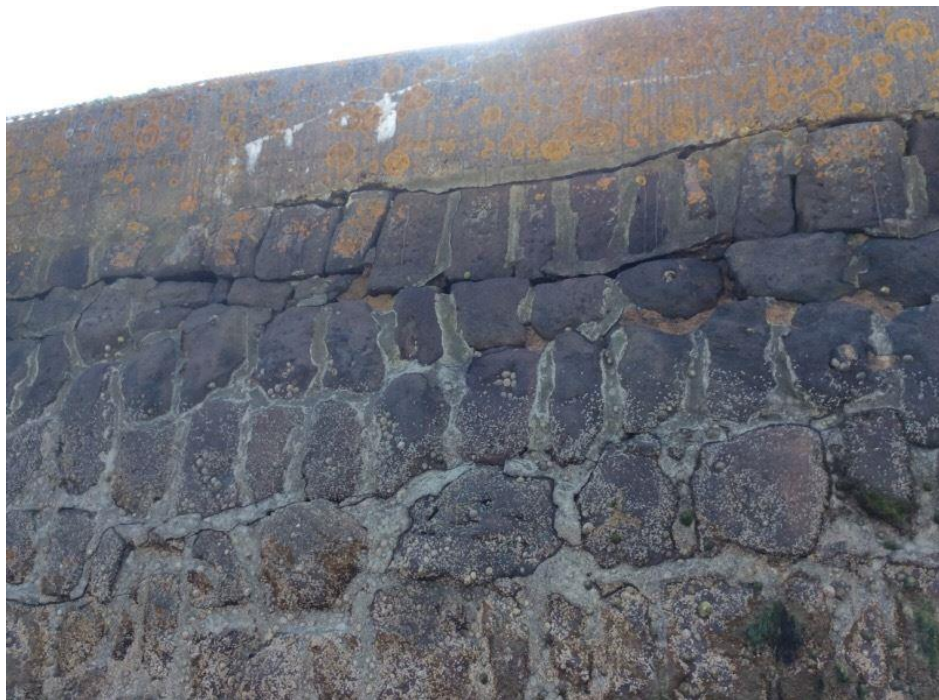
Section F
Quay face
Defect Ref: D78
Description: D78 - Open joints
Photo number: 218

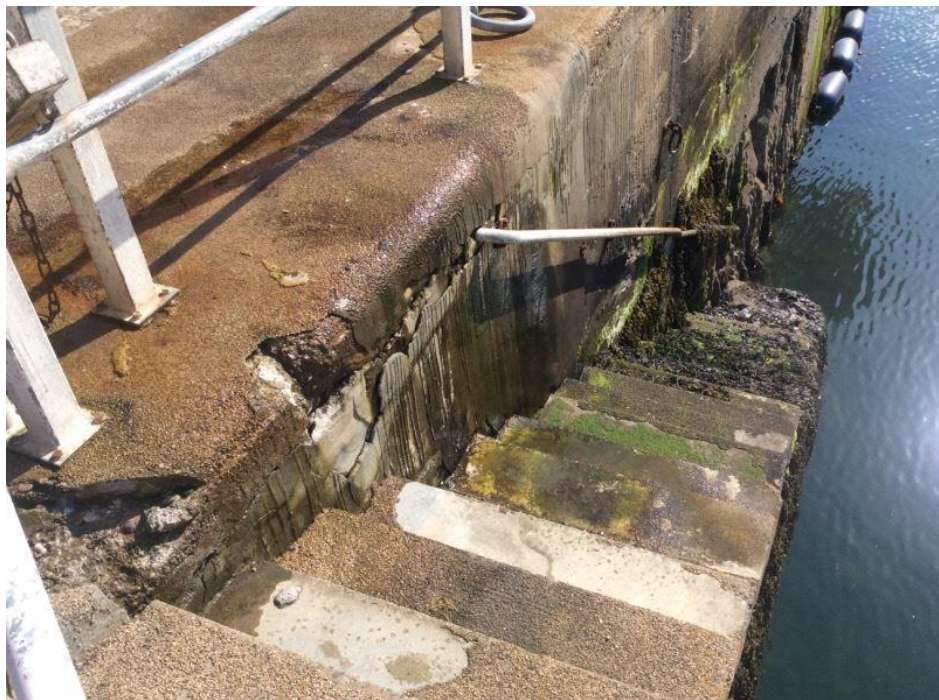
Section G
Quay face
Defect Ref: D81
Description: D81 -
Spalling , delaminating
concrete
Photo number: 219

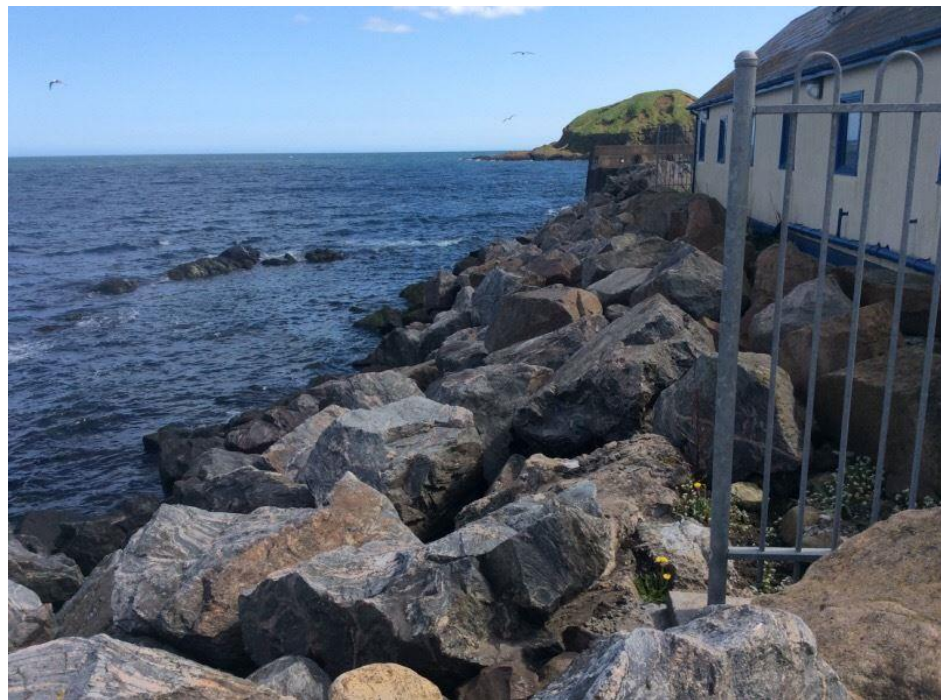
Section H
Rock armour
Defect Ref: D86
Description: D86 -
Overly steep rock armour
profile
Photo number: 186
