# Stonehaven Bay Coastal Flood Protection Study

## Natural Flood Management and River Basin Management Plan Report

### Final Report

December 2018

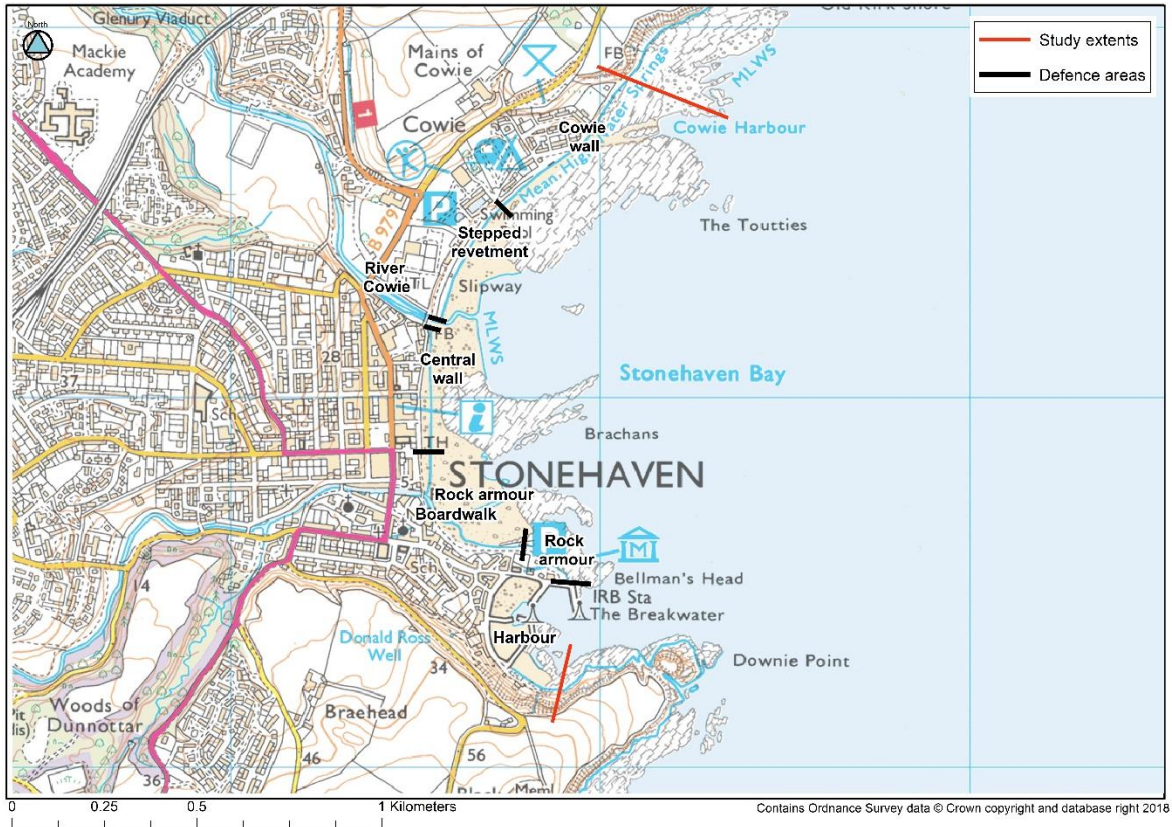
Figure 2-3: Area and defence types within Stonehaven Bay

There are several formal and informal coastal defences within the study area which include (south to north, Figure 2-3):

- Stonehaven Harbour which contains rock armour revetments, a breakwater, piers and quay walls.
- A large rock armour revetment to the north of Stonehaven harbour.

- A boardwalk section north of the harbour consisting of rock armour and a shingle beach which suffers erosion and damage during storm events. The Carron outfalls within this area.

- A concrete wall and shingle beach area fronting the Stonehaven properties.
- The outlet of the River Cowie consists of a combination of concrete walls, concrete revetments, and steel sheet piles.

- Stepped revetments between the mouth of the River Cowie and open air pool form the main coastal defence along the south Cowie frontage. It consists of a stepped concrete revetment with small wave return wall at the crest.

- A concrete and masonry wall defends the coast north of the pool, in front of Cowie village.
- It is understood that construction of the River Carron fluvial flood protection scheme is due to commence from August 2018.

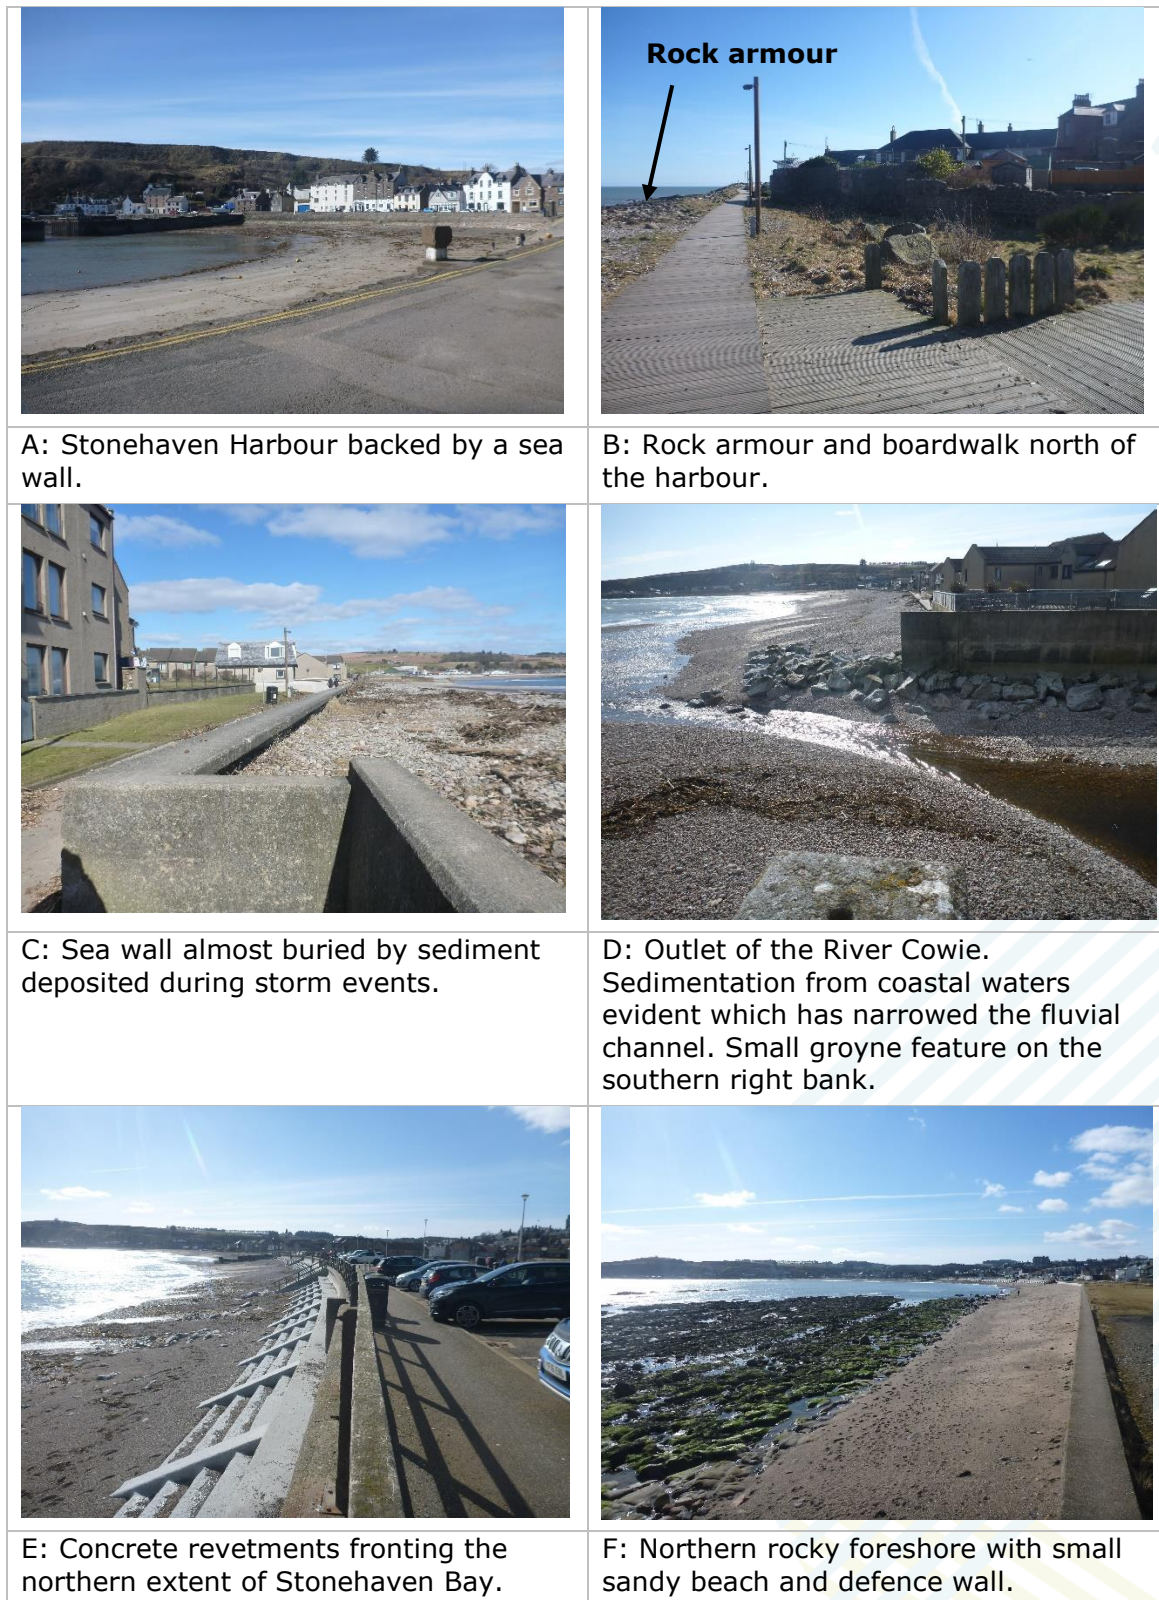
Figure 3-1: Coastal morphological pressures

Despite being of 'Good' morphological condition the coastline has been highly modified with coastal defences present along the entire study extent. These include a sea wall in Stonehaven Harbour (Figure 3-1, A), rock armour north of the harbour (Figure 3-1, B) stepped revetments with a small wave return wall at the crest through the centre and northern extent of Stonehaven Bay (Figure 3-1, C and E) and a sea wall at Cowie village (Figure 3-1, F).

Removal of the defences is not a viable option as they are the primary source of protection to the town, and managed realignment to set-back defences is not viable as land claim means the town backs directly onto the coastline. Limiting future additional hard-engineering along the coastline to maintain the 'Good' morphological RBMP status should be considered during the options appraisal. Where additional defences are required use of 'green' materials could be considered. For example, as is being developed through the EU funded Catterline coastal erosion project which is aiming to use trees, reclaimed timber, debris and biodegradable material to shore up the bay's defences to protect it from coastal erosion and landslides<sup>10</sup>.

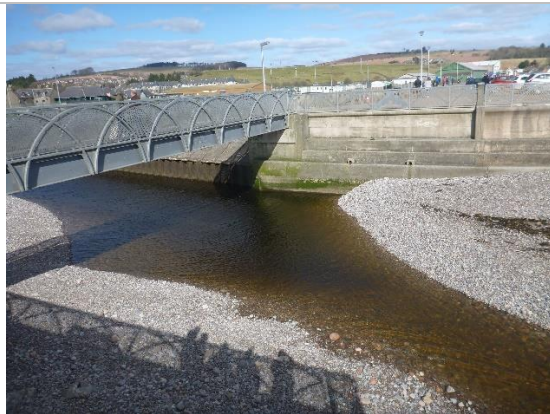
C: Looking downstream across the River Cowie. Narrowing of the channel outlet due to sedimentation.
