## 1. General information

Location Plan:		Stonehaven coastal defences Assessment Date: 14/05/2018

# COASTAL ASSET CONDITION SURVEY REPORT

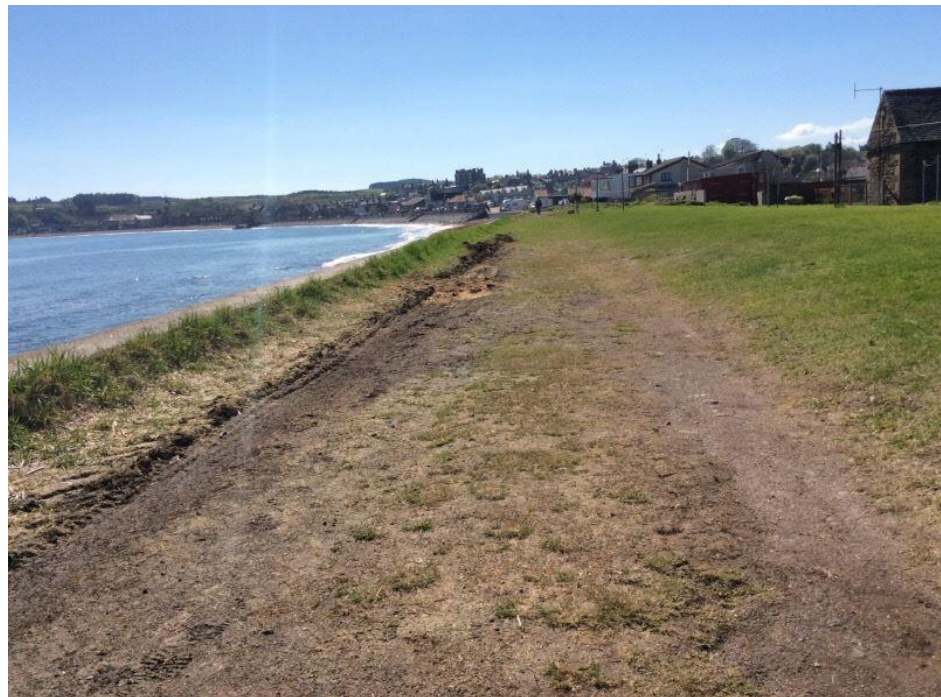
**Section B  
Crest  
Defect Ref: D1  
Description: D1 - Poorly  
vegetated and eroded  
crest  
Photo number: 63**

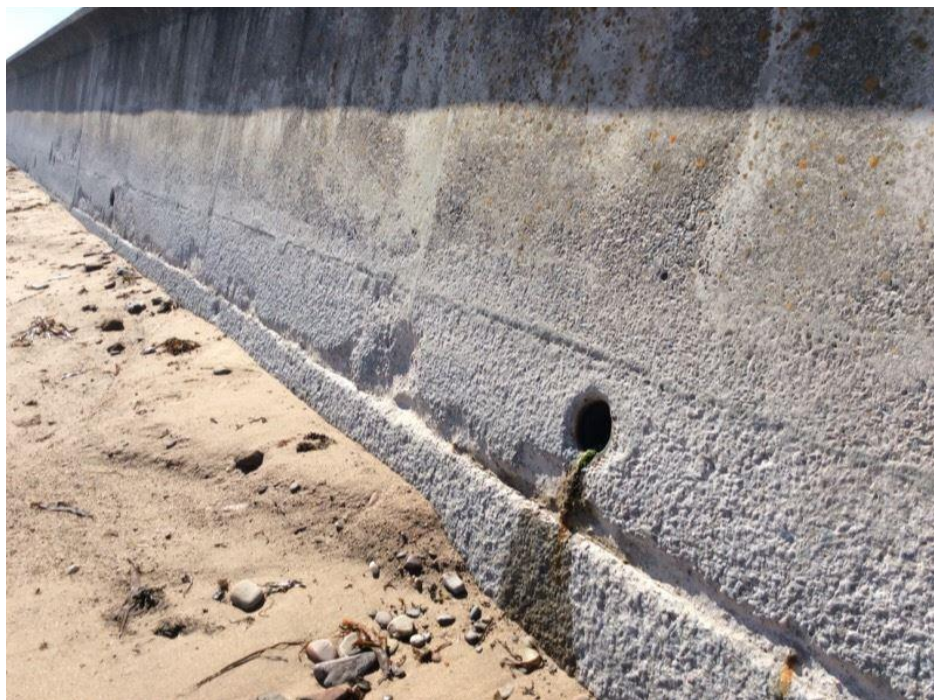
**Section B**  
**Exposed face**  
**Defect Ref: D7**  
**Description: D7 - 12**  
**missing flap valves**  
**Photo number: 52**

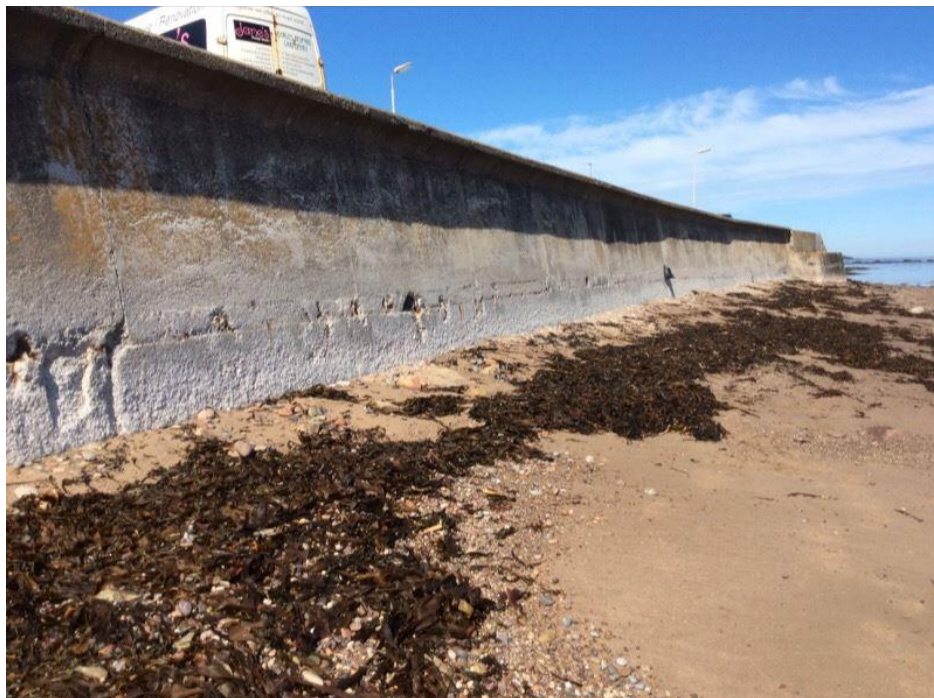
**Section B**  
**Exposed face**  
**Defect Ref: D8**  
**Description: D8 -**  
**Spalling concrete**  
**Photo number: 53**

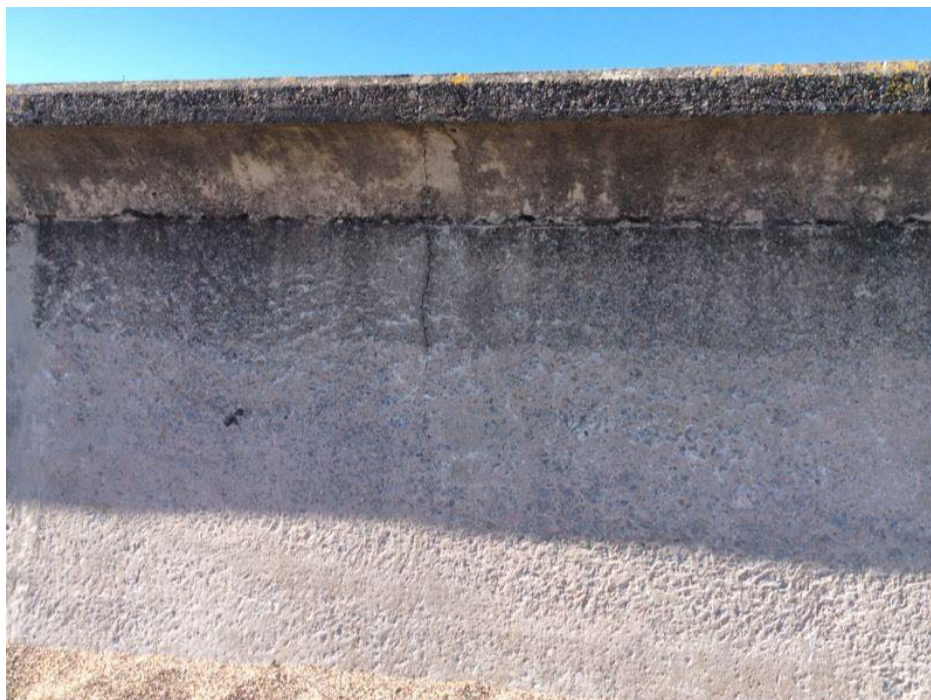
**Section B**  
**Exposed face**  
**Defect Ref: D11**  
**Description: D11 -**  
**Vertical crack**  
**Photo number: 56**

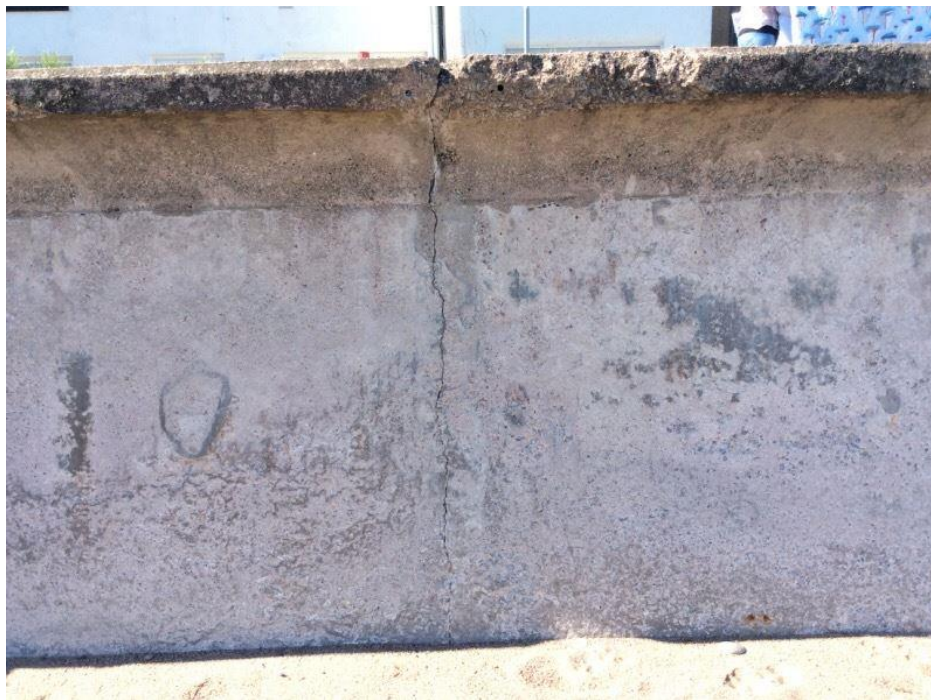
**Section B**  
**Exposed face**  
**Defect Ref: D12**  
**Description: D12 -**  
**Vertical fracture**  
**Photo number: 57**

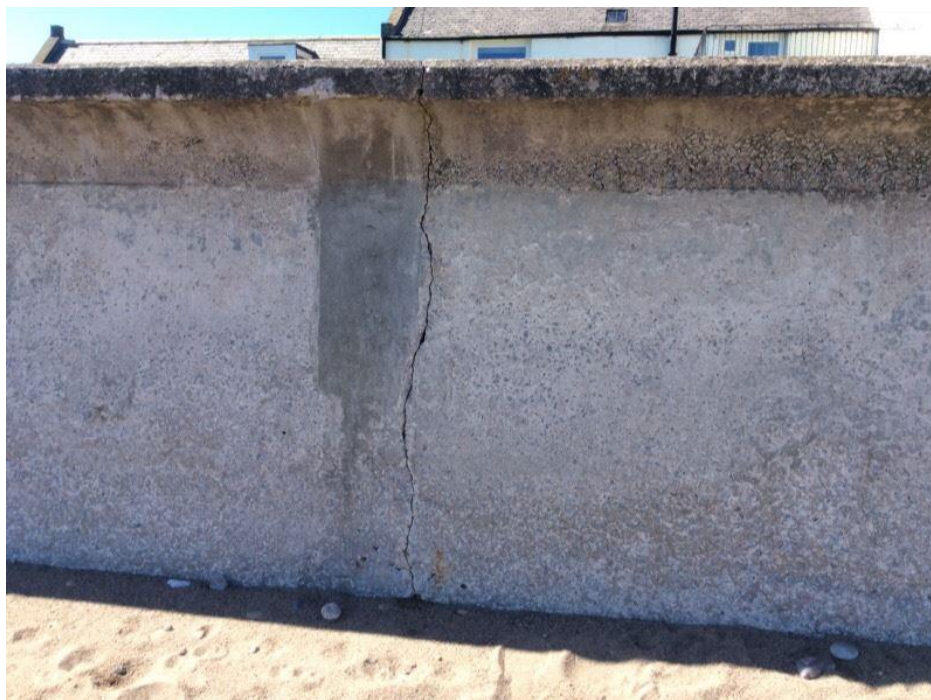
**Section B**  
**Exposed face**  
**Defect Ref: D15**  
**Description: D15 -**  
**Vertical fracture**  
**Photo number: 60**

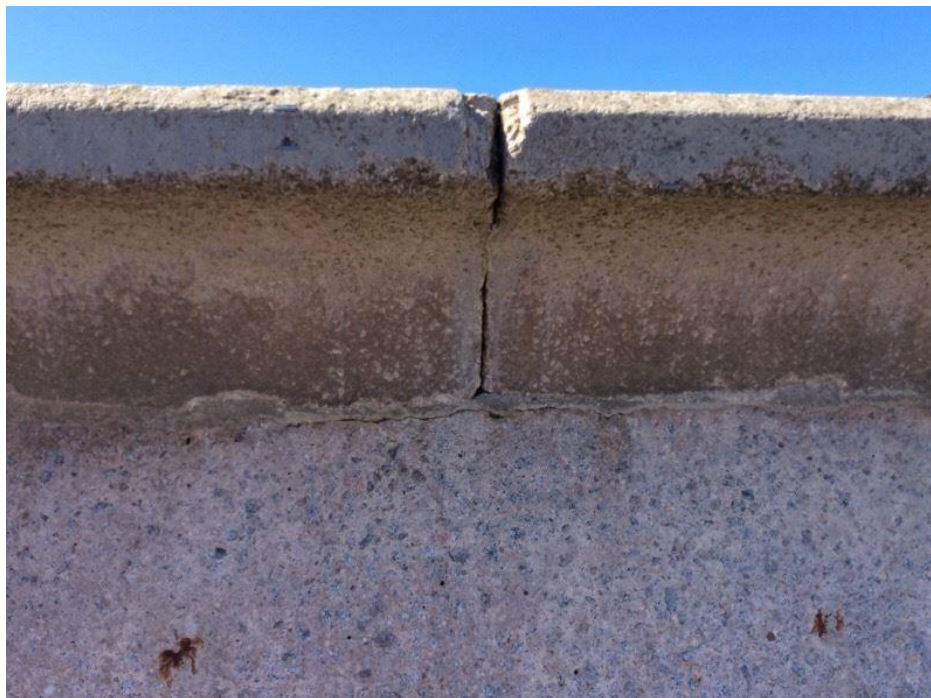
**Section B**  
**Exposed face**  
**Defect Ref: D16**  
**Description: D16 -**  
**Missing pointing between**  
**recurve units**  
**Photo number: 61**

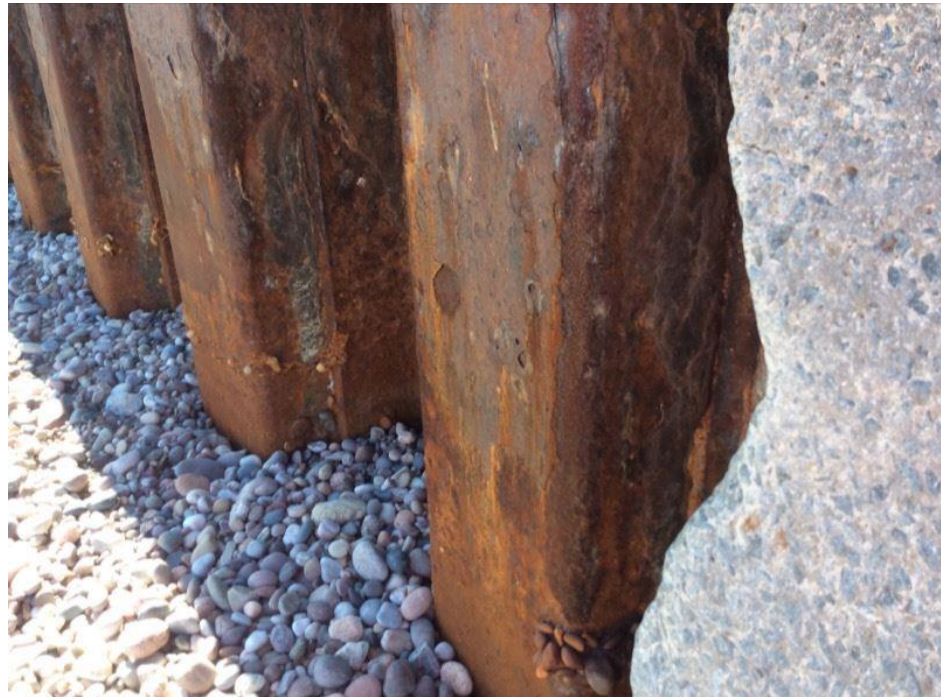
**Section B**  
**Exposed face**  
**Defect Ref: D18**  
**Description: D18 -**  
**Corroded sheet piles**  
**Photo number: 65**

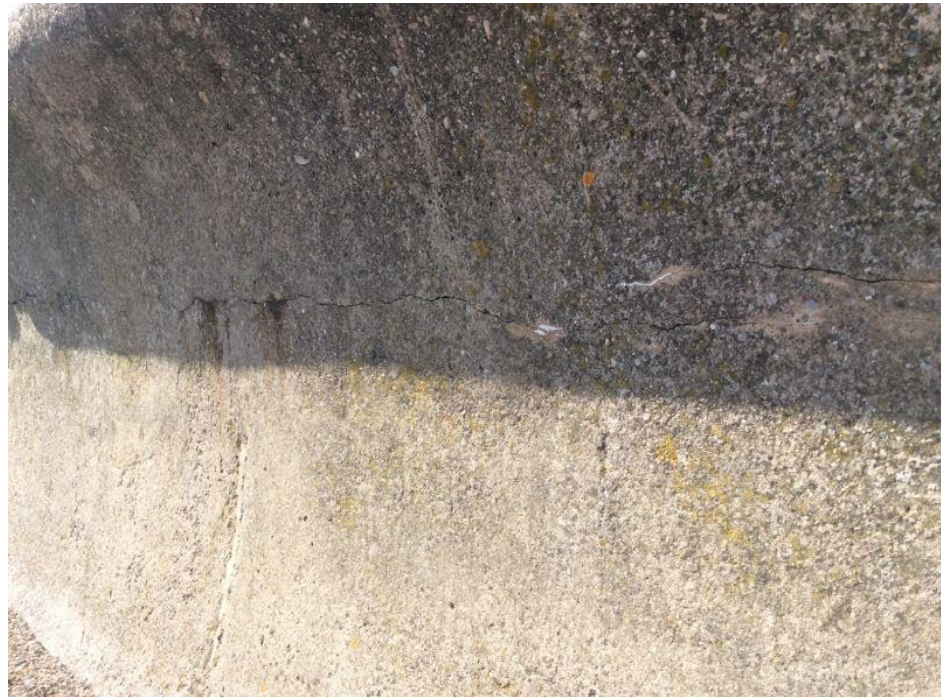
**Section C**  
**Splash wall**  
**Defect Ref: D24**  
**Description:** D24 - Cracking of concrete  
**Photo number: 71**

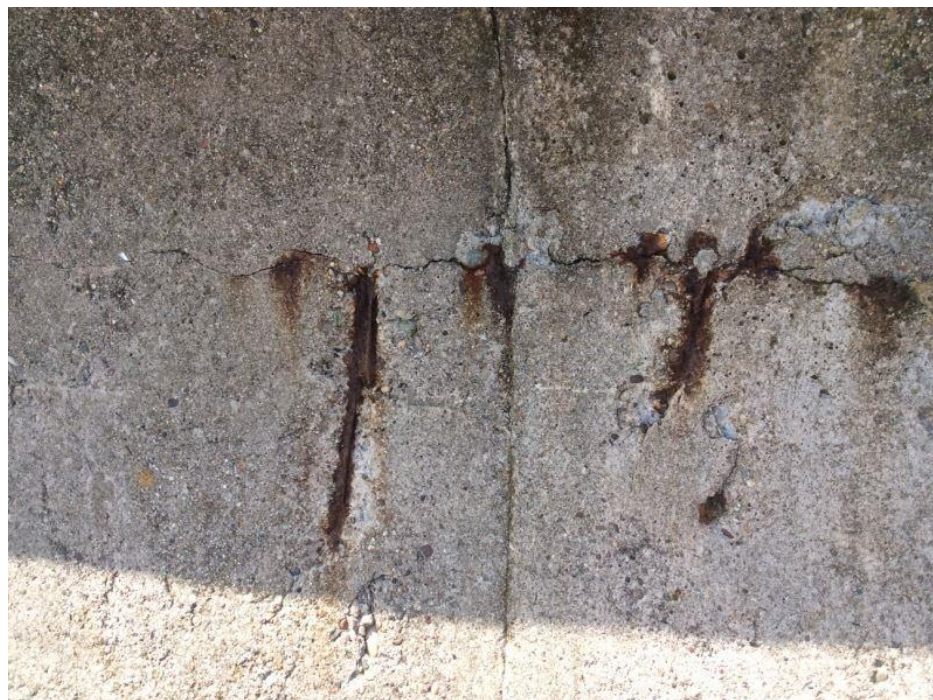
**Section C**  
**Splash wall**  
**Defect Ref: D29**  
**Description: D29 -**  
Exposed corroding  
reinforcement  
**Photo number: 79**

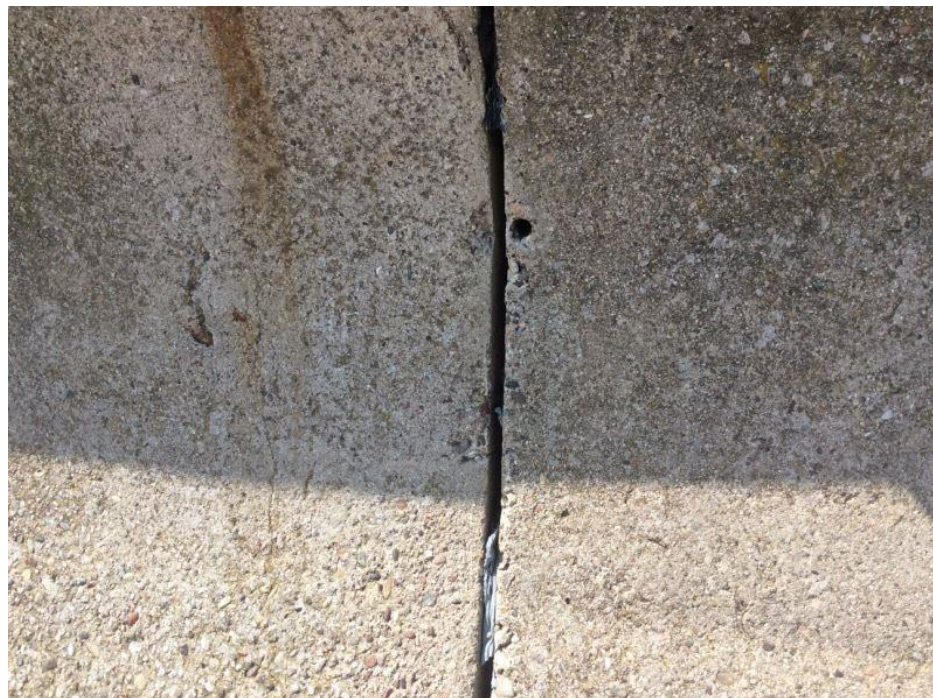
**Section C**  
**Splash wall**  
**Defect Ref: D30**  
**Description: D30 - Open**  
joints  
**Photo number: 76**

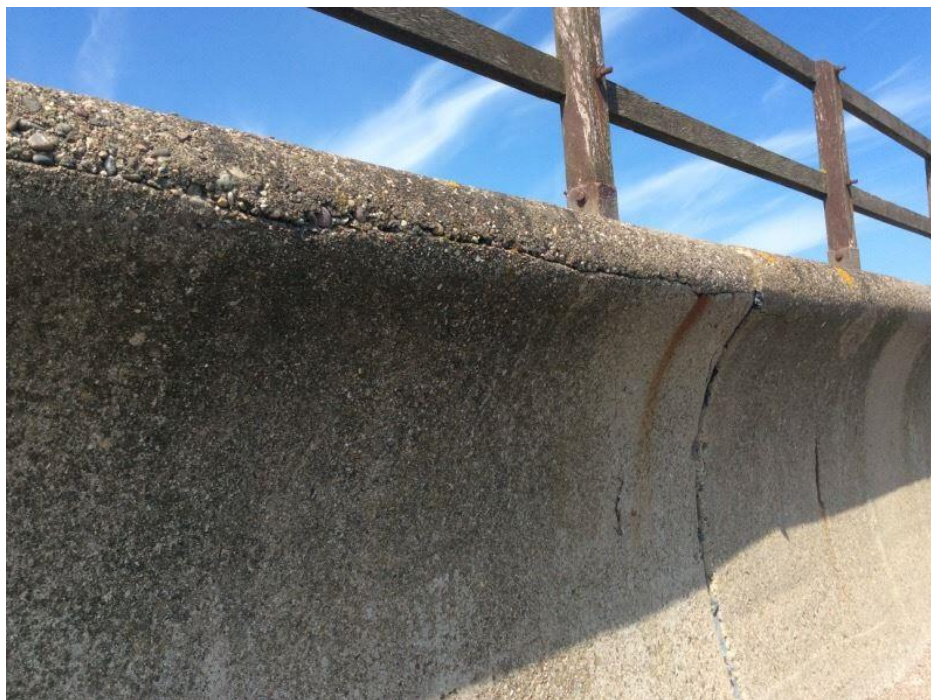
**Section C**  
**Splash wall**  
**Defect Ref: D31**  
**Description:** D31 -  
Cracking in upper radius  
of recurve  
**Photo number: 77**

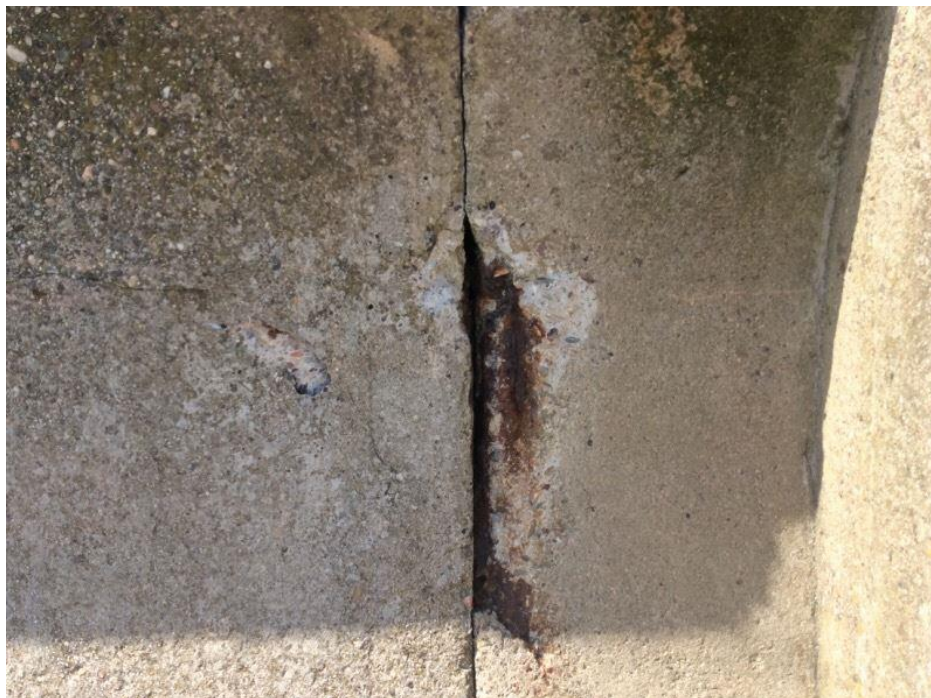
**Section C**  
**Splash wall**  
**Defect Ref: D32**  
**Description:** D32 -  
Exposed reinforcement  
and damaged concrete  
**Photo number: 78**

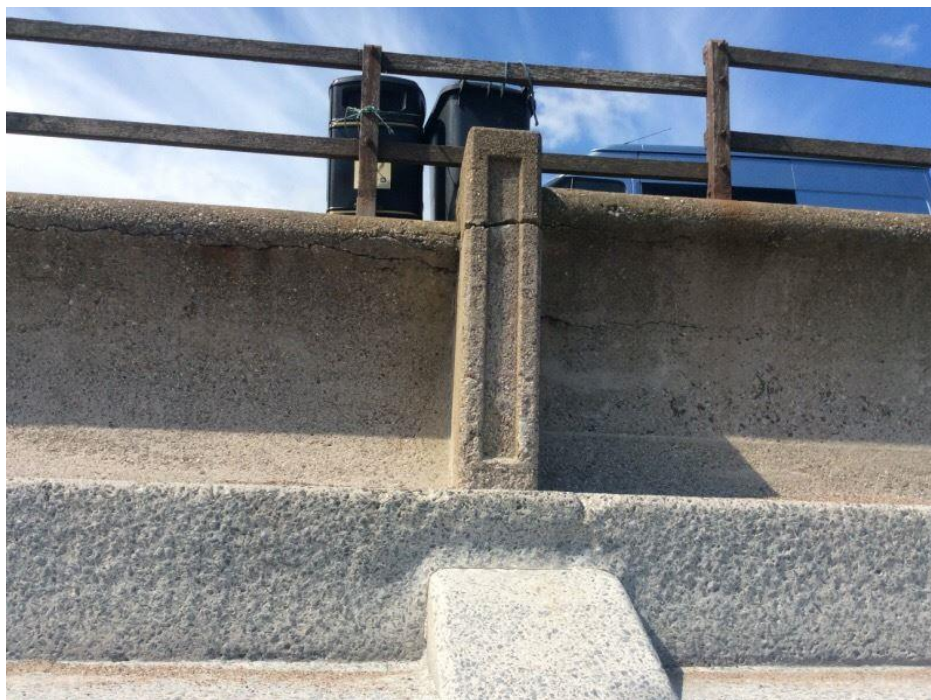
**Section C**  
**Splash wall**  
**Defect Ref: D37**  
**Description: D37 -**  
**Difference in crest level**  
**Photo number: 84**

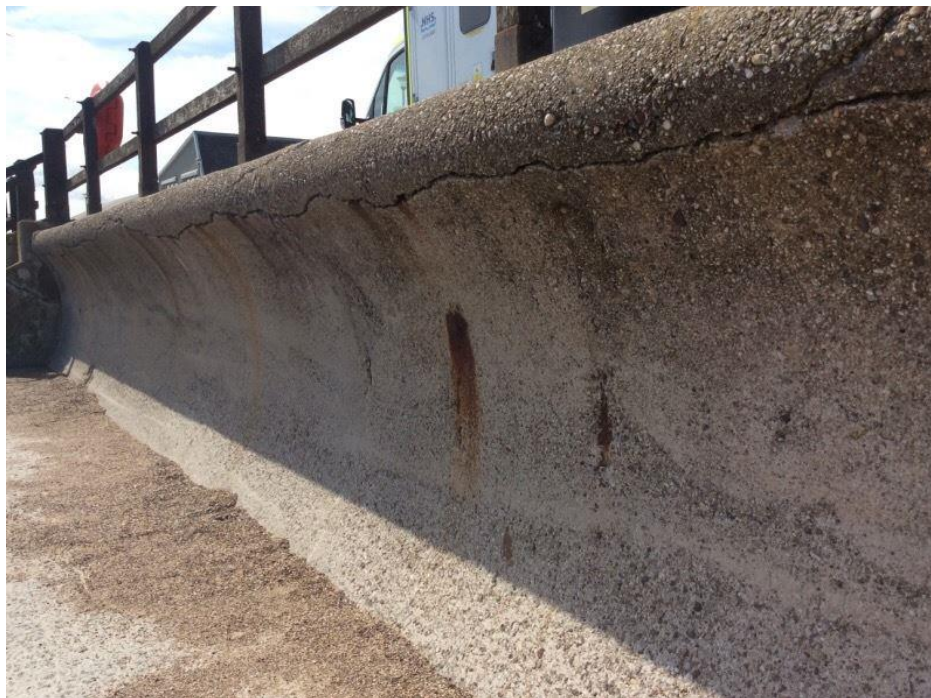
**Section C**  
**Splash wall**  
**Defect Ref: D38**  
**Description: D38 - 20m**  
**long cracks**  
**Photo number: 85**

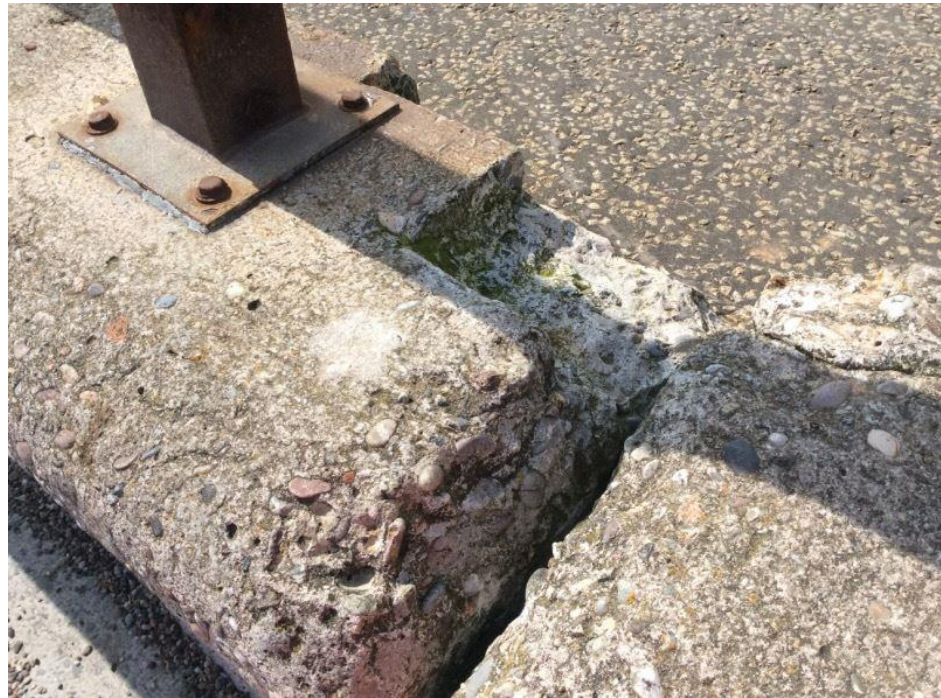
**Section C**  
**Splash wall**  
**Defect Ref: D49**  
**Description: D49 -**  
Damaged concrete on  
top of recurve  
**Photo number: 96**

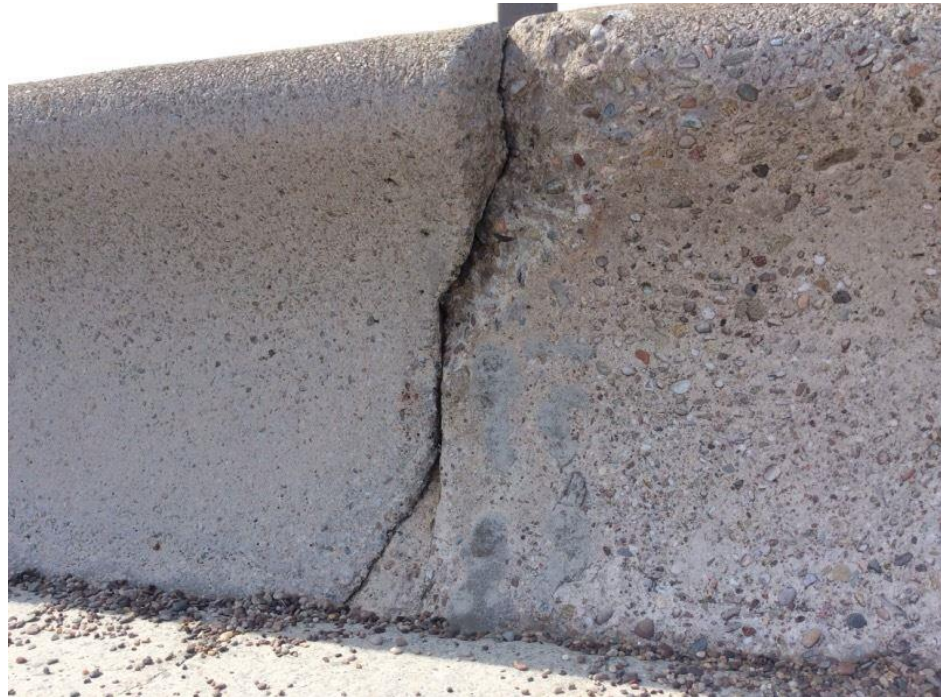
**Section C**  
**Splash wall**  
**Defect Ref: D50**  
**Description: D50 -**  
Vertical crack on recurve  
**Photo number: 97**

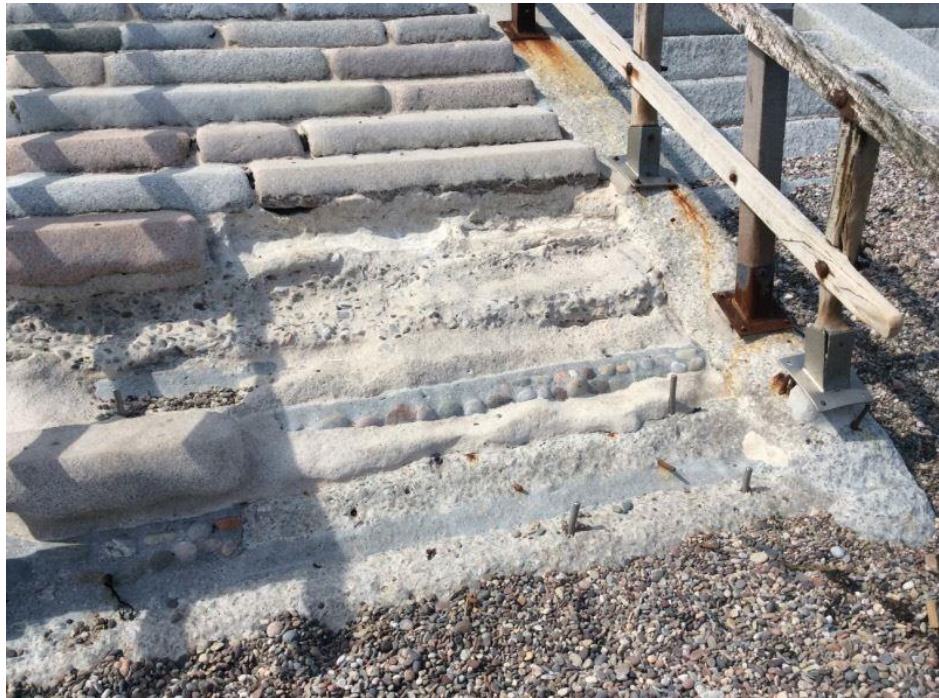
- H&S - The beach access steps have broken or poorly fixed hand railings. In general the steps are in poor condition, most notably one access point is missing 3 tiers of steps and has exposed dowel bars protruding from the concrete providing a severe health and safety hazard. It is recommended that these steps are closed to public access until remedial works are completed.
- Extensive damage to the concrete recurve wall was observed from the reinforcement corrosion.

**Section C**  
**Splash wall**  
**Defect Ref: D51**  
**Description:** D51 - Loss of steps and exposed dowels  
**Photo number: 98**

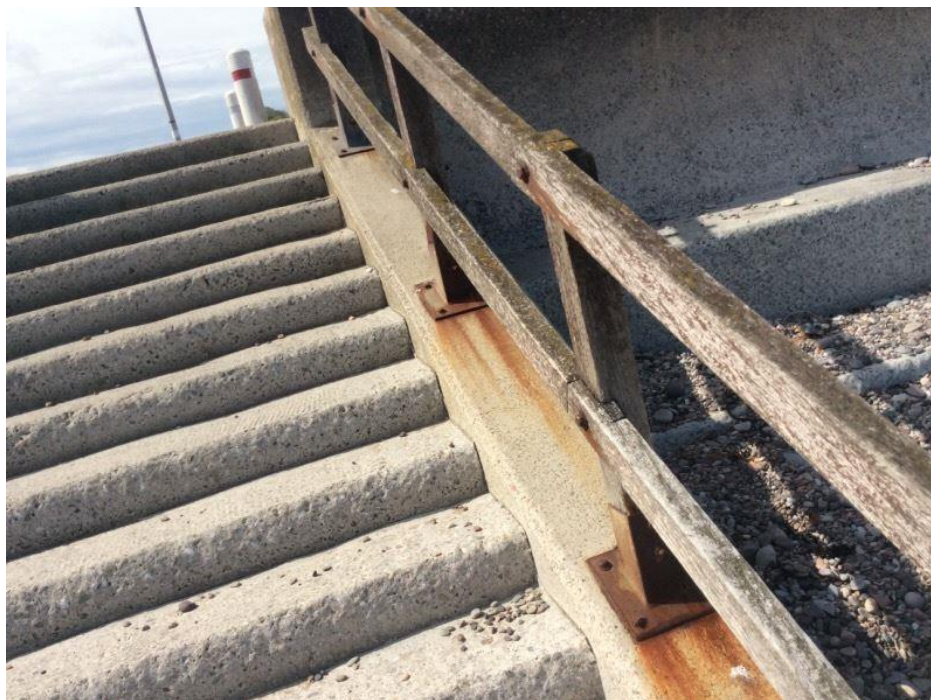
**Section C**  
**Exposed face**  
**Defect Ref: D55**  
**Description: D55 -**  
Corrosion of handrailing  
supports  
**Photo number: 102**

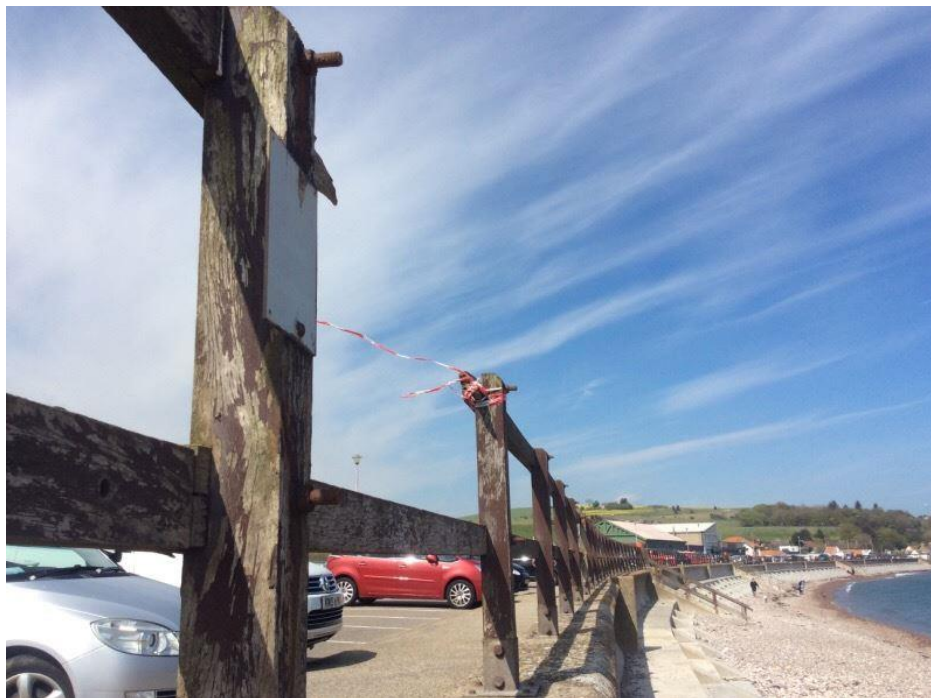
**Section C**  
**Splash wall**  
**Defect Ref: D56**  
**Description: D56 -**  
Missing handrails  
**Photo number: 103**

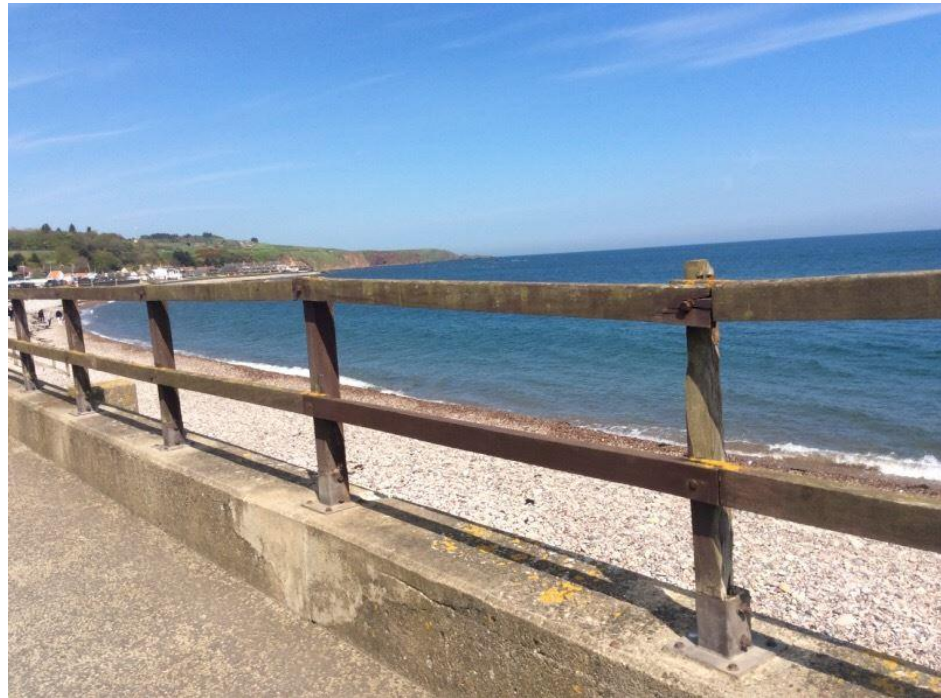
**Section C**  
**Splash wall**  
**Defect Ref: D57**  
**Description: D57 -**  
**Distorted handrails**  
**Photo number: 104**

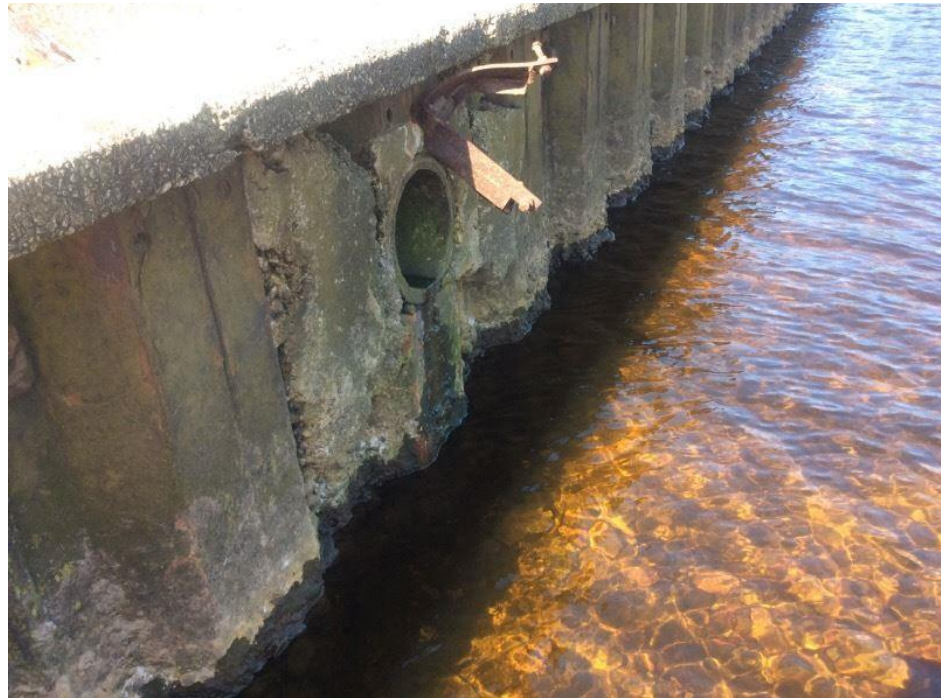
**Section D**  
**Piling**  
**Defect Ref: D59**  
**Description: D59 -**  
**Missing flap valve**  
**Photo number: 106**

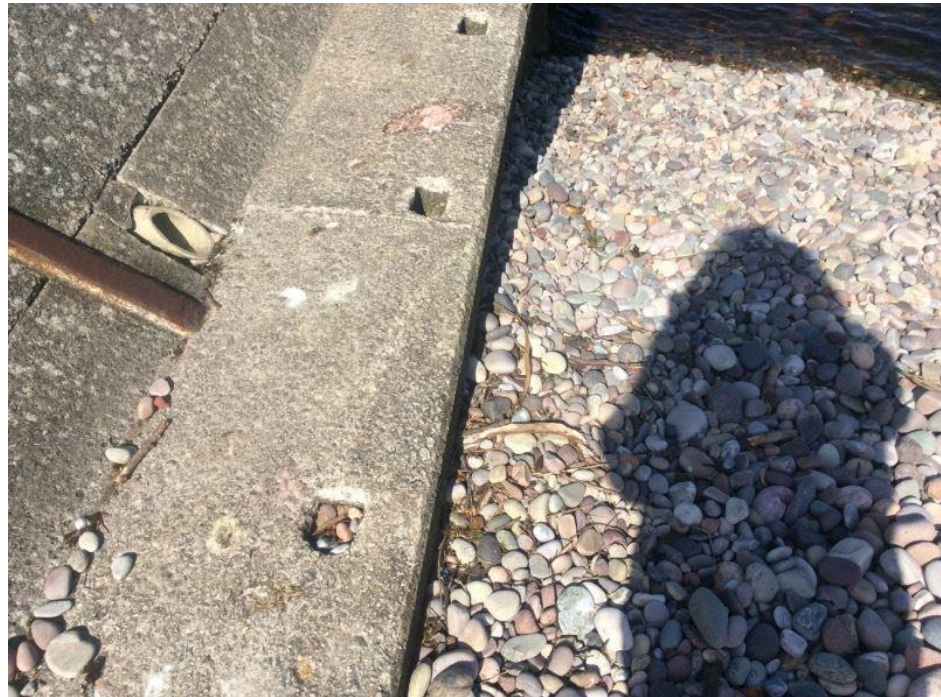
**Section D**  
**Channel side**  
**Defect Ref: D60**  
**Description: D60 -**  
**Drainage points blocked**  
**Photo number: 107**

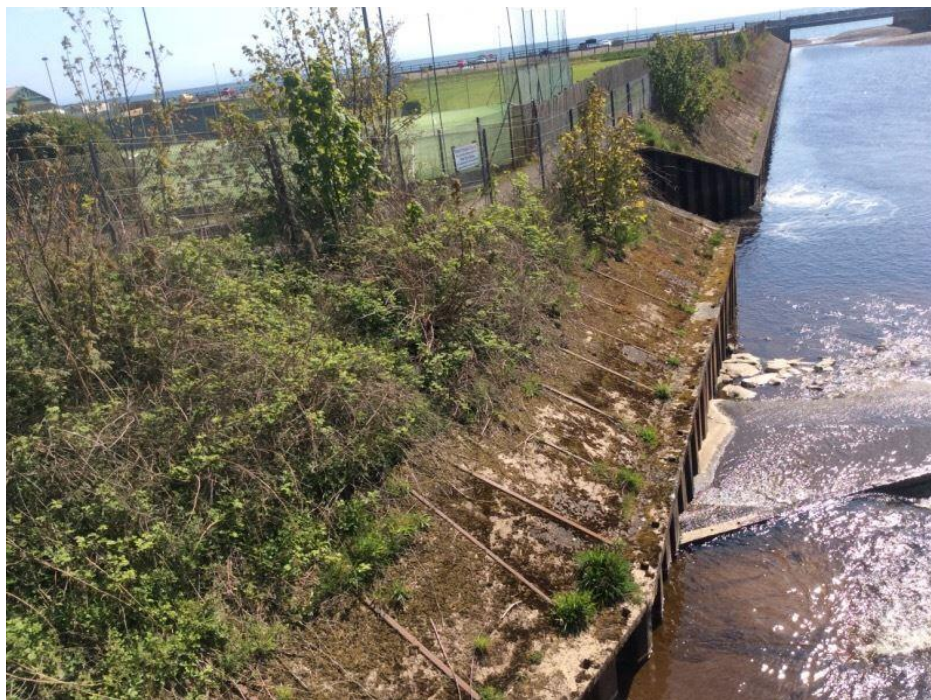
**Section D**  
**Channel side**  
**Defect Ref: D61**  
**Description:** D61 -  
Vegetation growth on top  
of concrete  
**Photo number: 122**

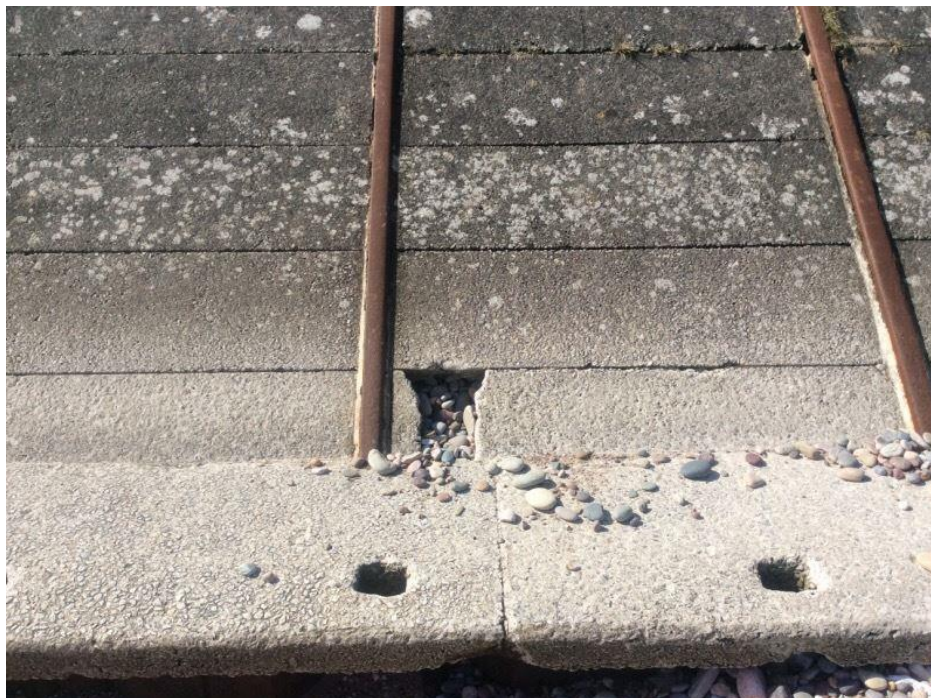
**Section D**  
**Channel side**  
**Defect Ref: D62**  
**Description:** D62 -  
Broken slab, potential for  
scour behind protected  
face  
**Photo number: 108**

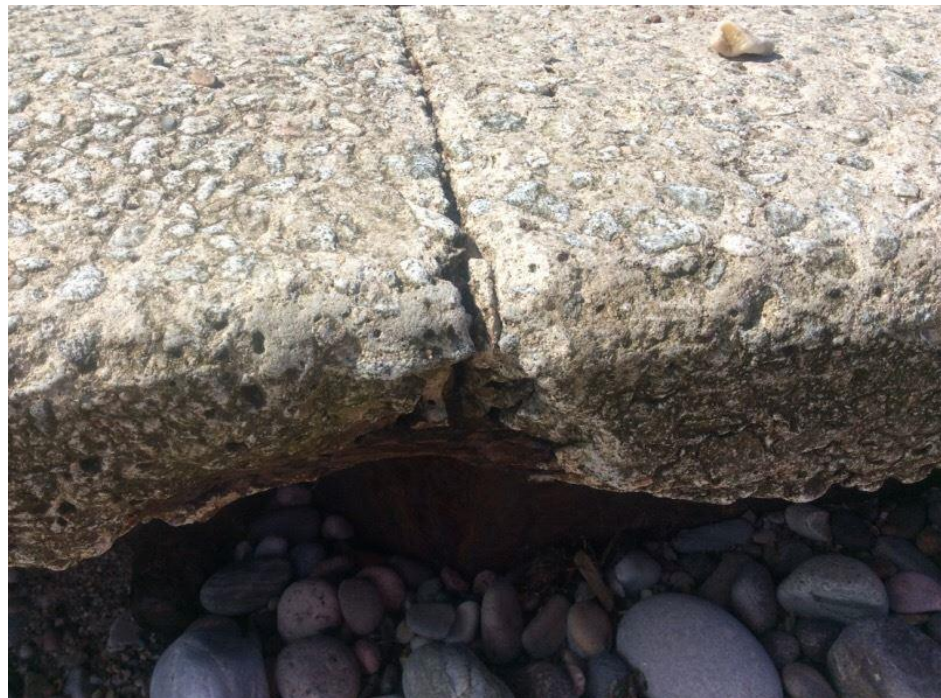
**Section D**  
**Piling**  
**Defect Ref: D63**  
**Description: D63 -**  
Damaged concrete  
capping beam exposing  
reinforcement  
**Photo number: 109**

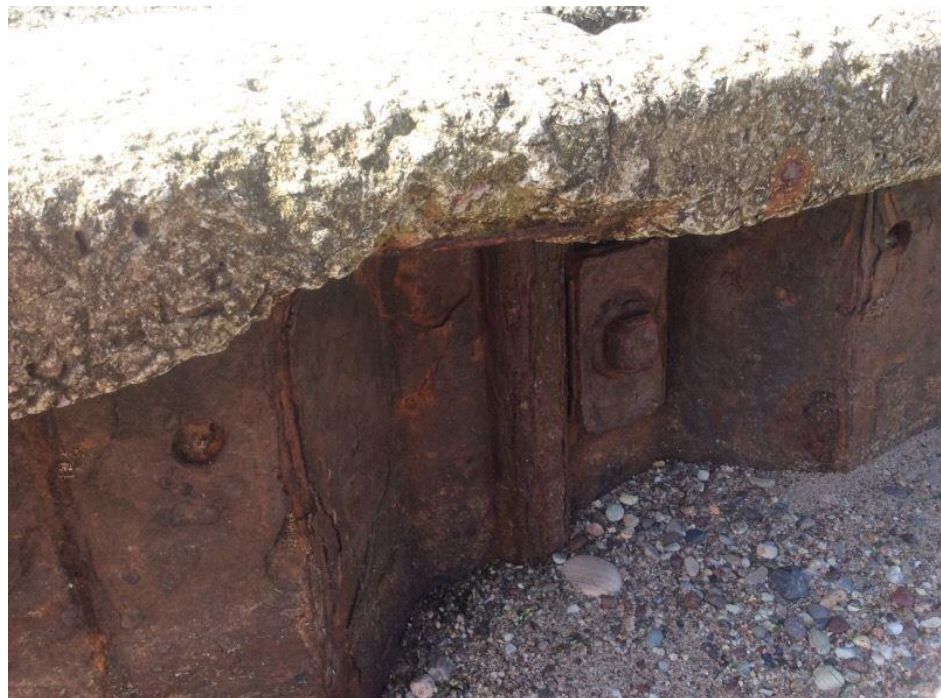
**Section D**  
**Piling**  
**Defect Ref: D63**  
**Description: D63 -**  
Damaged concrete  
capping beam exposing  
reinforcement  
**Photo number: 143**

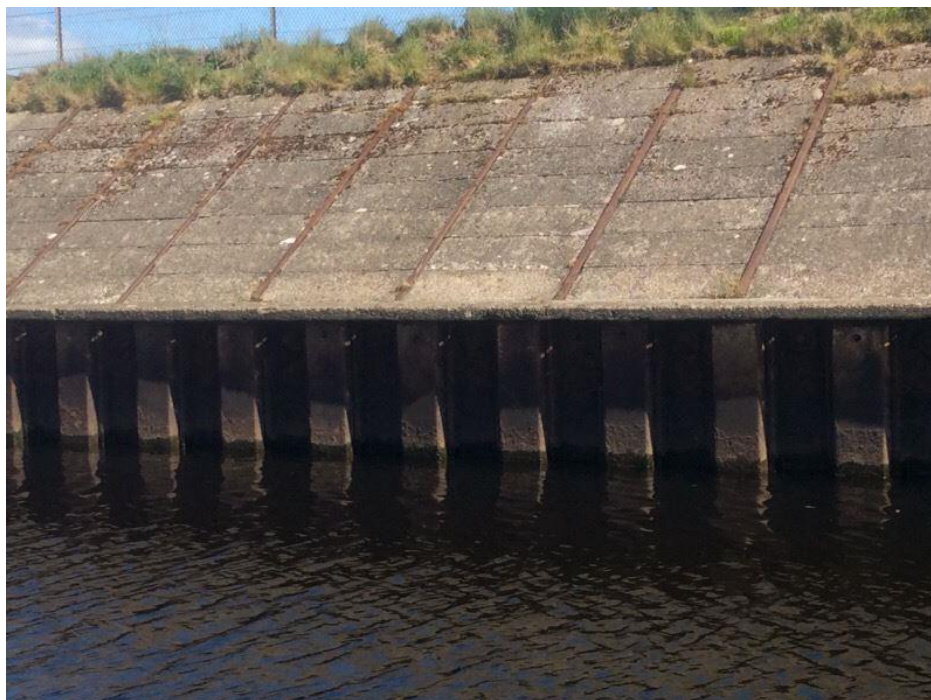
**Section D**  
**Piling**  
**Defect Ref: D64**  
**Description: D64 -**  
Anchor missing,  
potentially more than one  
**Photo number: 110**

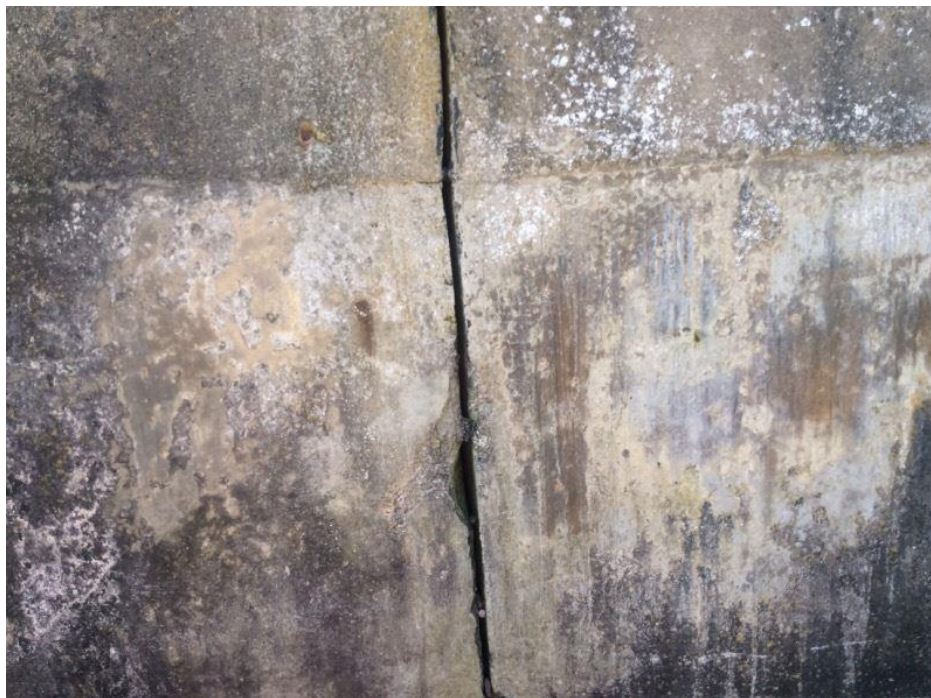
**Section D**  
**Exposed face**  
**Defect Ref: D65**  
**Description: D65 - Open**  
joints  
**Photo number: 111**

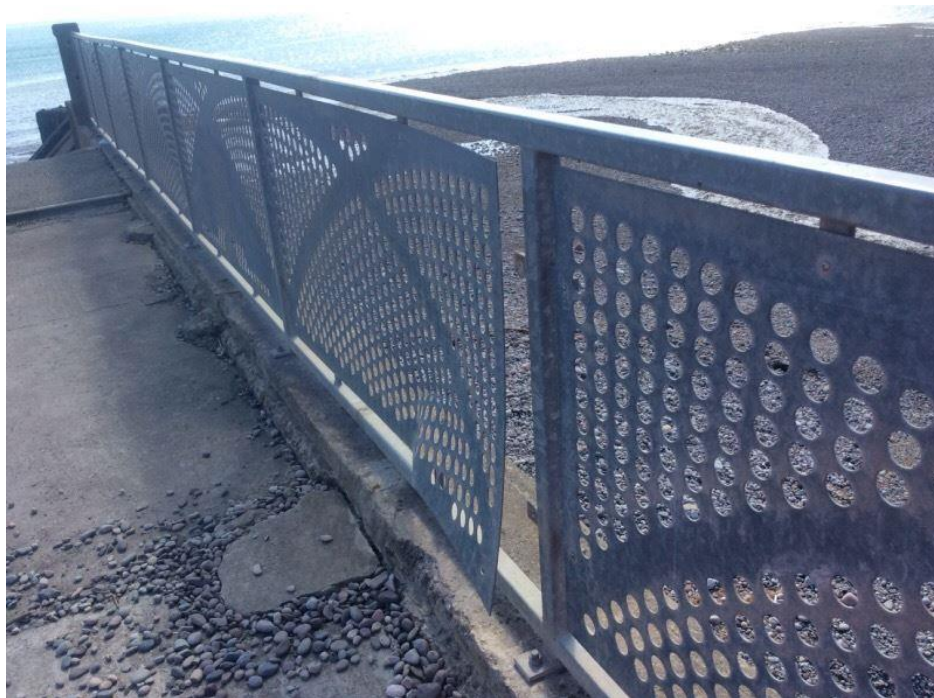
**Section D**  
**Exposed face**  
**Defect Ref: D68**  
**Description: D68 -**  
**Broken parapet**  
**Photo number: 114**

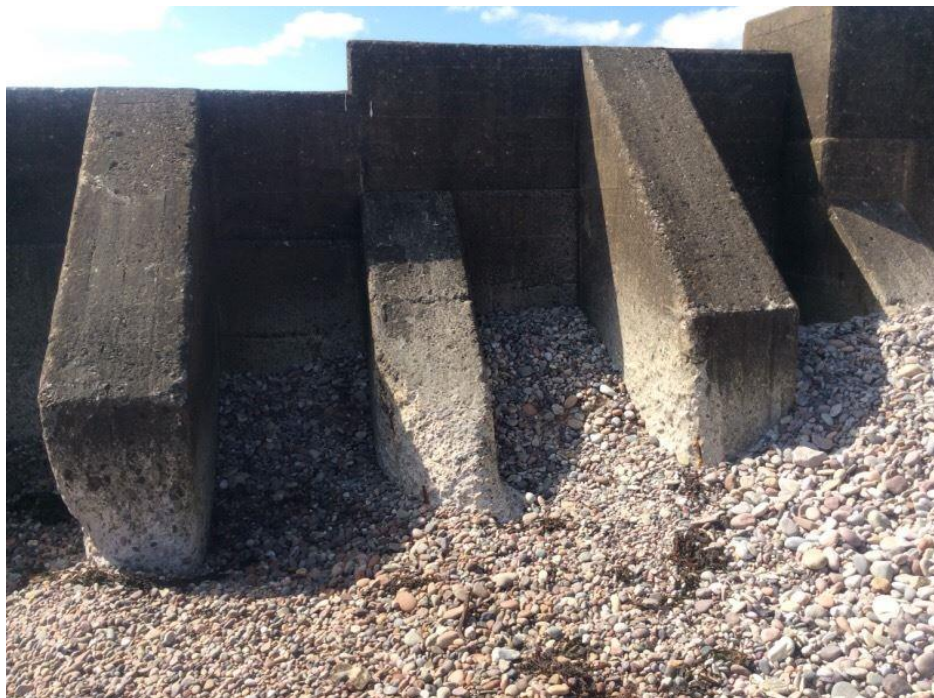
**Section D**  
**Exposed face**  
**Defect Ref: D69**  
**Description: D69 -**  
**Abrasion of concrete**  
**exposing reinforcement**  
**Photo number: 115**

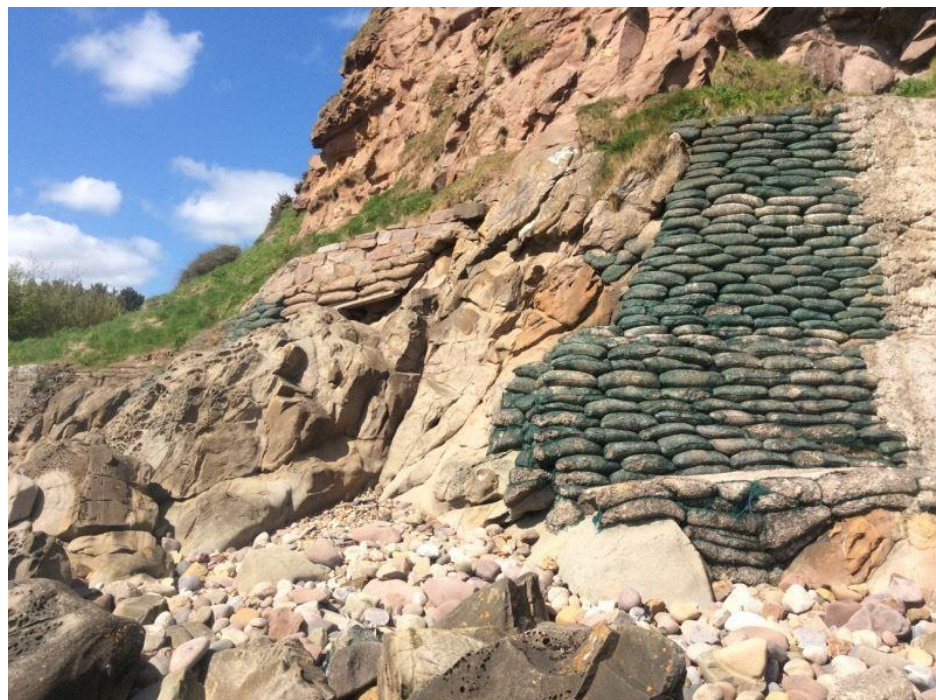
**Section A**  
**Exposed face**  
**Defect Ref: D76**  
**Description: D76 -**  
Improper design / repairs  
**Photo number: 123**

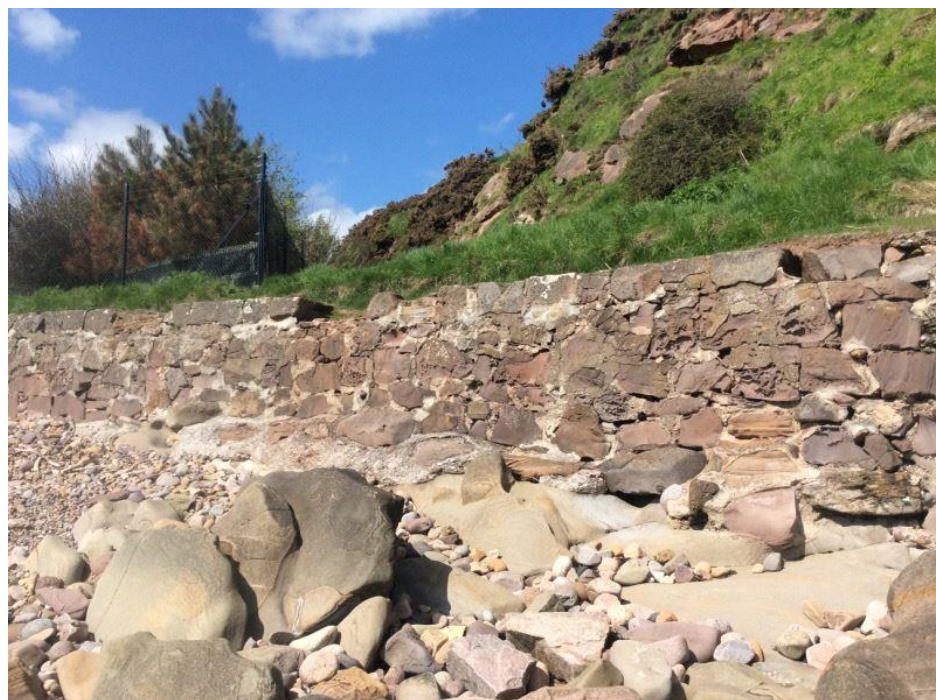
**Section A**  
**Exposed face**  
**Defect Ref: D77**  
**Description: D77 -**  
Missing blockwork  
**Photo number: 124**
