## 1. General information

Location Plan:		Stonehaven coastal defences Assessment Date: 14/05/2018

# COASTAL ASSET CONDITION SURVEY REPORT

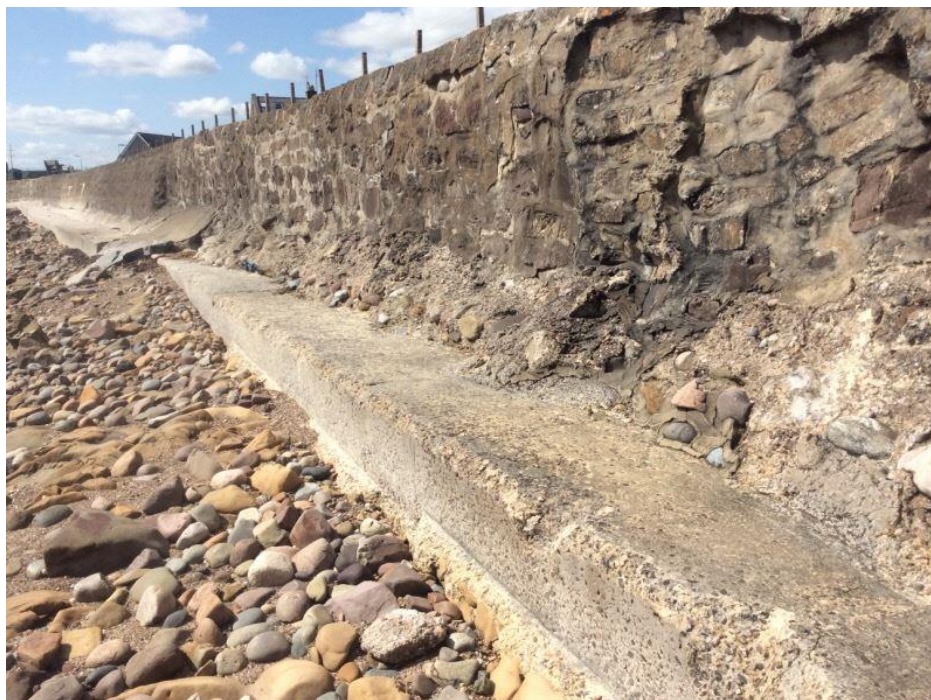
**Section A**  
**Exposed face**  
**Defect Ref: D80**  
**Description:** D80 -  
Dilapidated concrete  
repairs  
**Photo number: 127**

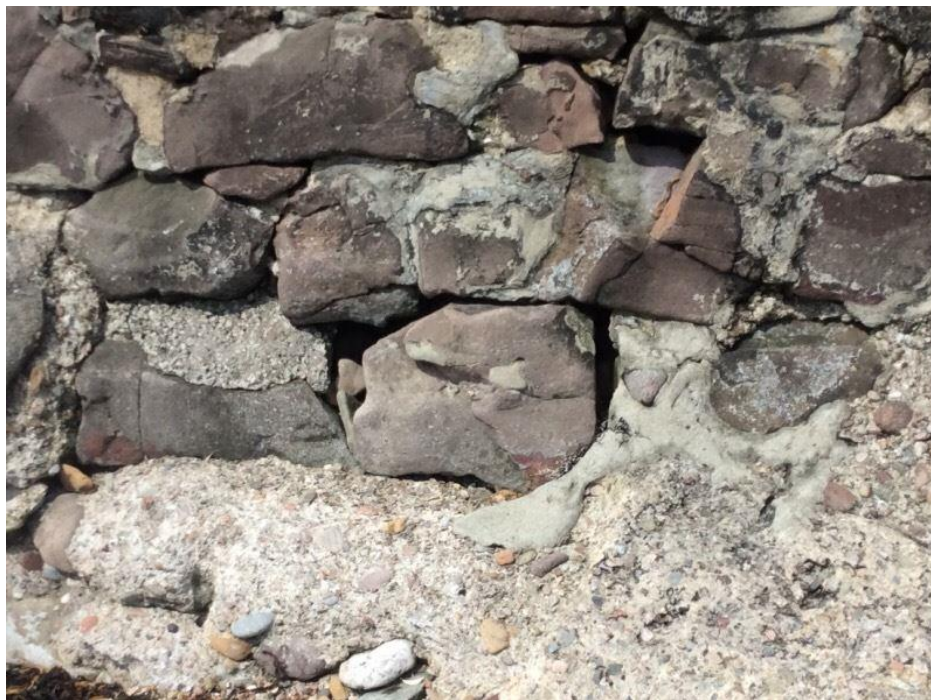
**Section A**  
**Exposed face**  
**Defect Ref: D81**  
**Description:** D81 -  
Voiding around  
blockwork  
**Photo number: 128**

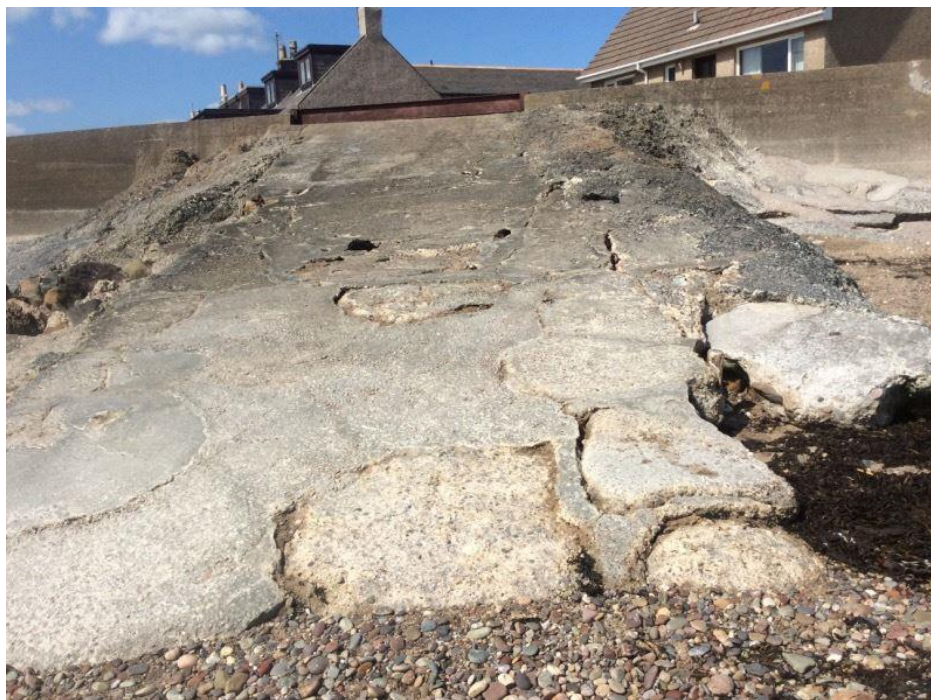
**Section A**  
**Access strip**  
**Defect Ref: D83**  
**Description: D83 -**  
Holes on top of the  
slipway  
**Photo number: 144**

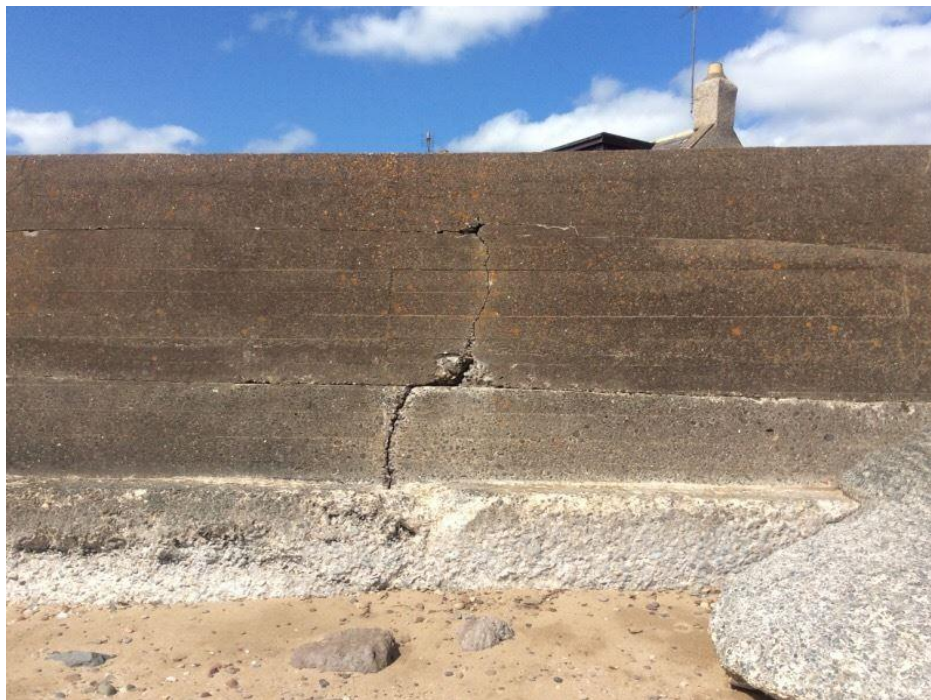
**Section A**  
**Exposed face**  
**Defect Ref: D84**  
**Description: D84 -**  
Cracking of concrete  
**Photo number: 131**

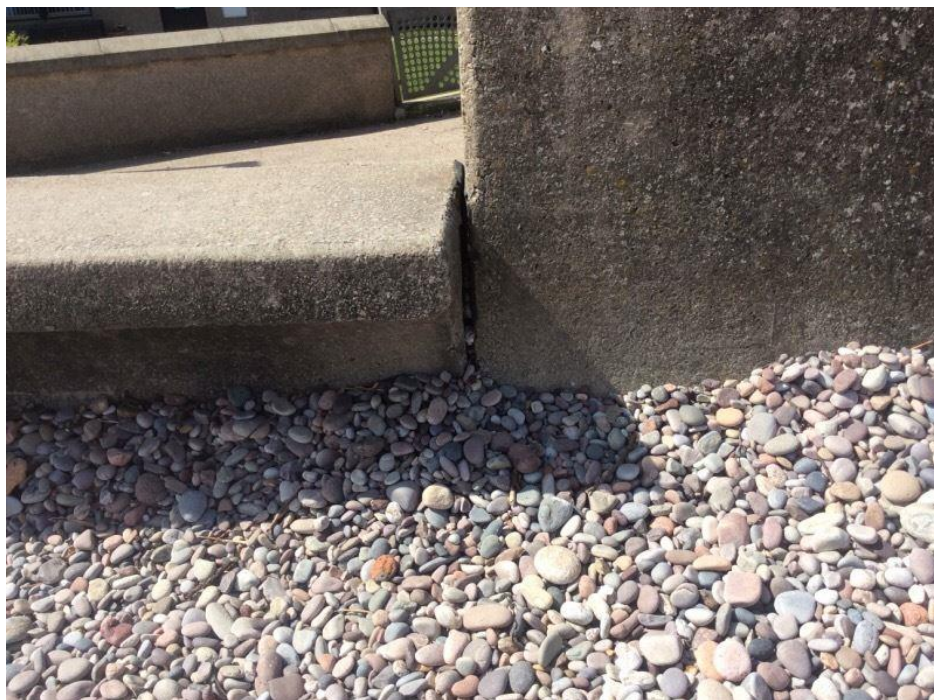
**Section E**  
**Exposed face**  
**Defect Ref: D88**  
**Description: D88 - Open joints**  
**Photo number: 132**

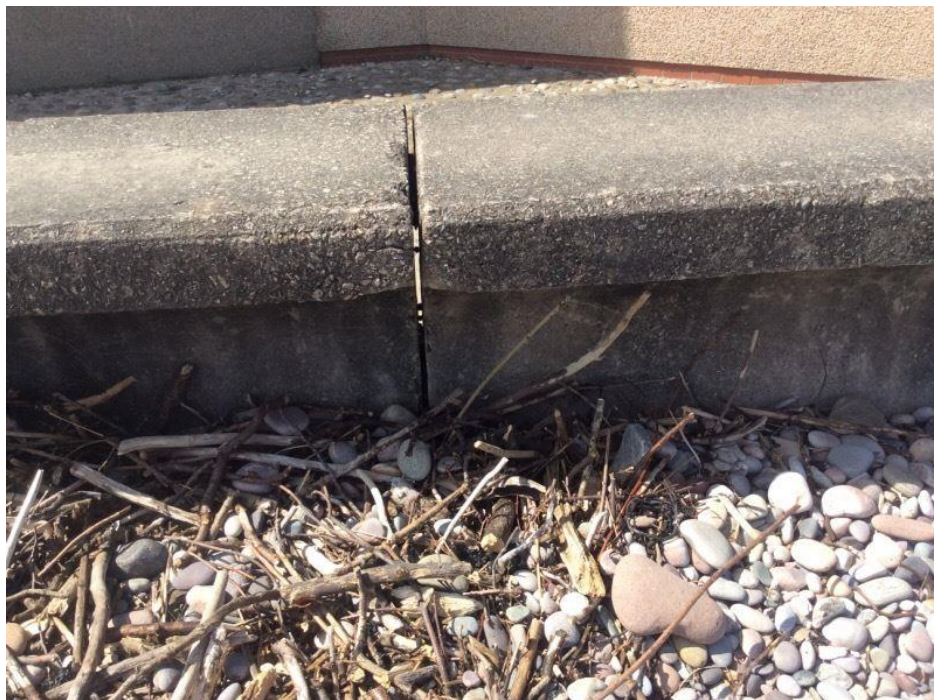
**Section E**  
**Exposed face**  
**Defect Ref: D88**  
**Description: D88 - Open joints**  
**Photo number: 146**

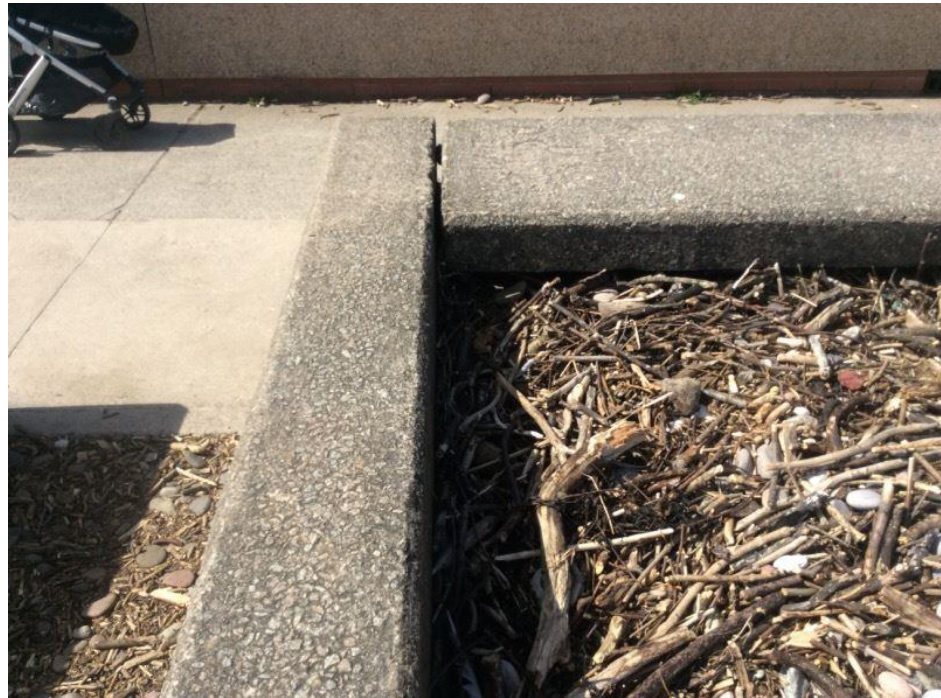
**Section E**  
**Exposed face**  
**Defect Ref: D88**  
**Description: D88 - Open joints**  
**Photo number: 150**

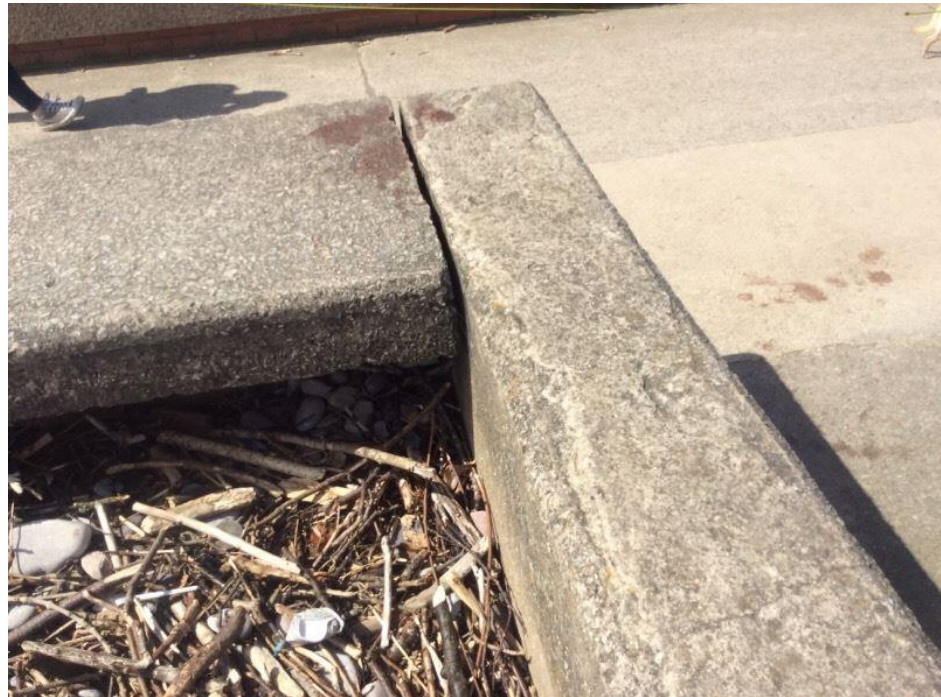
**Section E**  
**Exposed face**  
**Defect Ref: D88**  
**Description: D88 - Open joints**  
**Photo number: 154**

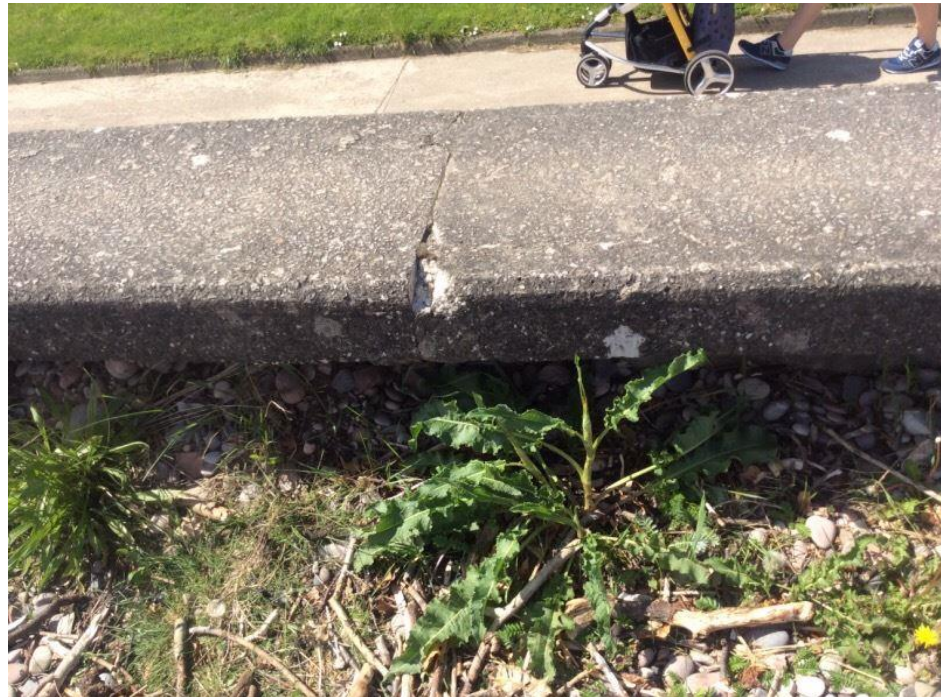
**Section E**  
**Exposed face**  
**Defect Ref: D88**  
**Description: D88 - Open joints**  
**Photo number: 161**

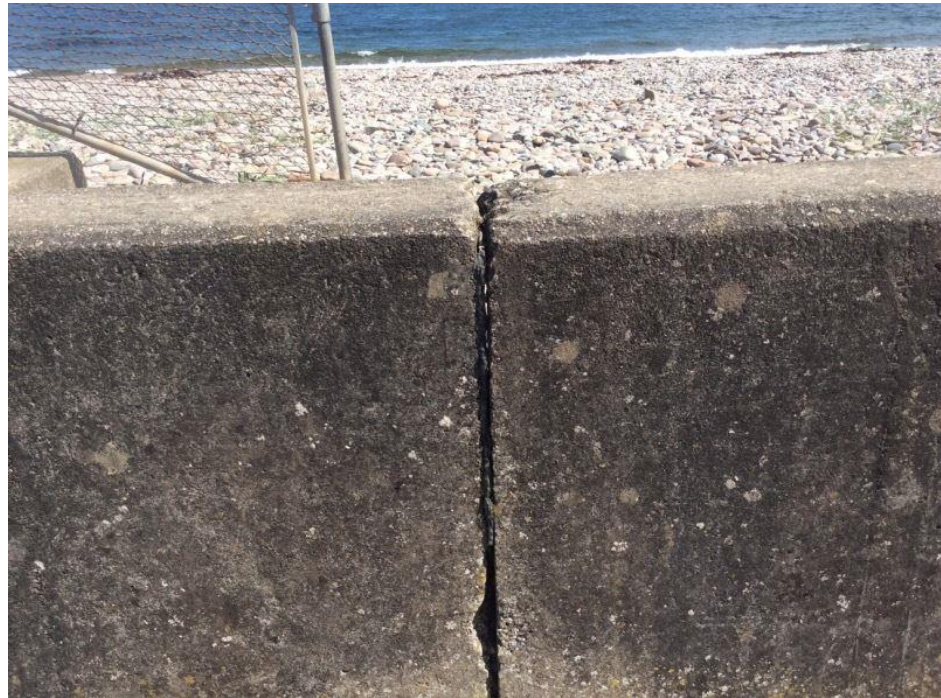
**Section E**  
**Exposed face**  
**Defect Ref: D88**  
**Description: D88 - Open joints**  
**Photo number: 163**

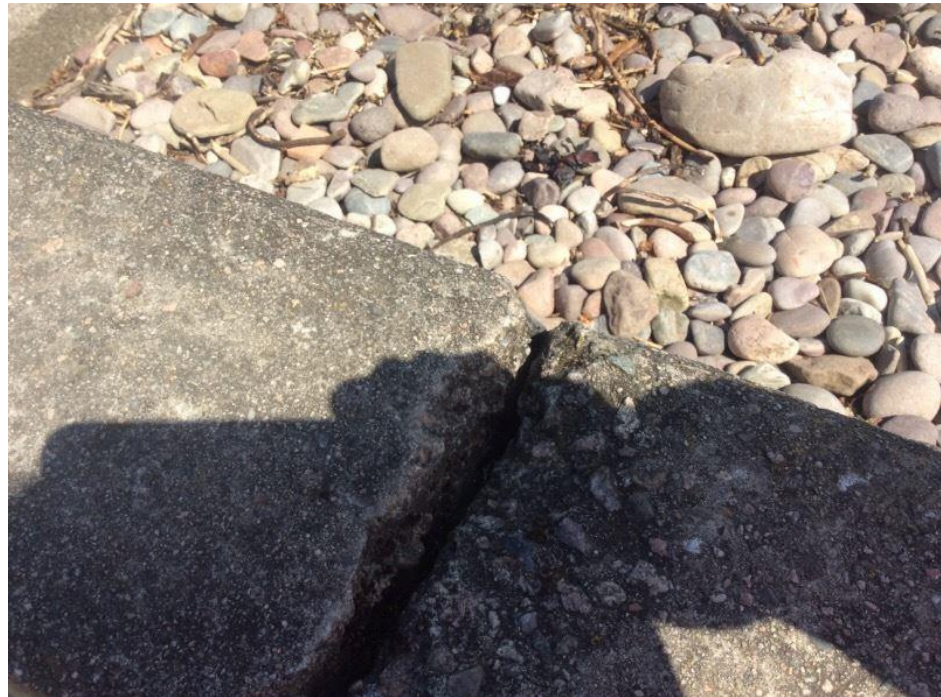
**Section E**  
**Exposed face**  
**Defect Ref: D88**  
**Description: D88 - Open joints**  
**Photo number: 165**

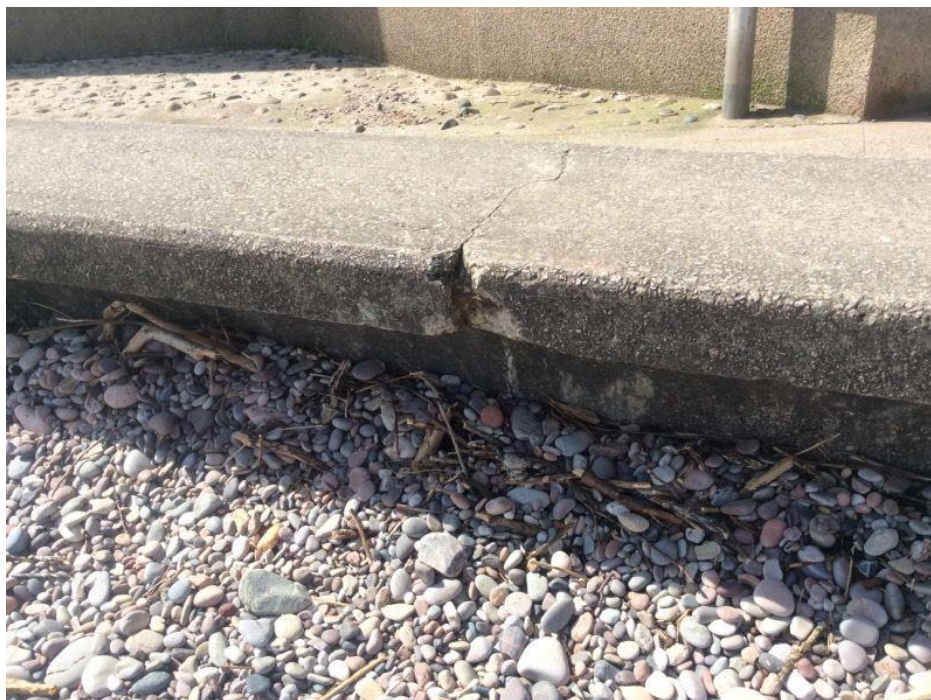
**Section E**  
**Exposed face**  
**Defect Ref: D89**  
**Description:** D89 -  
Chipped concrete by  
expansion joint with  
exposure of  
reinforcement  
**Photo number: 133**

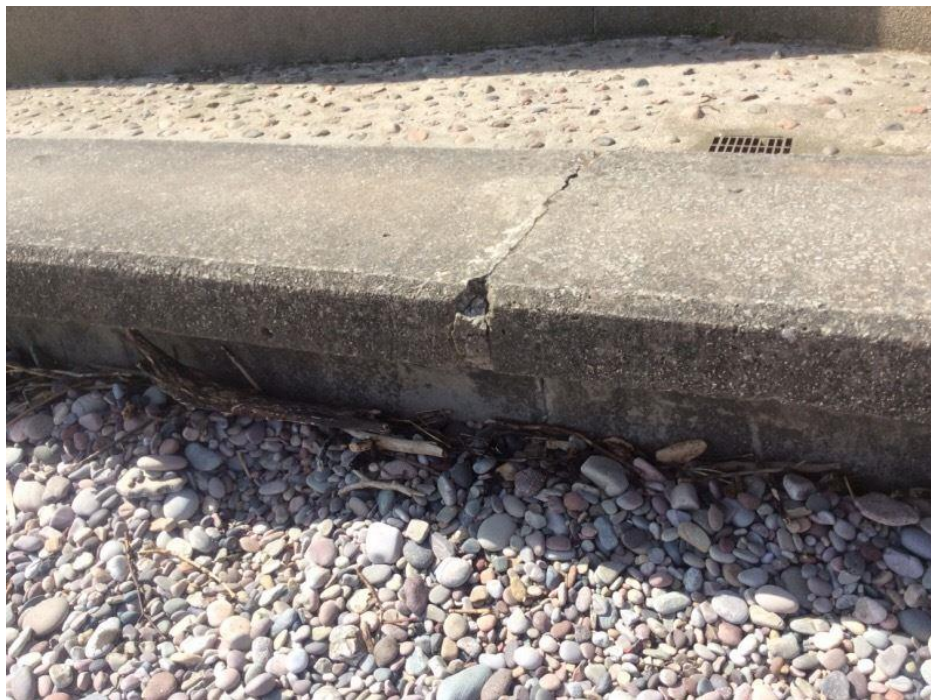
**Section E**  
**Exposed face**  
**Defect Ref: D89**  
**Description:** D89 -  
Chipped concrete by  
expansion joint with  
exposure of  
reinforcement  
**Photo number: 145**

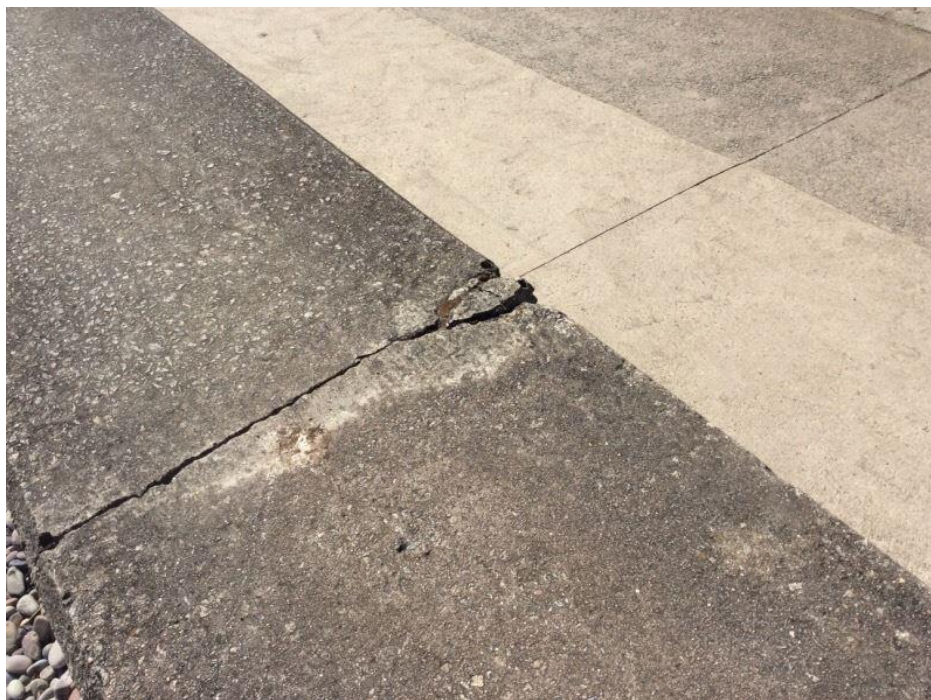
**Section E**  
**Exposed face**  
**Defect Ref: D89**  
**Description:** D89 -  
Chipped concrete by  
expansion joint with  
exposure of  
reinforcement  
**Photo number: 149**

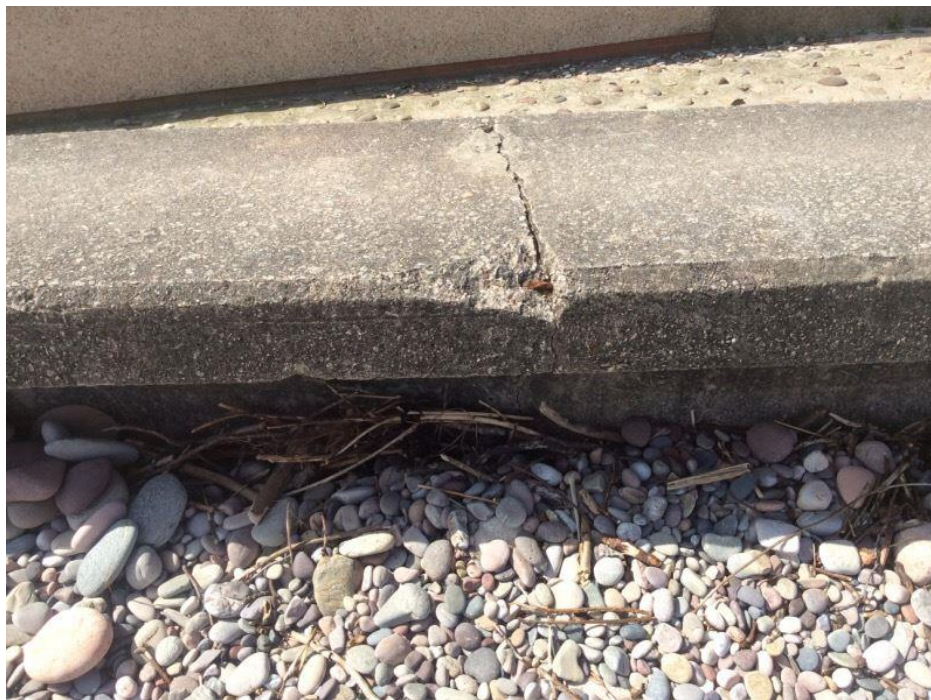
**Section E**  
**Exposed face**  
**Defect Ref: D89**  
**Description:** D89 -  
Chipped concrete by  
expansion joint with  
exposure of  
reinforcement  
**Photo number: 153**

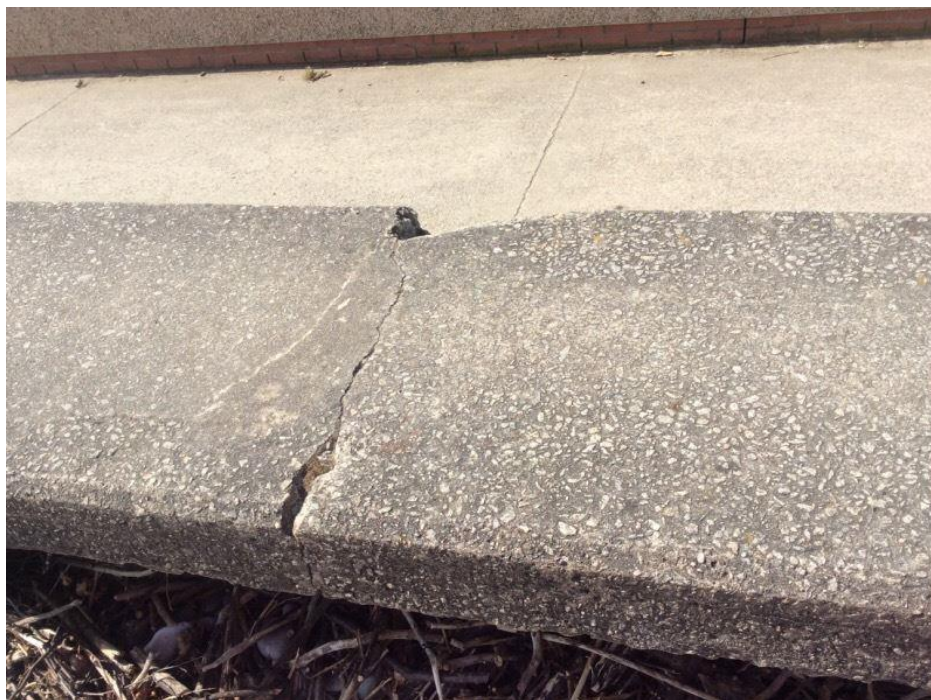
**Section E**  
**Exposed face**  
**Defect Ref: D89**  
**Description:** D89 -  
Chipped concrete by  
expansion joint with  
exposure of  
reinforcement  
**Photo number: 157**

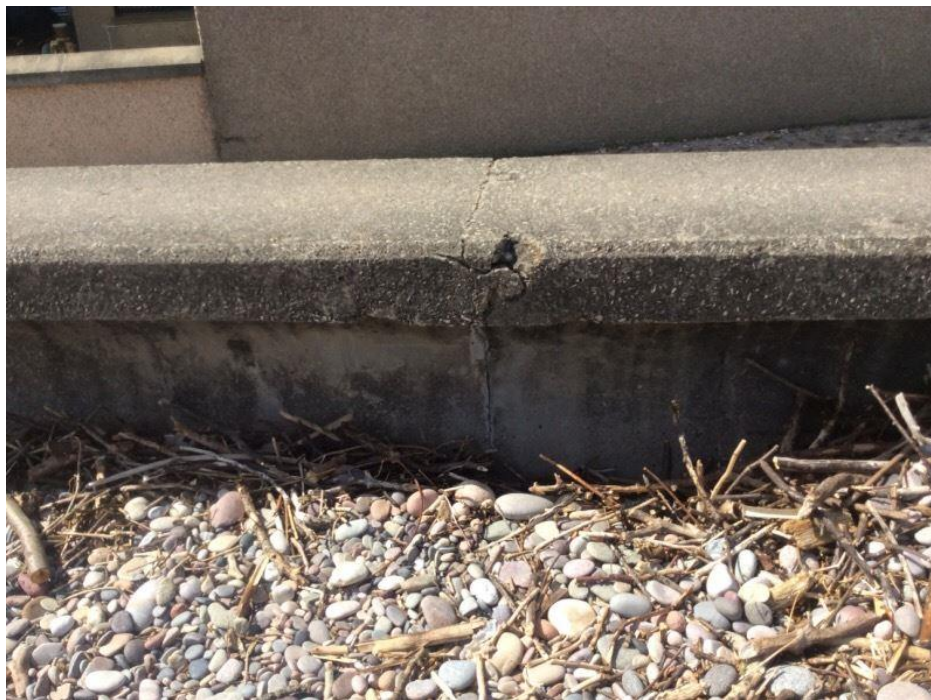
**Section E**  
**Exposed face**  
**Defect Ref: D89**  
**Description:** D89 -  
Chipped concrete by  
expansion joint with  
exposure of  
reinforcement  
**Photo number: 160**

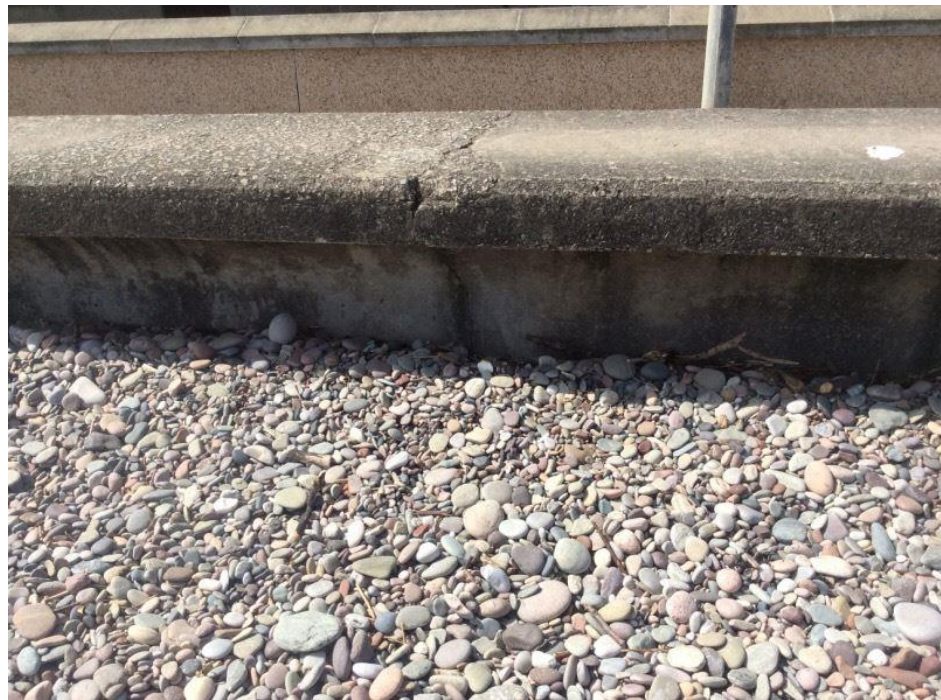
**Section E**  
**Exposed face**  
**Defect Ref: D89**  
**Description:** D89 -  
Chipped concrete by  
expansion joint with  
exposure of  
reinforcement  
**Photo number: 162**

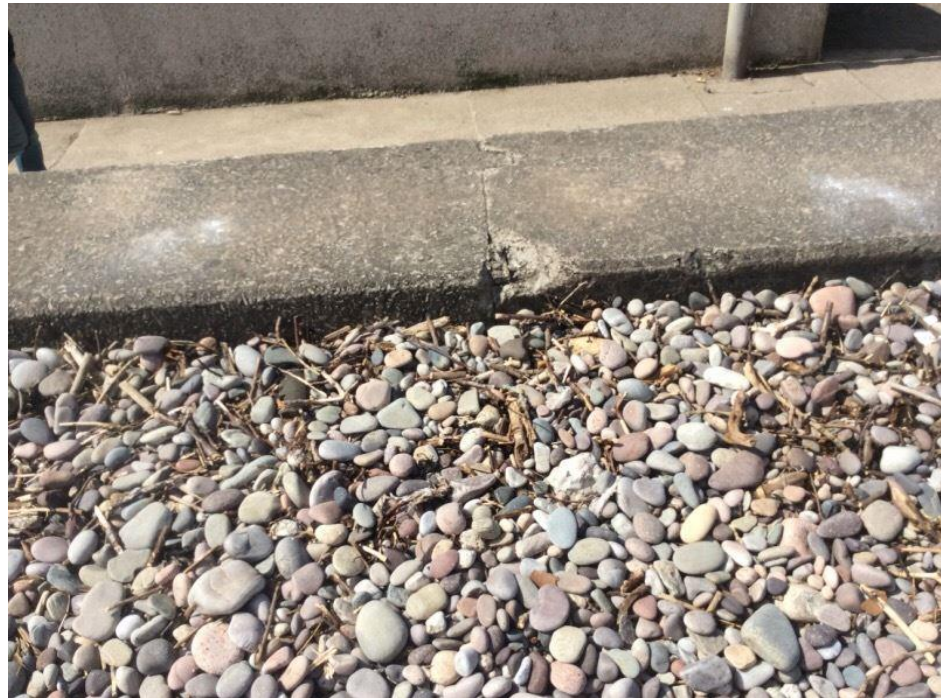
**Section E**  
**Exposed face**  
**Defect Ref: D89**  
**Description:** D89 -  
Chipped concrete by  
expansion joint with  
exposure of  
reinforcement  
**Photo number: 166**

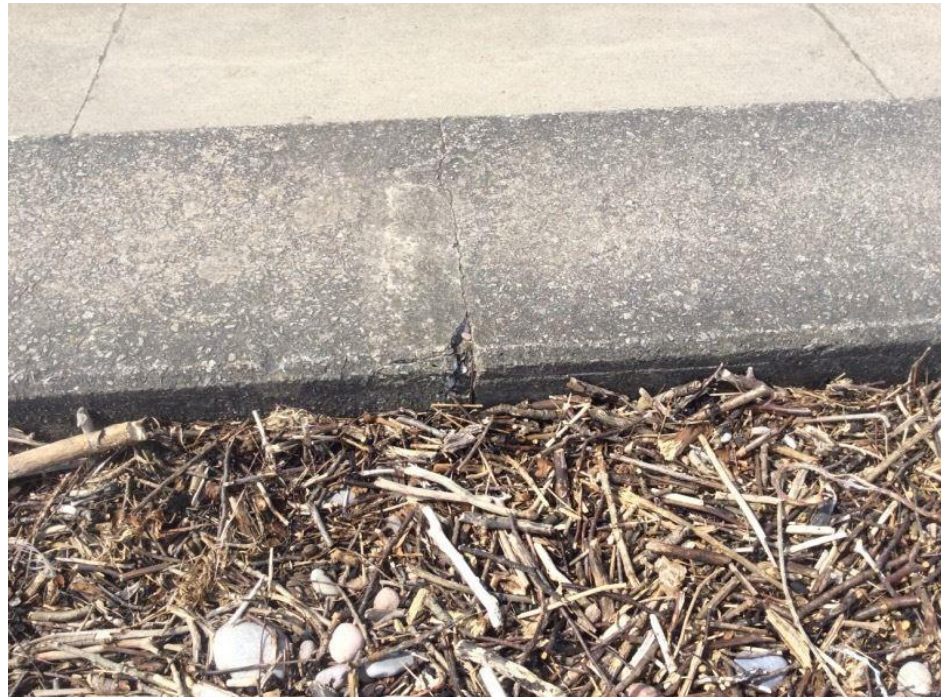
**Section E**  
**Exposed face**  
**Defect Ref: D89**  
**Description:** D89 -  
Chipped concrete by  
expansion joint with  
exposure of  
reinforcement  
**Photo number: 167**

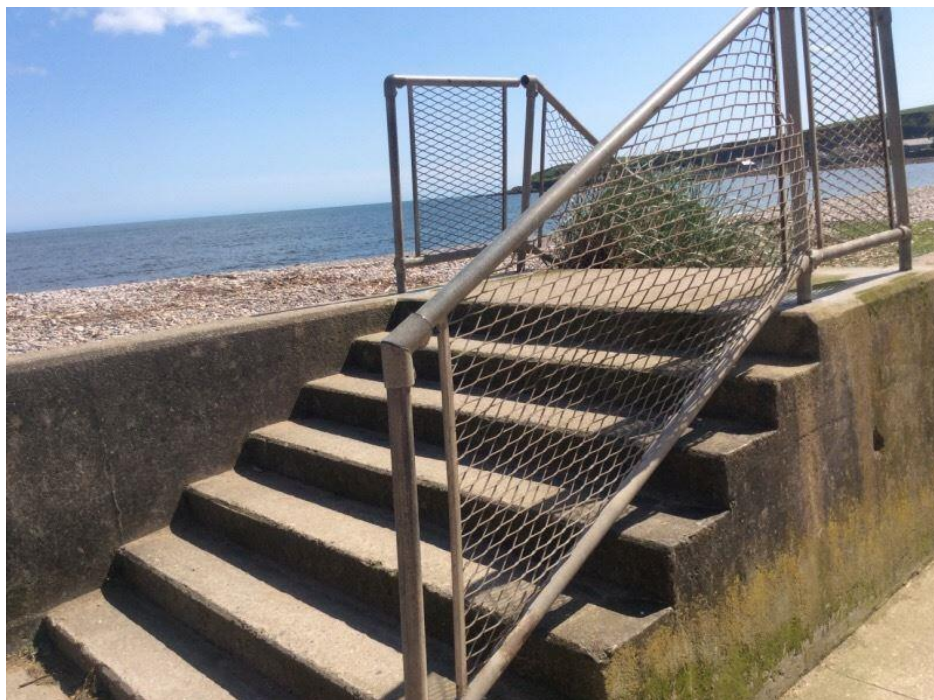
**Section E**  
**Exposed face**  
**Defect Ref: D91**  
**Description: D91 -**  
Distortion of parapet  
**Photo number: 135**

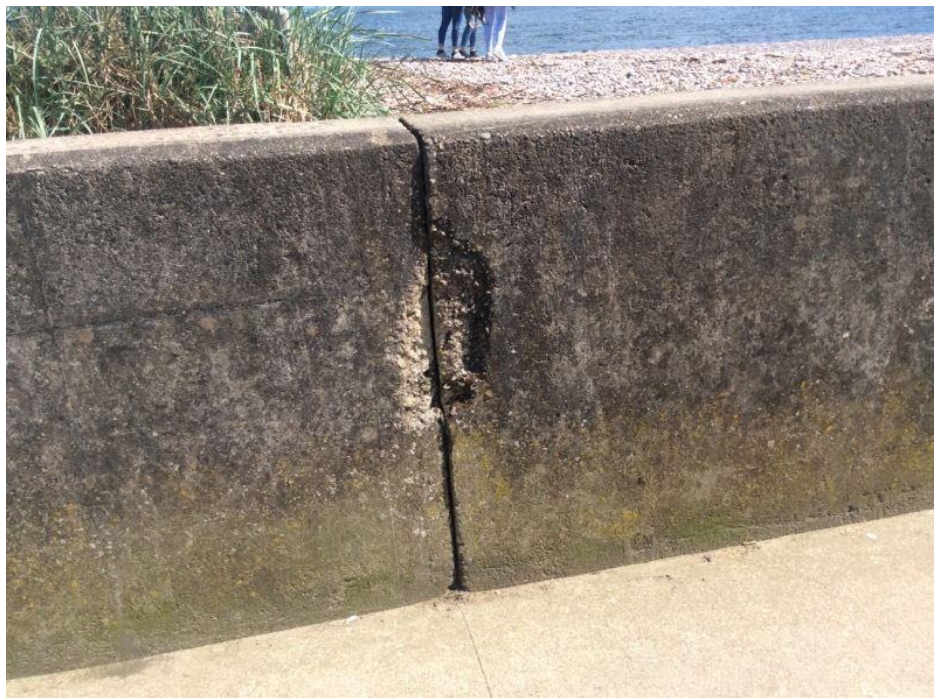
**Section E**  
**Exposed face**  
**Defect Ref: D92**  
**Description: D92 -**  
Chipped concrete by the  
expansion joint  
approximately 0.4x0.2m  
**Photo number: 136**

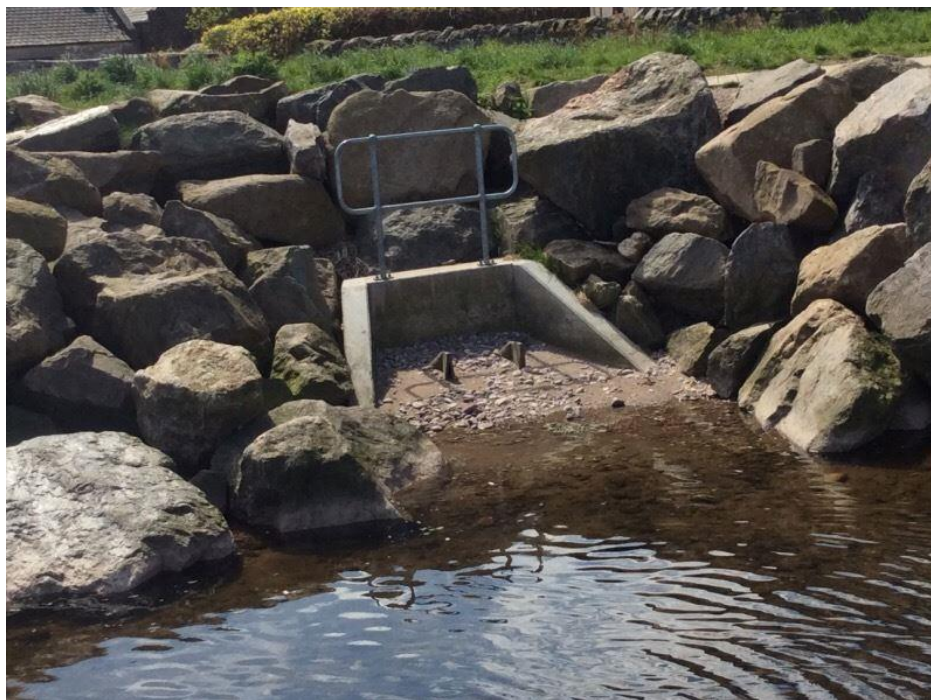
**Section F**  
**Rock armour**  
**Defect Ref: D96**  
**Description: D96 -**  
Duckbill valves blocked  
up  
**Photo number: 140**

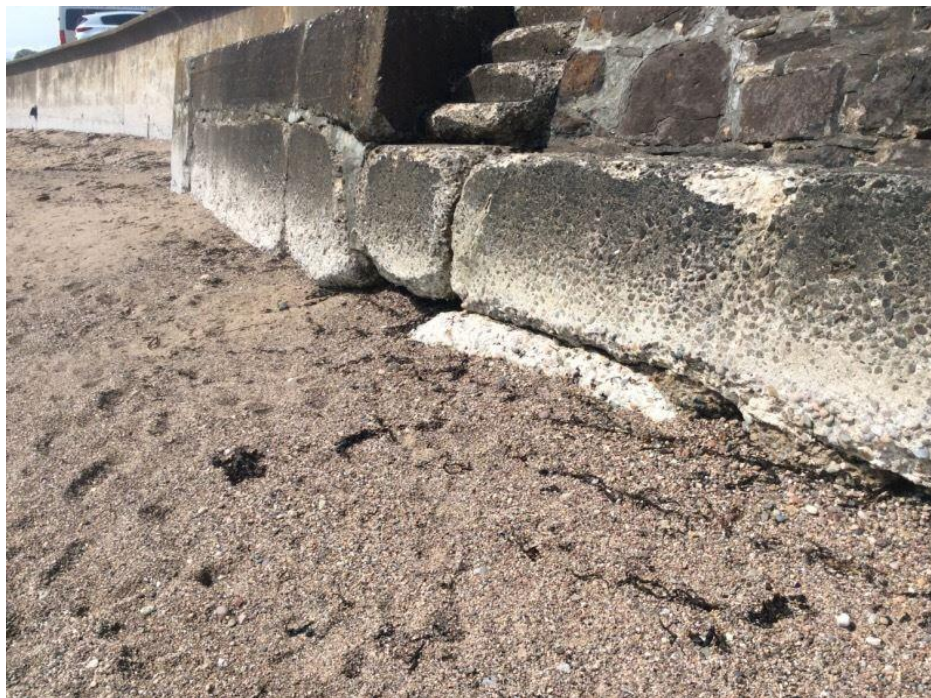
**Section A**  
**Seaward toe**  
**Defect Ref: D97**  
**Description: D97 - Poor**  
protection of the toe  
**Photo number: 141**

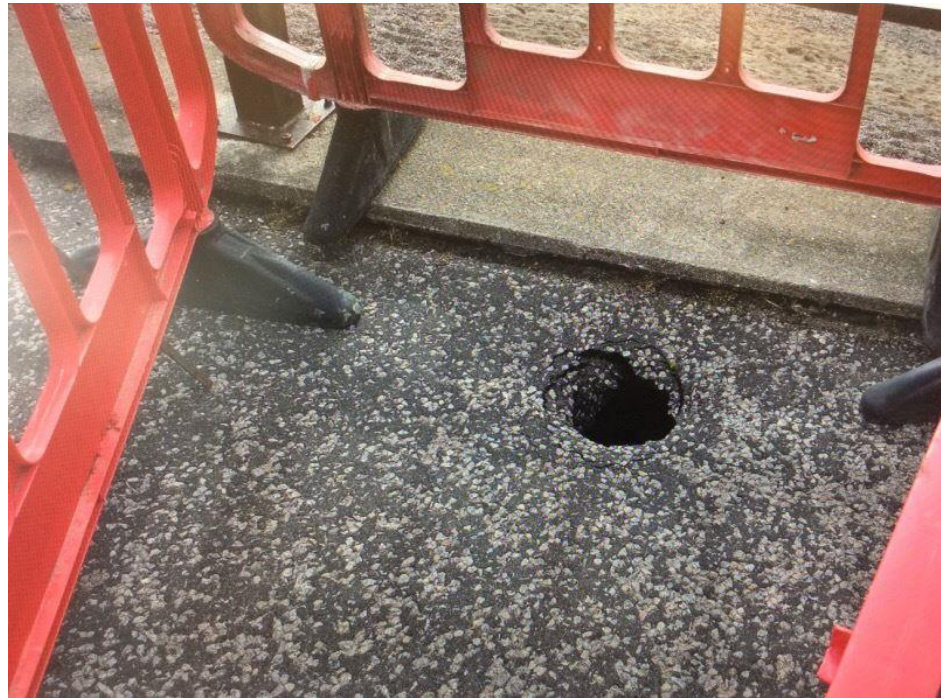
**Section B**  
**Crest**  
**Defect Ref: D98**  
**Description:** Sinkhole in crest (observed following initial inspection)  
**Photo number: 142**

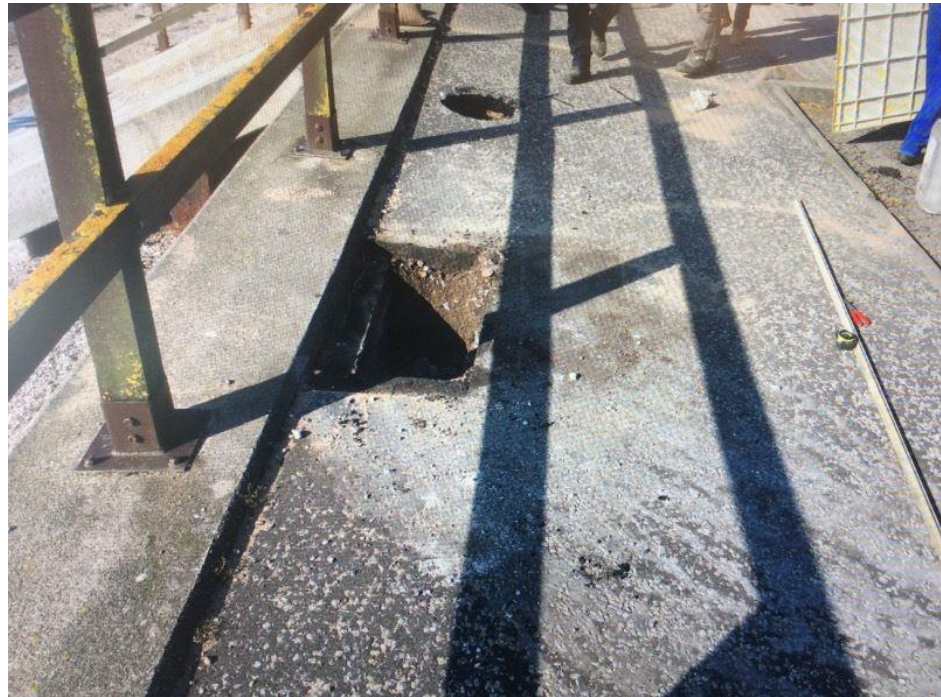
**Section B**  
**Crest**  
**Defect Ref: D98**  
**Description:** Sinkhole in crest (observed following initial inspection)  
**Photo number: 148**
