Stonehaven Bay Coastal Flood Protection Study

Information Review Report

Final Report

September 2018

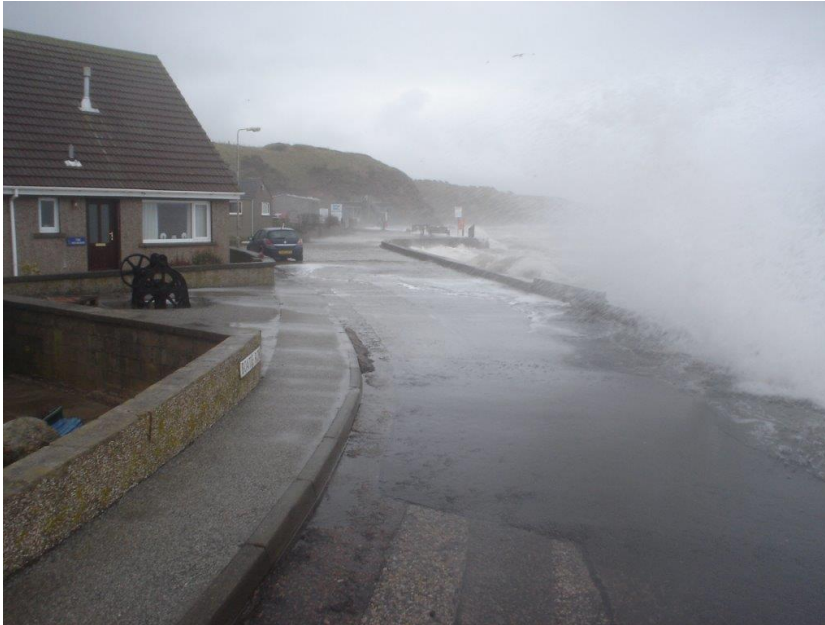
Overtopping of wall at Cowie village. Photograph supplied by Aberdeenshire Council.

The coastal historical flood record for Stonehaven has been documented within Table 2-2, with a selection of photographs presented within Figure 2-1. The events range from waves overtopping the outer harbour wall with no effect on roads or properties, to large scale events that resulted in flooding to multiple properties and evacuations. In reality, overtopping of the outer harbour wall happens far more frequently than is recorded herein; a number of events have been included where good imagery is available, primarily for completeness of the record of coastal mechanisms that occur within the study area.

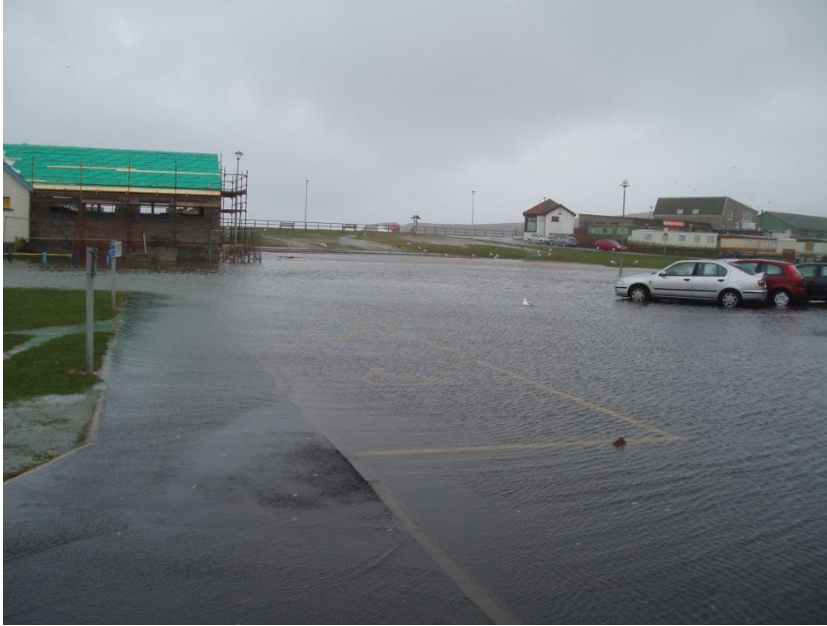
Flooding of car park behind swimming pool due to overland flow from overtopping of Cowie promenade. Photograph supplied by Aberdeenshire Council.

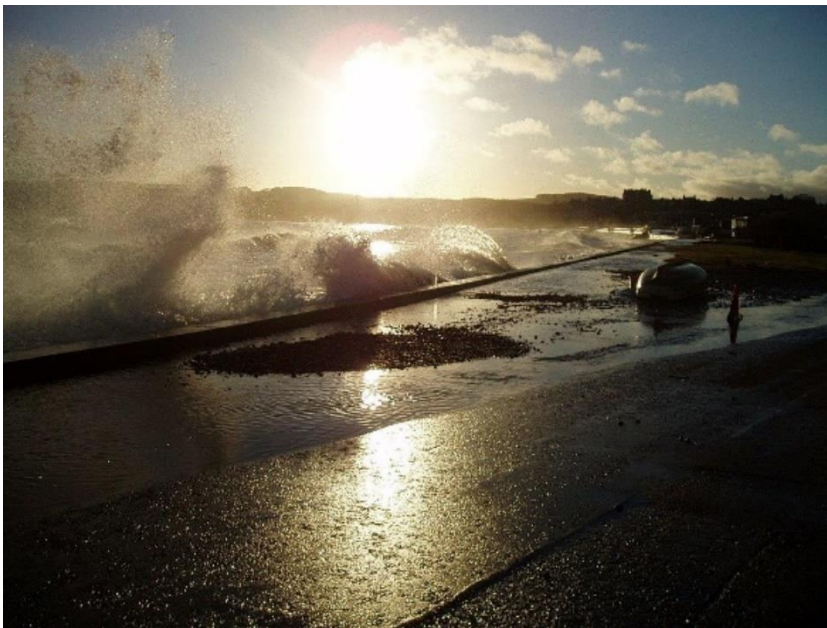
Overtopping of wall at Cowie village. Photograph supplied by Aberdeenshire Council.

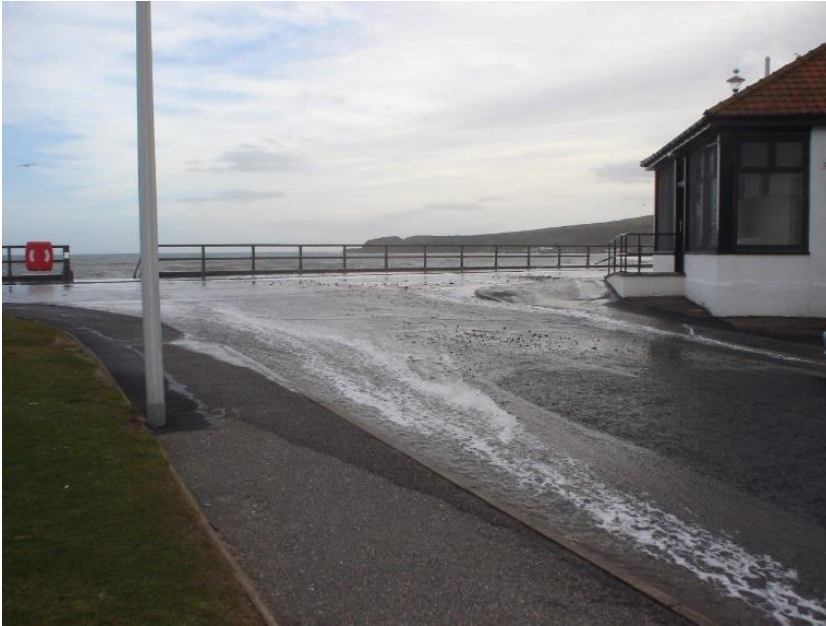
Overland flow due to overtopping at Cowie promenade. Photograph supplied by Aberdeenshire Council.

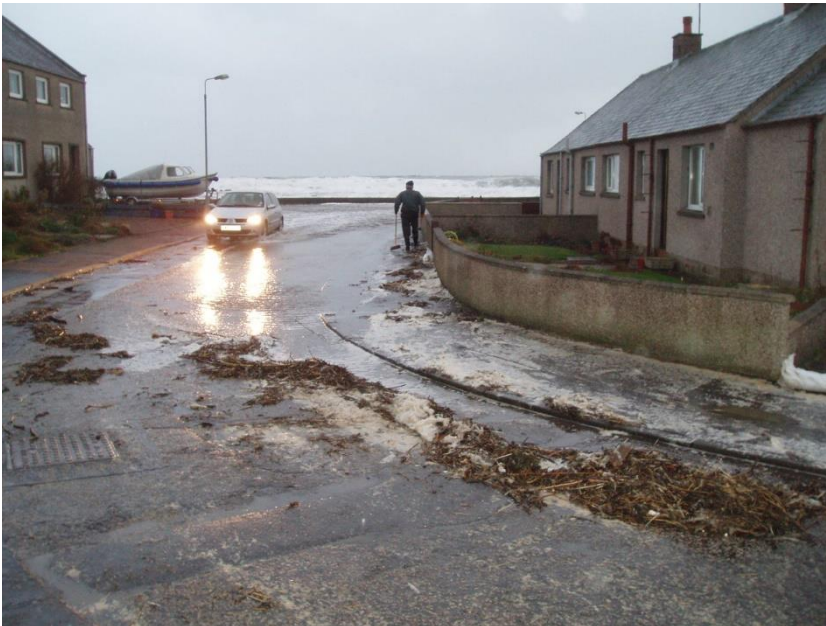
Flooding in Cowie village due to overtopping. Photograph supplied by Aberdeenshire Council.

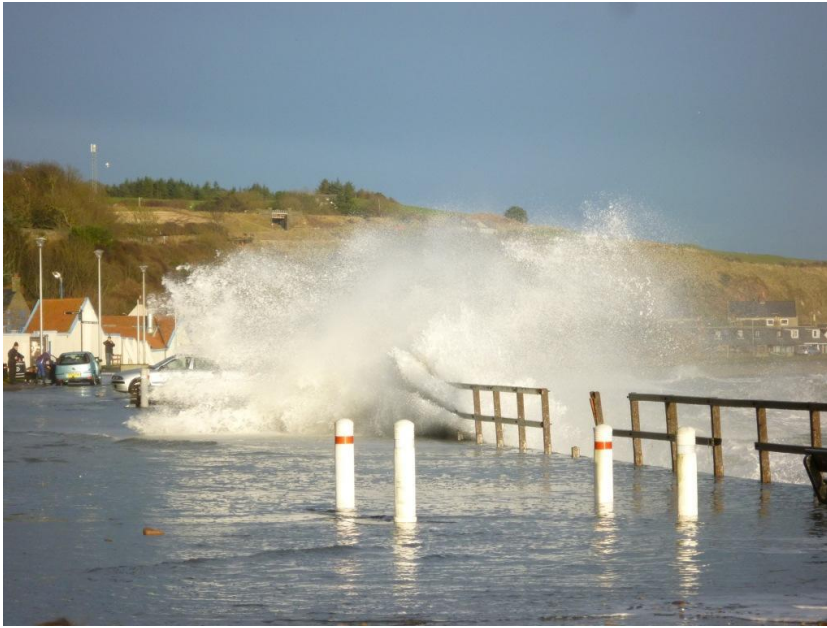
Overtopping of stepped revetment at Cowie promenade. Photograph supplied by Aberdeenshire Council.

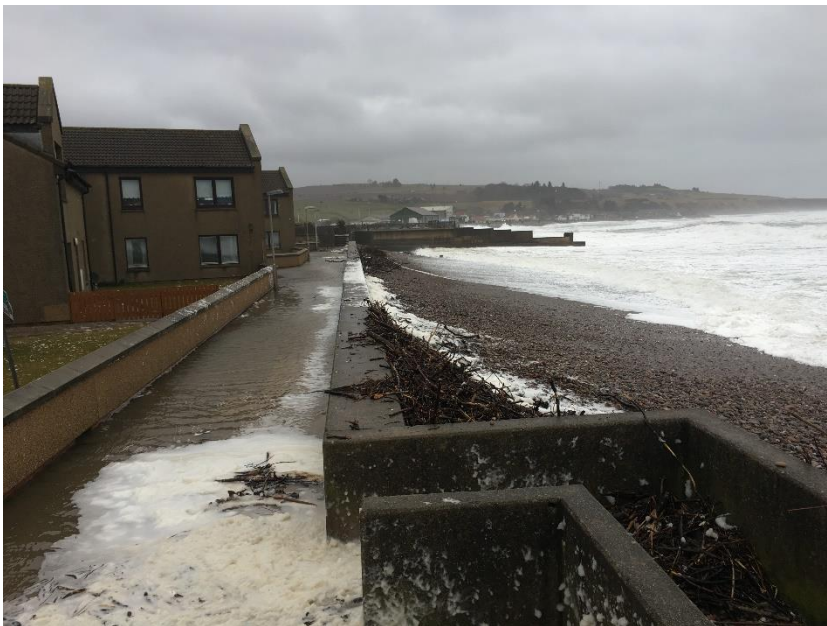
Overtopping of central wall section. Photograph supplied by Aberdeenshire Council.

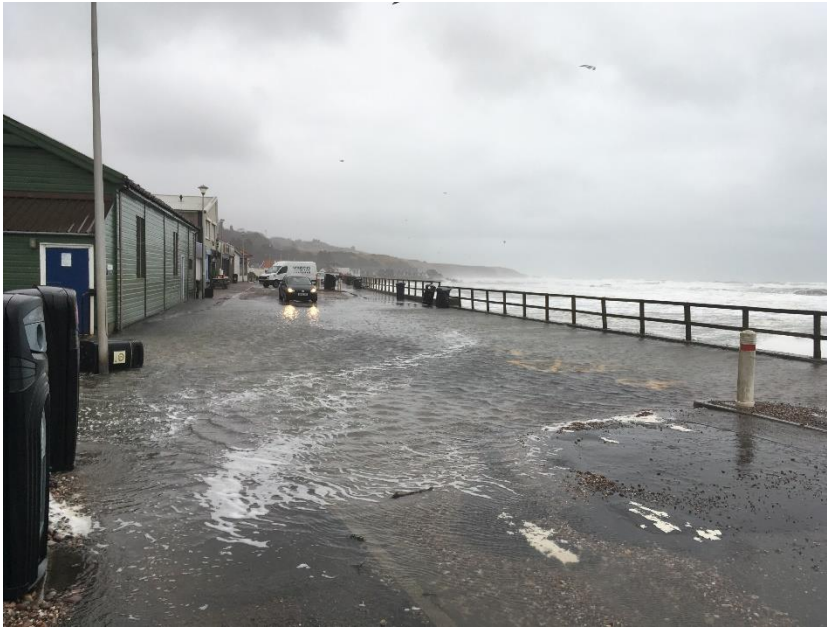
Overtopping at Cowie promenade. Photograph supplied by Aberdeenshire Council.

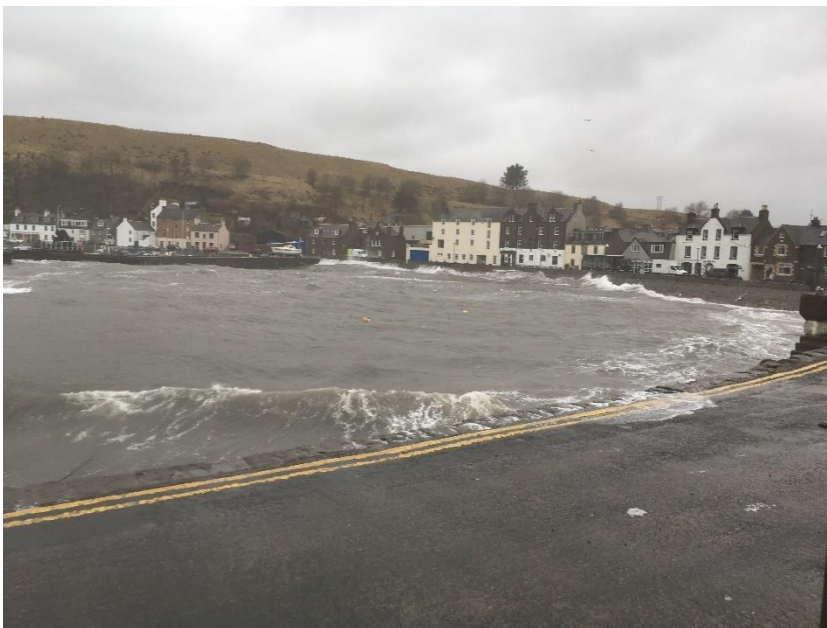
Wave action within the harbour. Photograph supplied by Aberdeenshire Council.

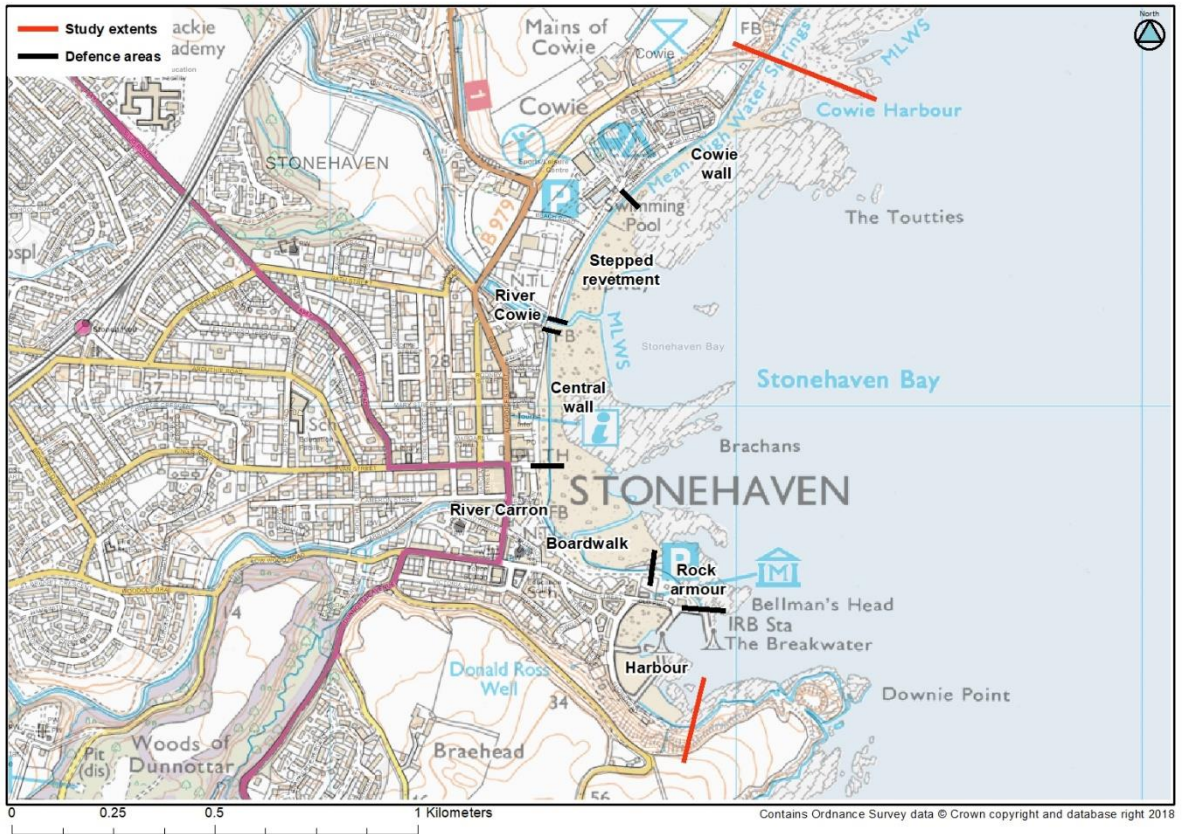
Figure 4-1: Areas and defence types within Stonehaven Bay

The frontage varies through Stonehaven and Cowie, with the general areas denoted within Figure 4-1 below.

Each of these areas/defence types is summarised below, running from south to north. Aberdeenshire Council's records and the Scottish Flood Defence Asset Database (SFDAD) website were checked for any details of any of the defences.

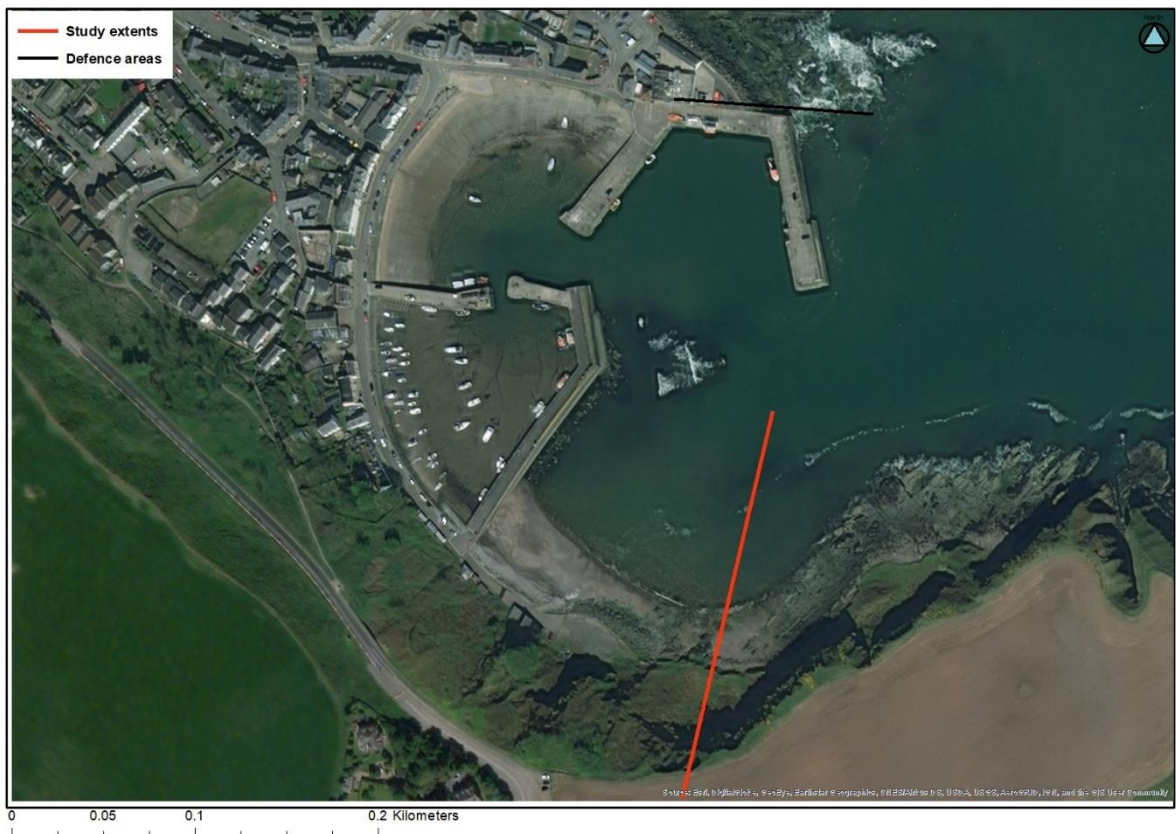
Figure 4-2: Aerial image of harbour area

In 2017, Aberdeenshire Council commissioned an inspection of the structural assets within the harbour. This concluded that several of the elements are in very poor condition with multiple structural defects. The content and recommendations made here will be reviewed in detail during the structural surveys, with a focus on any defects or works likely flood risk. It is understood that the diver inspection was repeated in May 2018; this up to date information is to be provided by Aberdeenshire Council once available.

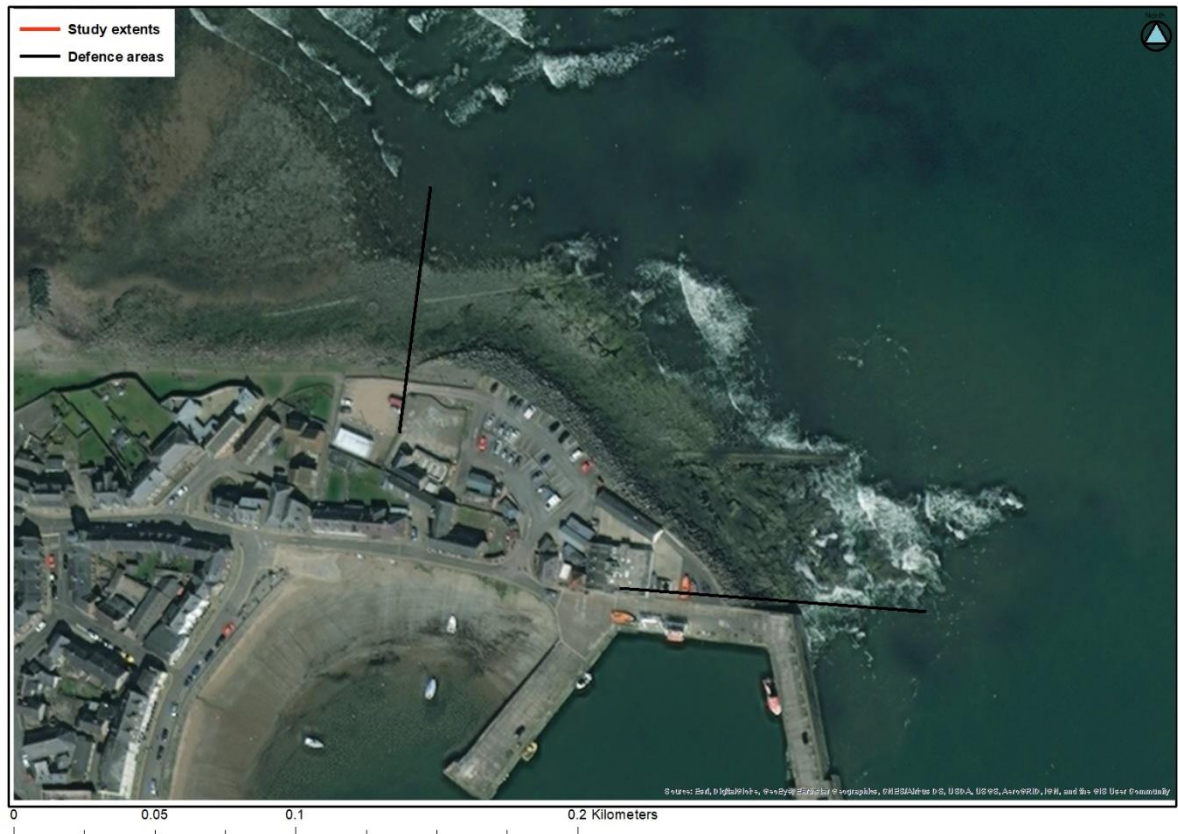
Figure 4-3: Aerial image of rock armour section

To the north of the harbour is a public car park that is fronted by a substantial rock armour revetment. This is placed along the headland from the outer breakwater to within the bay.

No drawings or details have been made available and the condition of this will be reviewed during the structural surveys. The outcomes and recommendations of this will be used to inform the options appraisal and any further engineering works required.

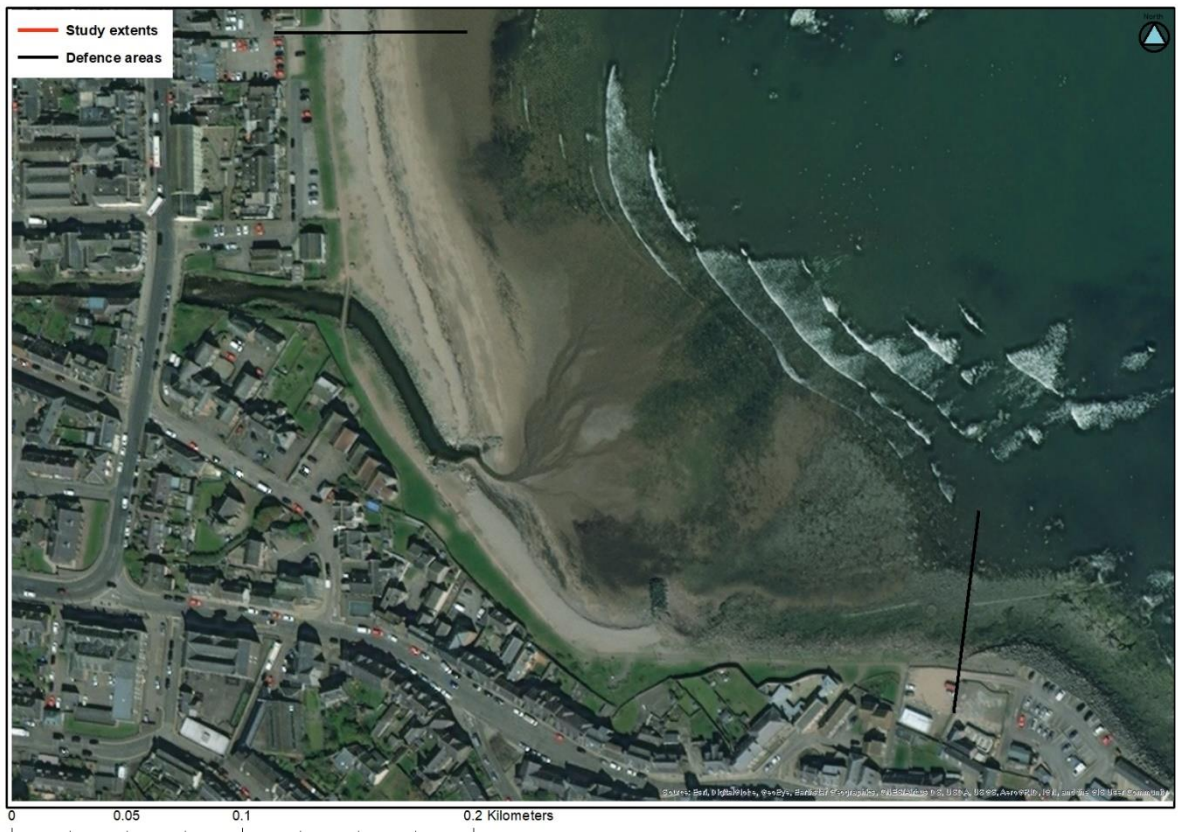
Figure 4-4: Aerial image of boardwalk section

South of the Carron, the beach is prone to erosion with the timber walkway washed away during the December 2012 event. This is likely a combination of wave energy and the influence of the mouth of the River Carron, which directs flow longshore towards the area. Shingle deposited in the mouth of the River Cowie is periodically recycled and placed here to reduce erosion, with limited success.

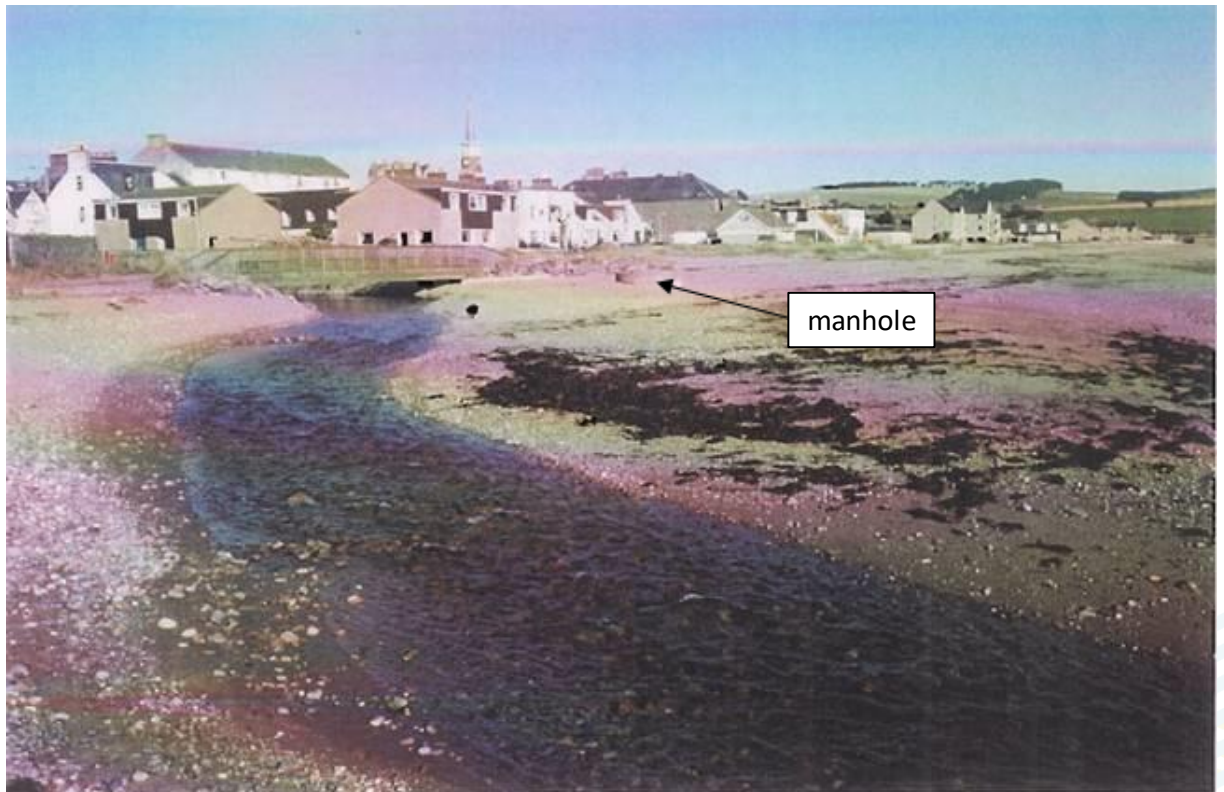
Figure 4-5: Historical natural outfall of the River Carron

Historically the River Carron discharged freely across the beach (Figure 4-5). In 1998 HR Wallingford were commissioned by Aberdeenshire Council to consider options for maintaining a channel for the River Carron across the beach; concerns were that the discharge of floodwater was being hampered by the low clearance of the footbridge crossing the channel and the deflection and partial siltation of the channel across the beach. The report³ considered a number of training wall configurations, with the recommended option presented within **Figure 4-6**.

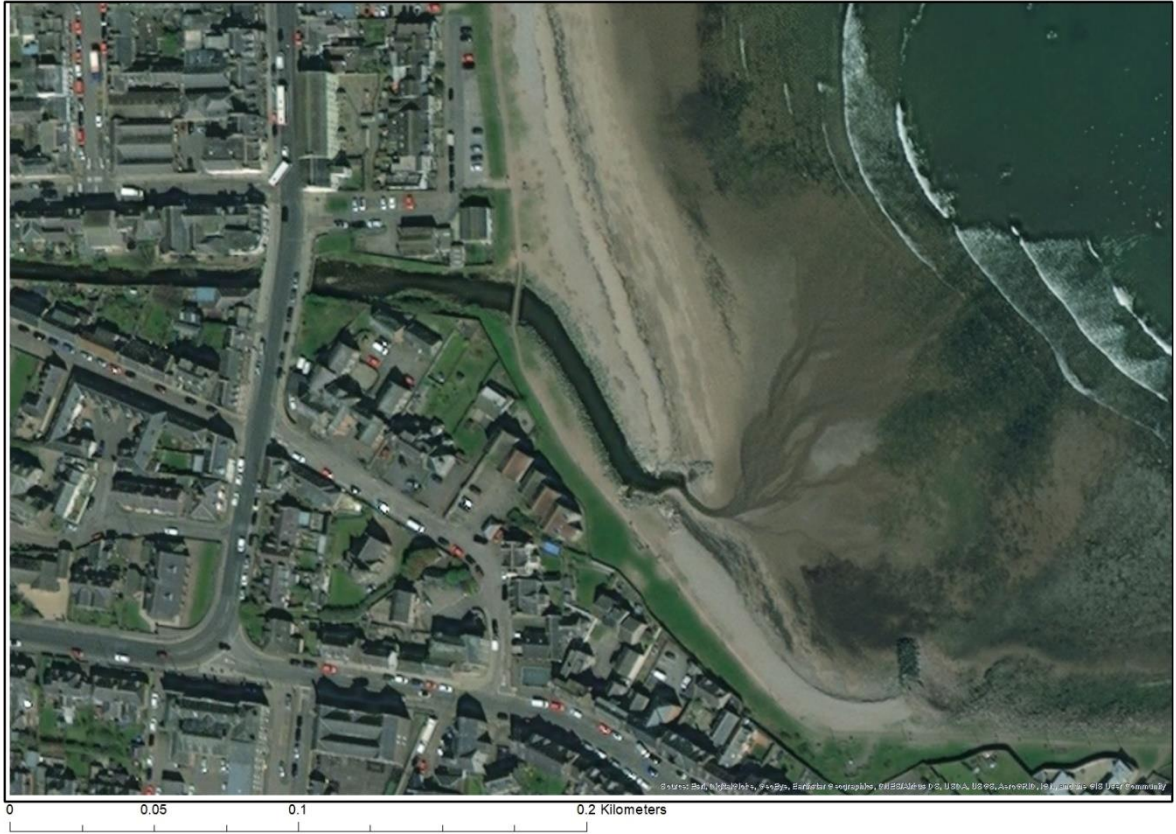
Figure 4-7: Current configuration at the mouth of the River Carron

The configuration of the rock armour training structure that was built at the mouth of the Carron differs from that shown above. Details of the final design and the date of construction have been requested from Aberdeenshire Council, and these details will be incorporated into future phases of the study once they are made available. The current configuration at the mouth of the Carron can be seen in **Figure 4-7**.

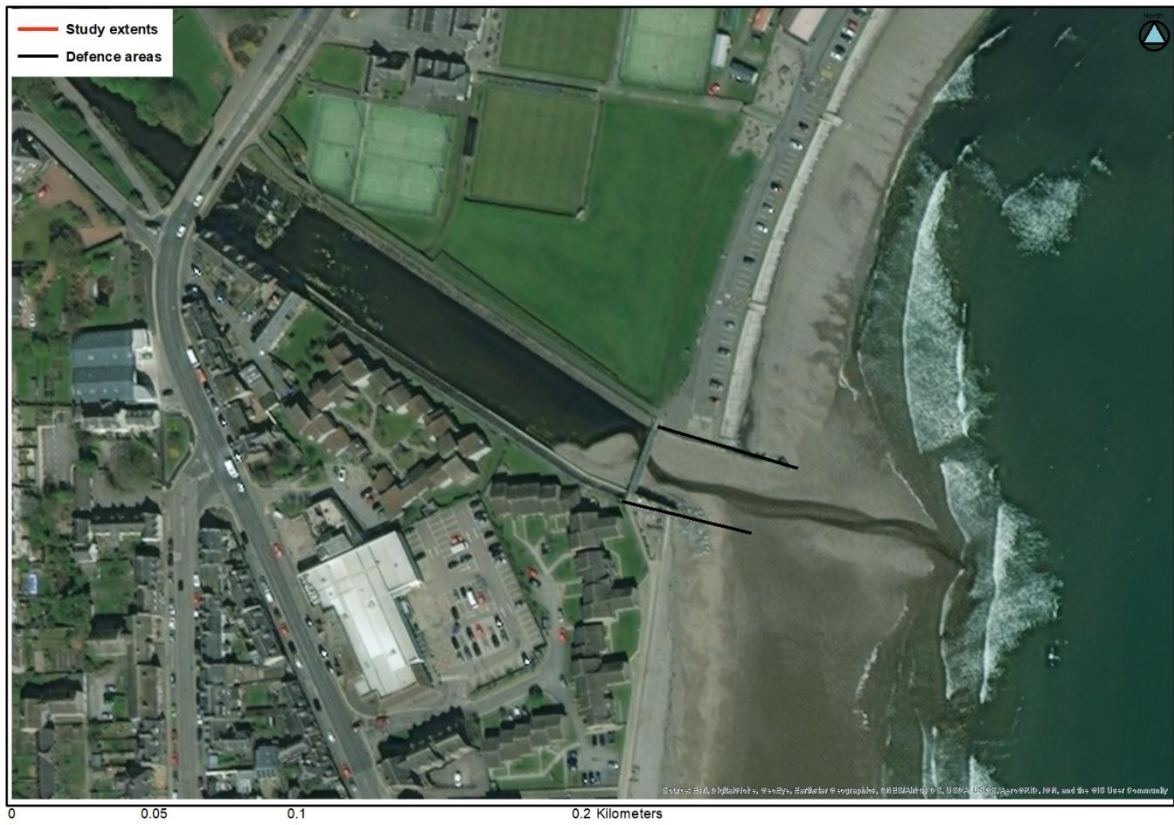
Figure 4-9: Aerial image of River Cowie section

The River Cowie section consists of a combination of concrete walls, concrete revetments, and steel sheet piles. The defences extend from the mouth of the River to the B979 road bridge, 200m upstream. During storm conditions, waves can propagate into the mouth of the river and break on the weir at the road bridge. The south bank of the river is also at risk from overtopping from oblique waves that enter the mouth and roll along the revetment.

Drawings of the structures are available from Aberdeenshire Council and will be reviewed in detail during the options appraisal and engineering phases. It is understood that the section on the north bank has been undermined in the past and will likely require additional engineering works.

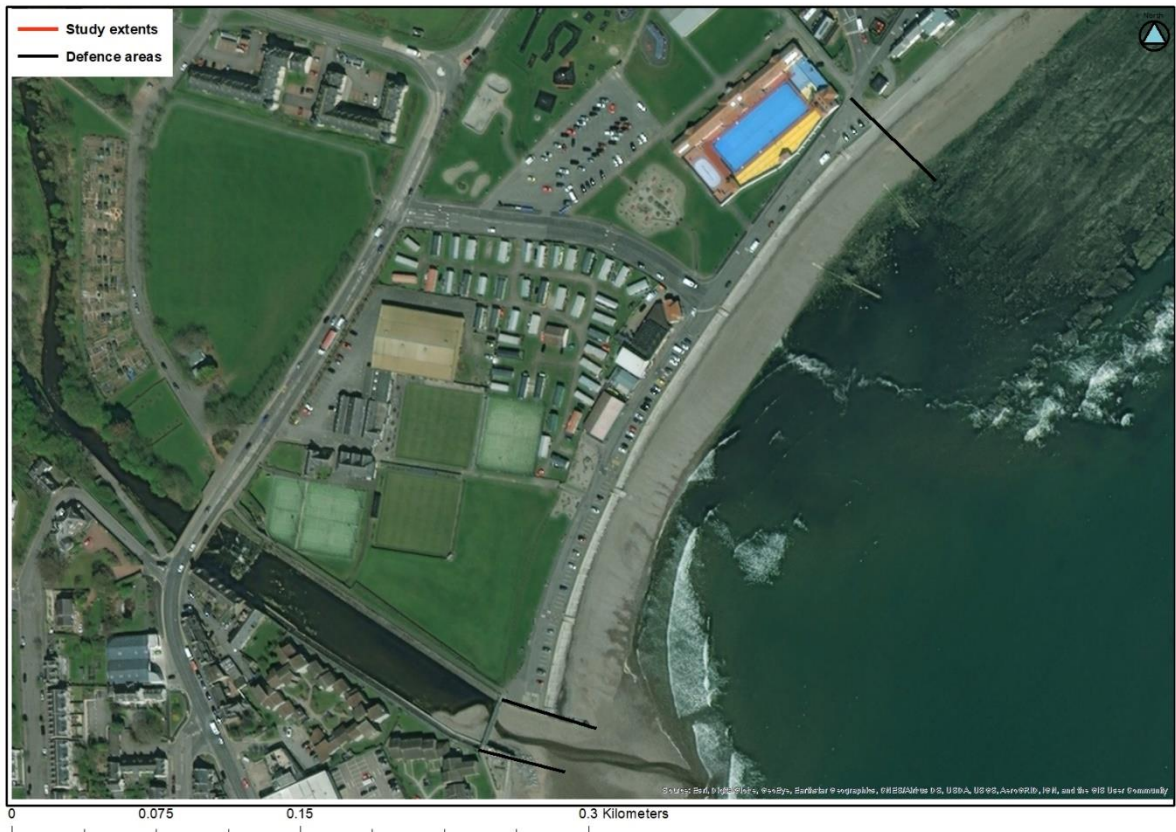
Figure 4-10: Aerial image of stepped revetment section

Over the years there has been significant damage to the structure from undermining and scour at the toe. Currently most of the toe is buried under a considerable depth of sediment. The sediment here is much finer than further south in the bay, with rock armour installed along the toe of the defences in 2006.

Overtopping here happens regularly, with significant damage to the shorefront commercial properties occurring in recent years. The local topography means that when significant overtopping occurs water will flow west, flooding the leisure centre car park, caravan park, and bowling club.

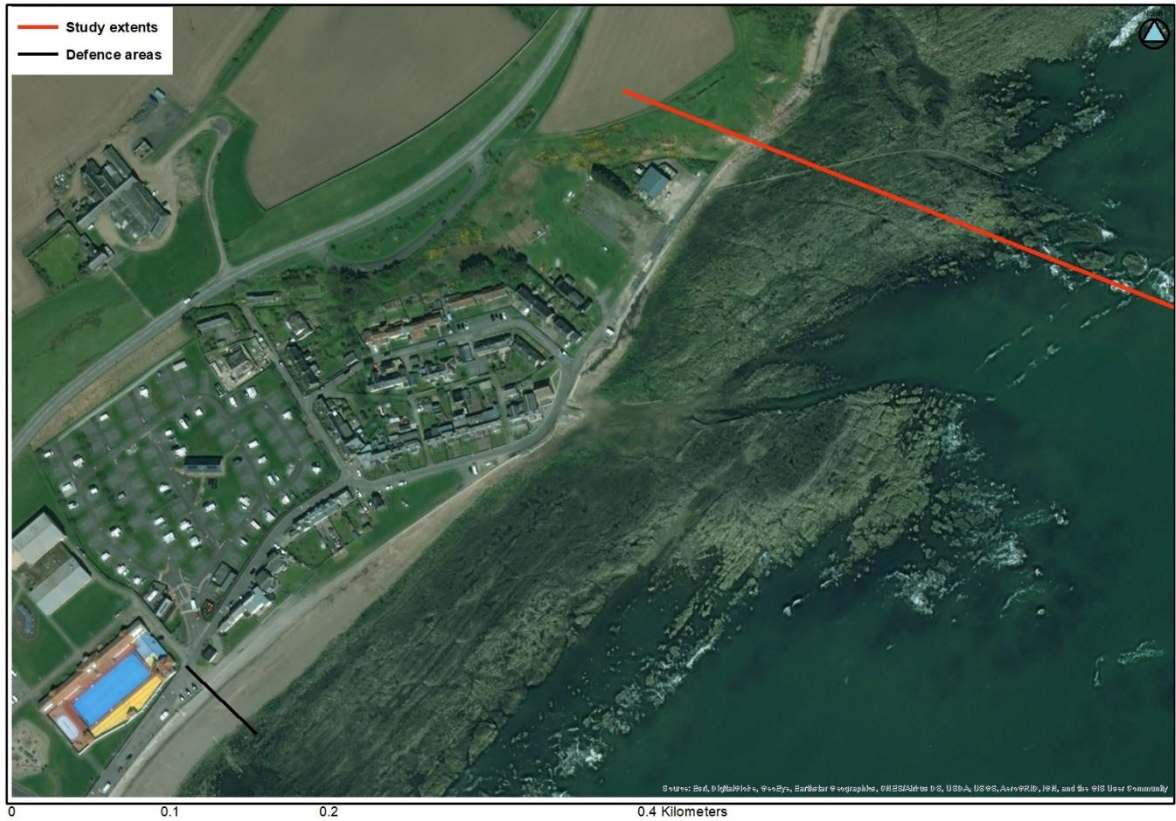
Figure 4-11: Aerial image of Cowie wall section

The Cowie wall section runs from the open-air pool to the limit of the residential properties in Cowie. It is a vertical concrete wall that experiences extremely variable sediment depths at the toes. The natural rocky foreshore provides a degree of protection from incoming wave energy, but frequent overtopping exists. Flooding to properties here also occurs during the more extreme events.

Drawings are available from Aberdeenshire Council archives for the southern half of this section.

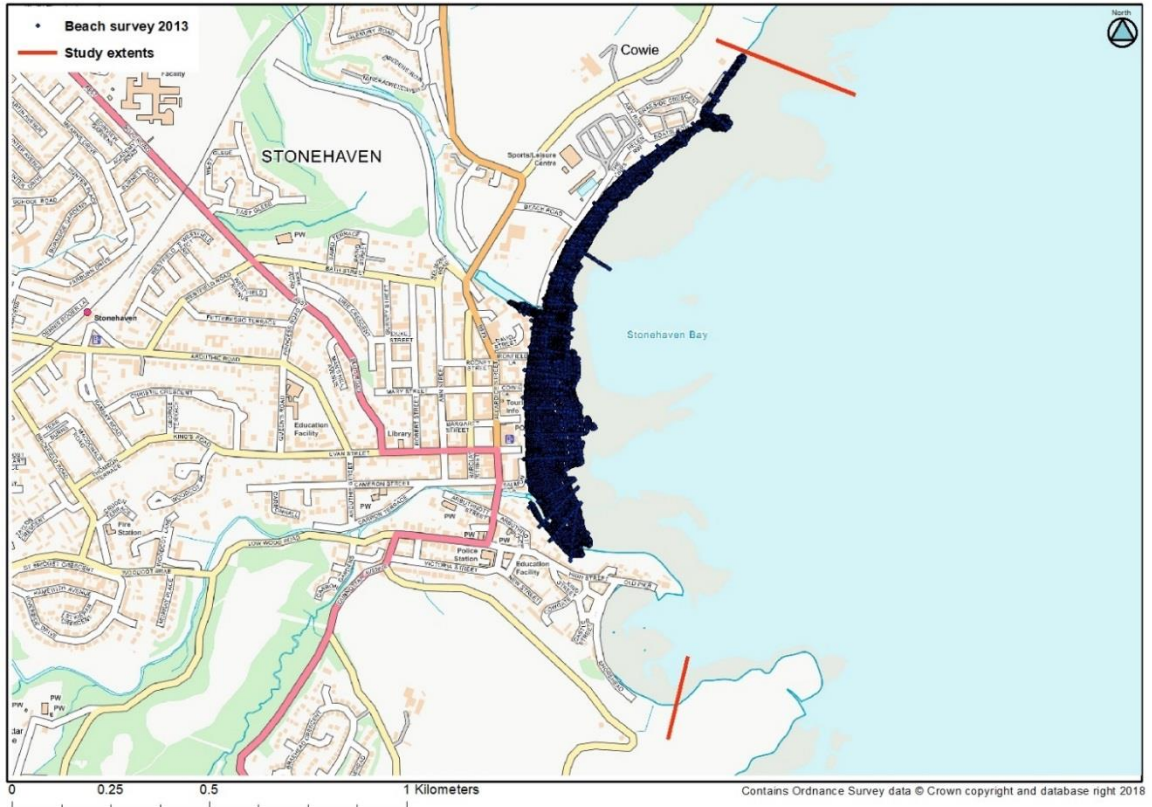
Figure 6-4: Extent of the 2013 beach survey

The extent of the two beach surveys are shown in Figure 6-4, the extent of the 2017 FFS survey presented within Figure 6-5 and the locations of the existing threshold surveys shown in Figure 6-6.

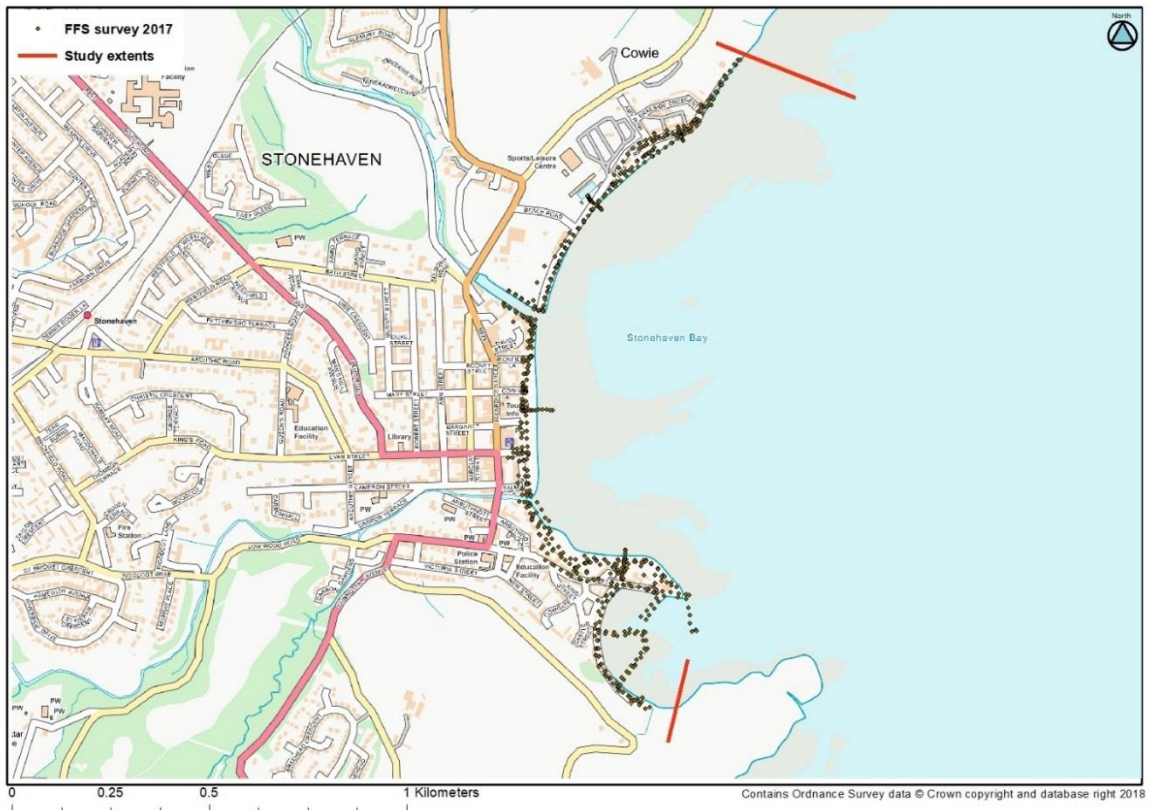
Figure 6-5: Extent of the 2017 FFS survey
