Location Plan:		Stonehaven harbour Assessment Date: 15/05/2018

Exam Type:	Detailed	
	Complete Survey:	Yes	
	Structure Ref:	1	
	OS Ref:	387867 , 785378	
	Survey Unit:	N/A	
	Governing SMP2:	N/A	
	SMP2 Policy Unit:	N/A	
	SMP2 Policy:	N/A	
<p>NOTE: This document has been prepared as an Asset Condition Survey Report for Aberdeenshire Council. JBA Consulting accepts no responsibility or liability for any use that is made of this document other than by the Client for the purposes for which it was originally commissioned and prepared.</p>

COASTAL ASSET CONDITION SURVEY REPORT

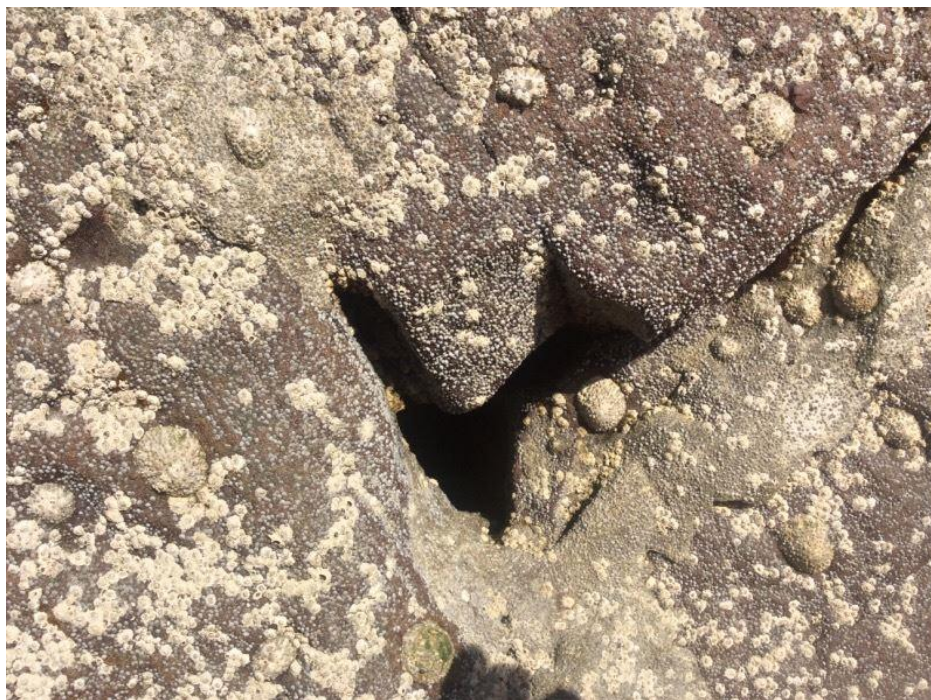
- There are signs of voiding behind the blockwork on the seaward and quay face.
- The sheet piles are heavily corroded with some complete loss of section through the piles.
- Corroded ladders.

Section B
Seaward face
Defect Ref: D11
Description: D11 -
Voiding behind seaward
face
Photo number: 112

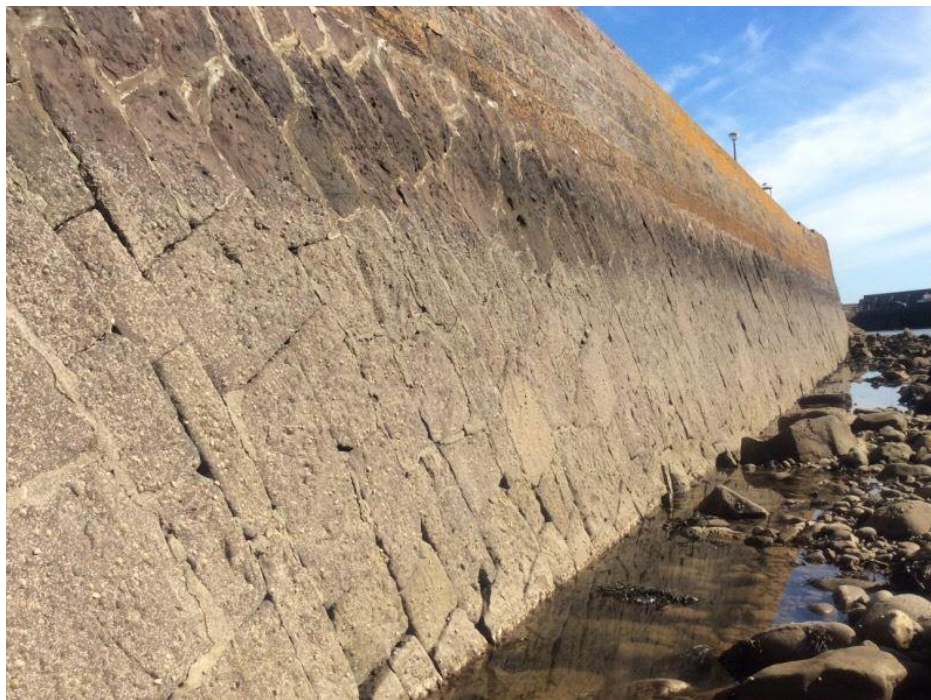
Section B
Seaward face
Defect Ref: D11
Description: D11 -
Voiding behind seaward
face
Photo number: 190

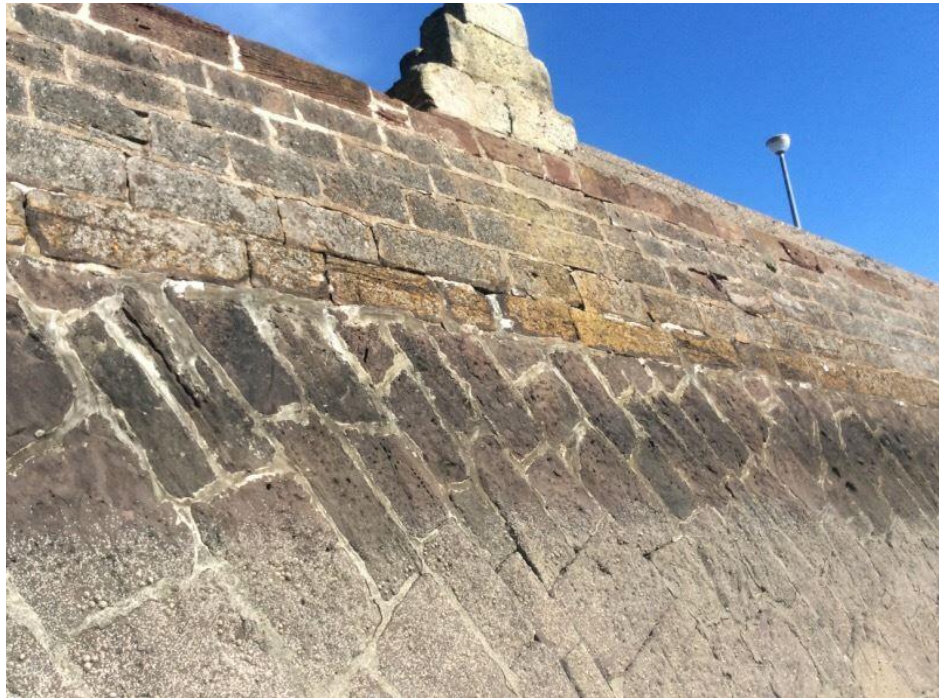
Section B
Capping
Defect Ref: D12
Description: D12 - Open joints
Photo number: 113

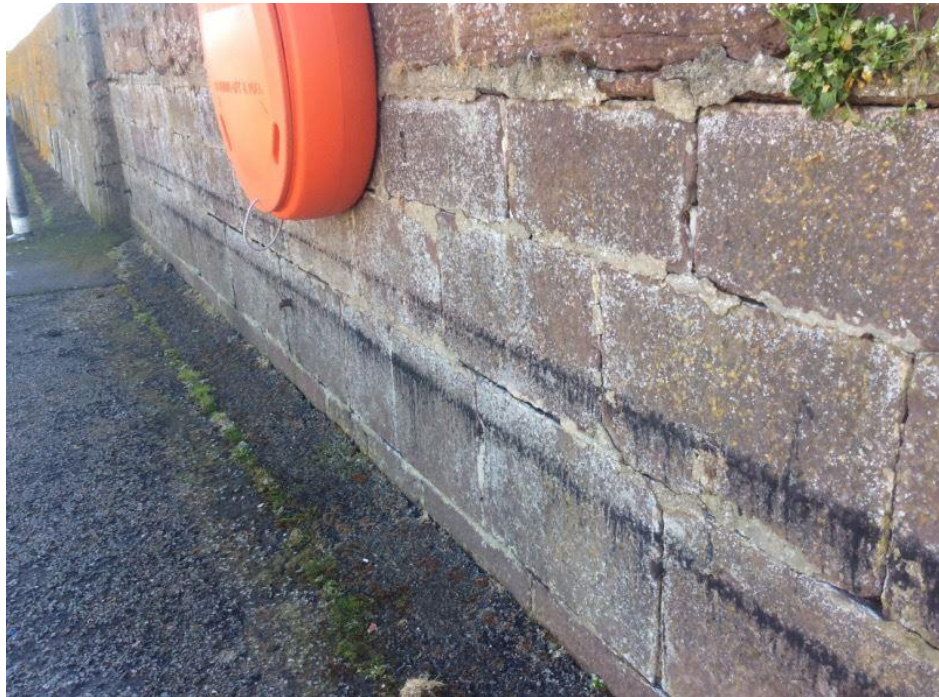
Section B
Capping
Defect Ref: D12
Description: D12 - Open joints
Photo number: 192

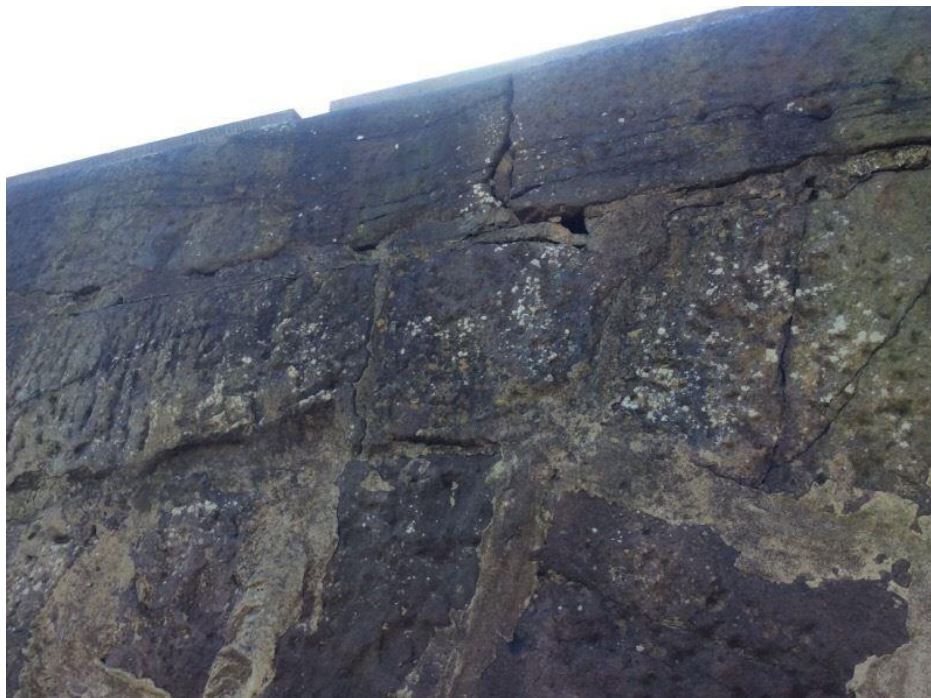
Section B
Quay face
Defect Ref: D13
Description: D13 -
Small cracks of masonry
blocks.
Photo number: 191

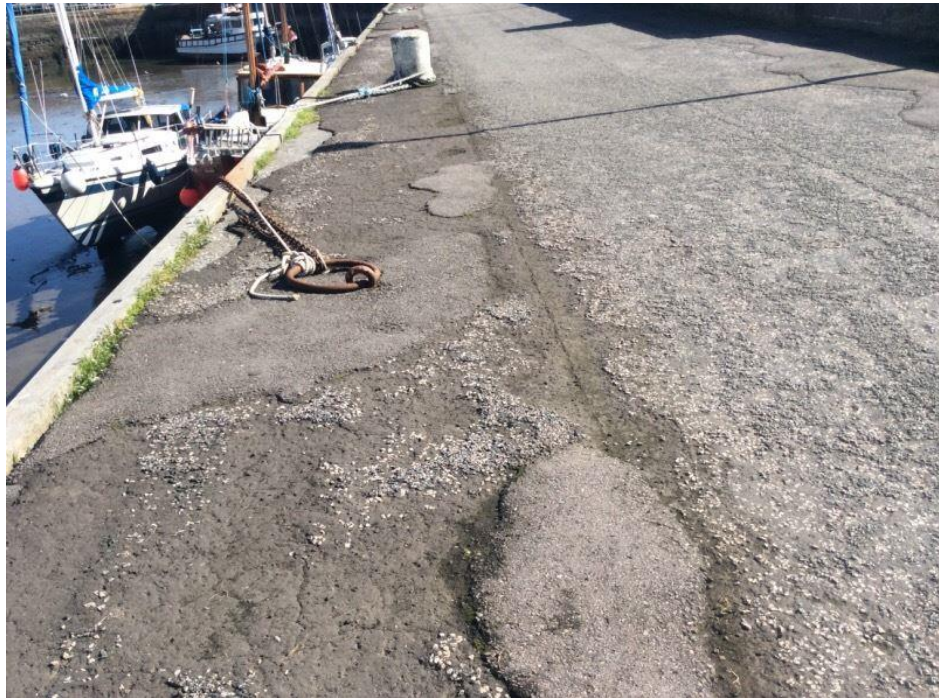
Section B
Deck
Defect Ref: D15
Description: D15 -
Dilapidated tarmac
surface.
Photo number: 115

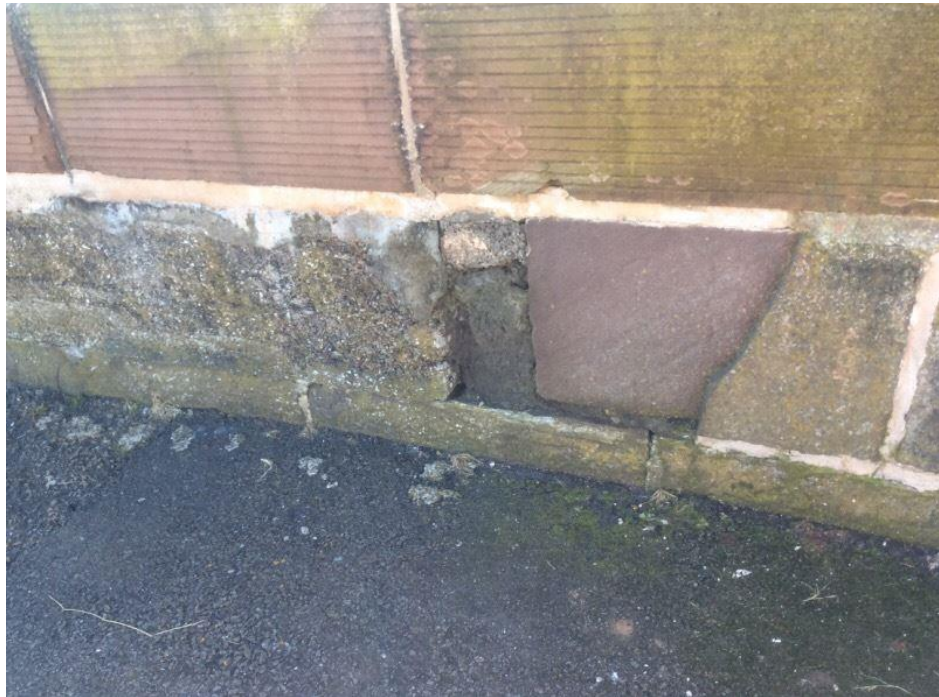
Section B
Capping
Defect Ref: D16
Description: D16 -
Weathering of repairs
Photo number: 116

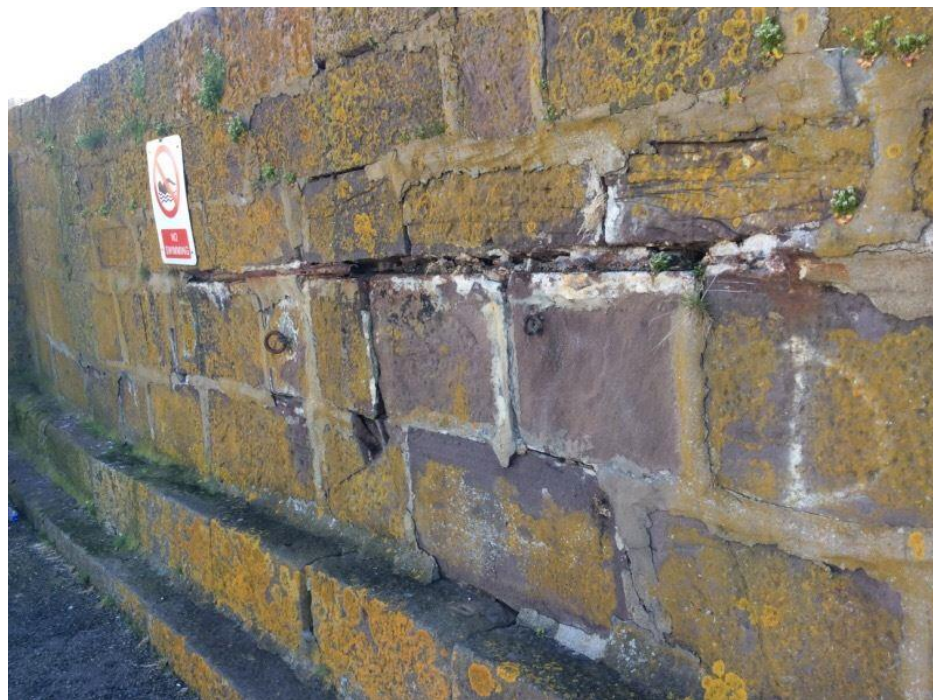
Section B
Capping
Defect Ref: D17
Description: D17 -
Corroding piping joints.
Photo number: 223

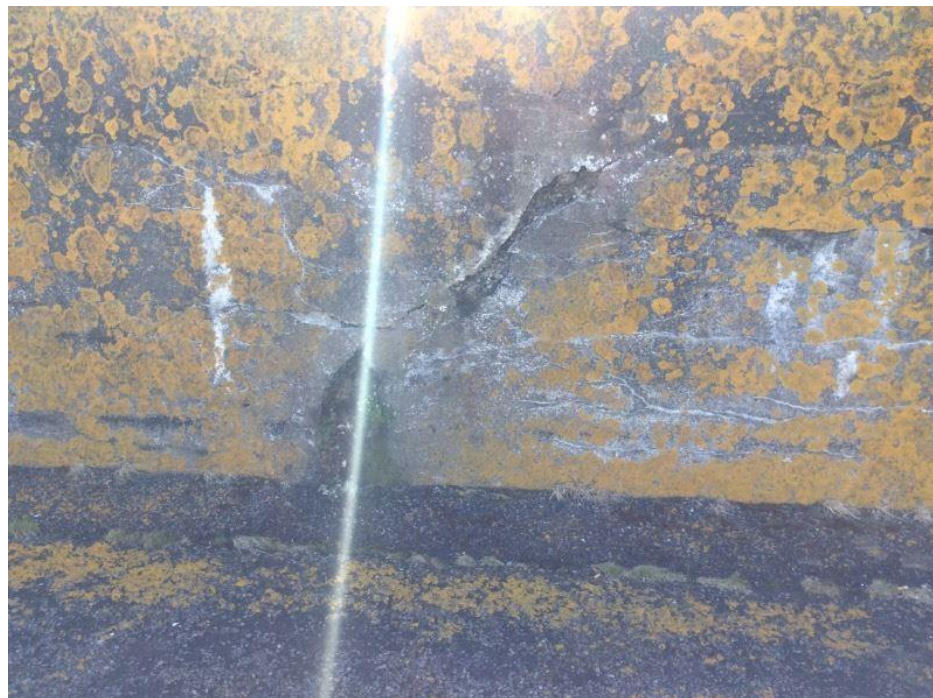
Section B
Capping
Defect Ref: D18
Description: D18 -
Cracking and spalling of
concrete rendering
throughout section.
Photo number: 118

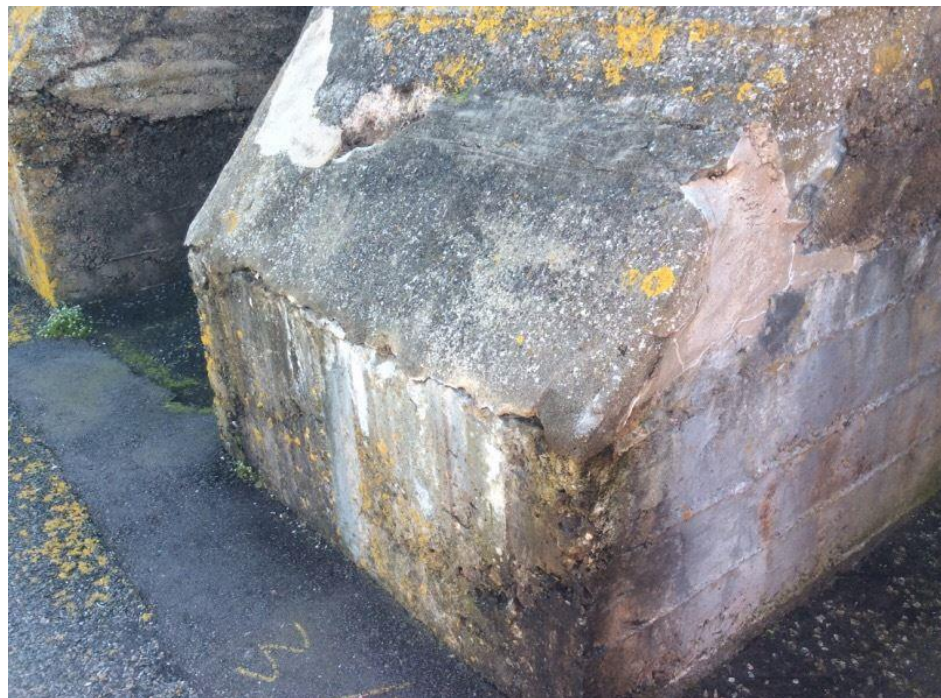
Section B
Capping
Defect Ref: D19
Description: D19 - Spalling, cracking and honeycombing of buttress elements of the wall.
Photo number: 193

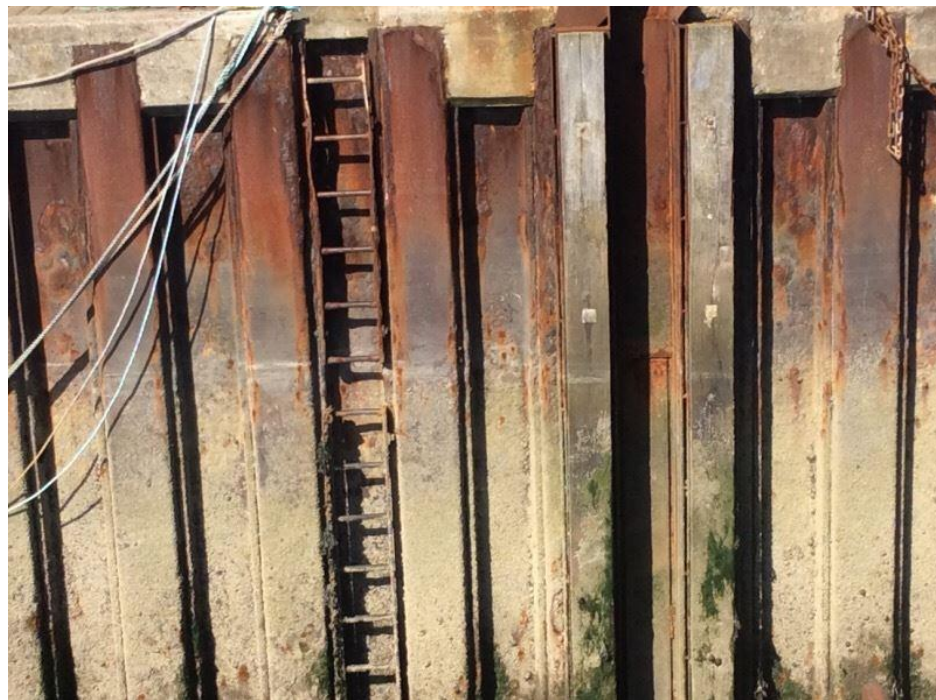
Section D
Sheet piling
Defect Ref: D22
Description: D22 -
Health and Safety -
Heavily corroded ladder.
Photo number: 122

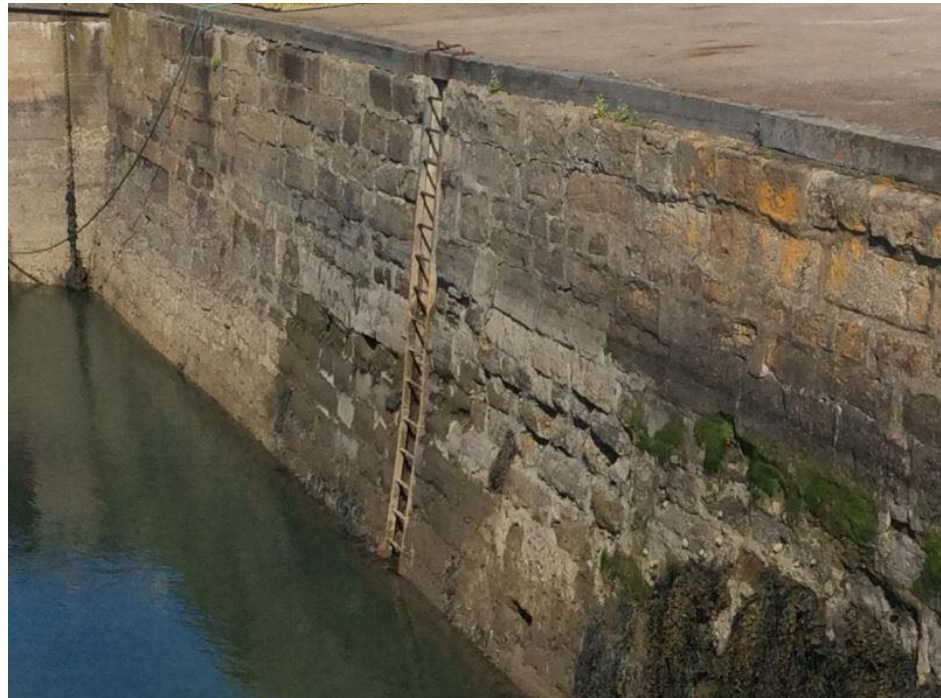
Section B
Quay face
Defect Ref: D27
Description: D27 -
Corroded ladder
Photo number: 127

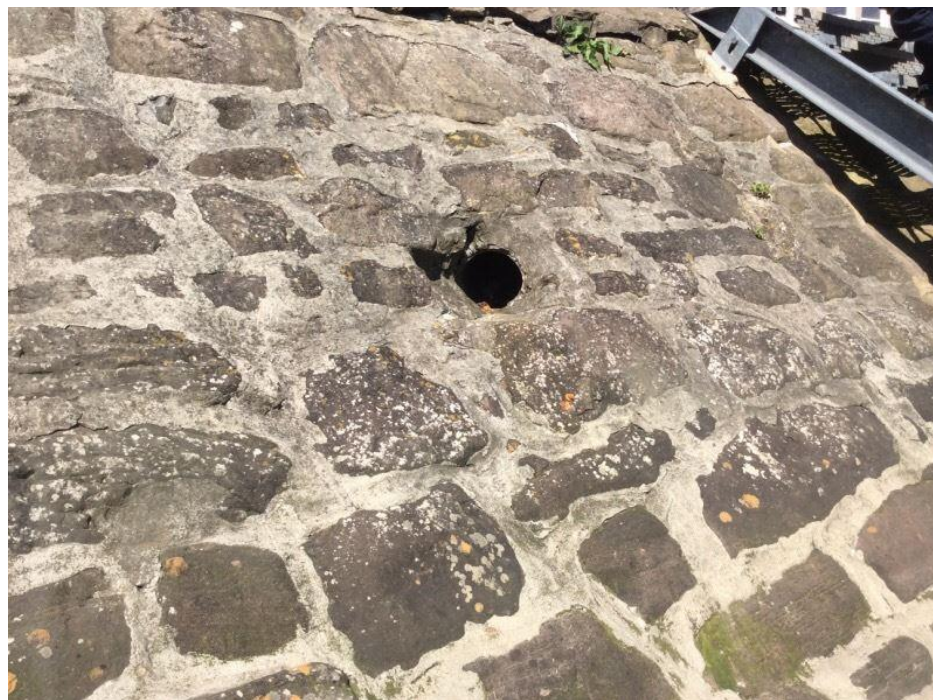
Section C
Exposed face
Defect Ref: D31
Description: D31 -
Missing flap valve
Photo number: 226

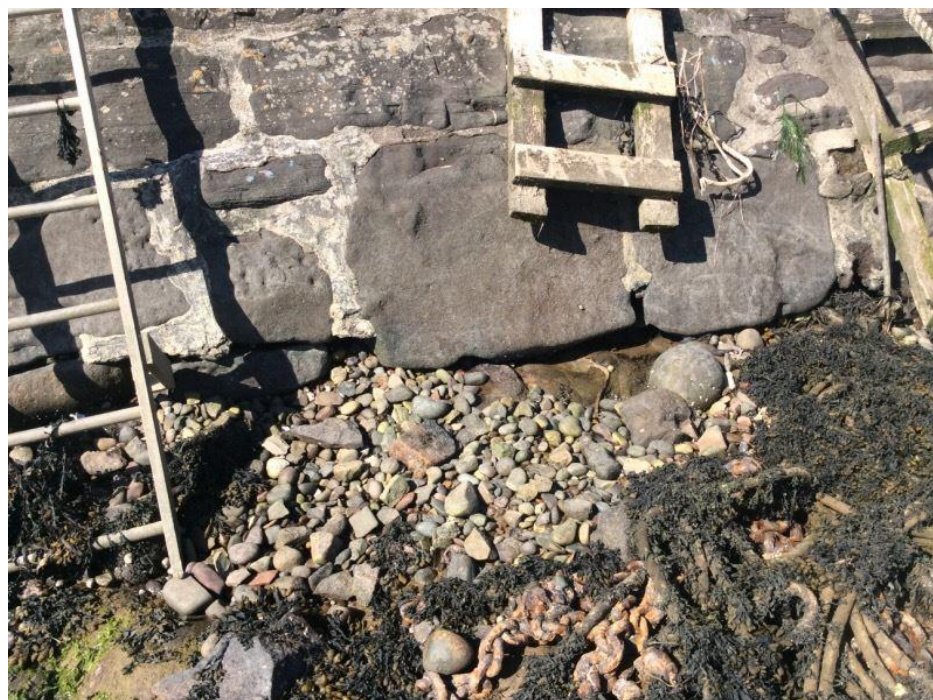
Section C
Exposed face
Defect Ref: D32
Description: D32 -
Undermining scour of
exposed face
approximately 10m
Photo number: 132

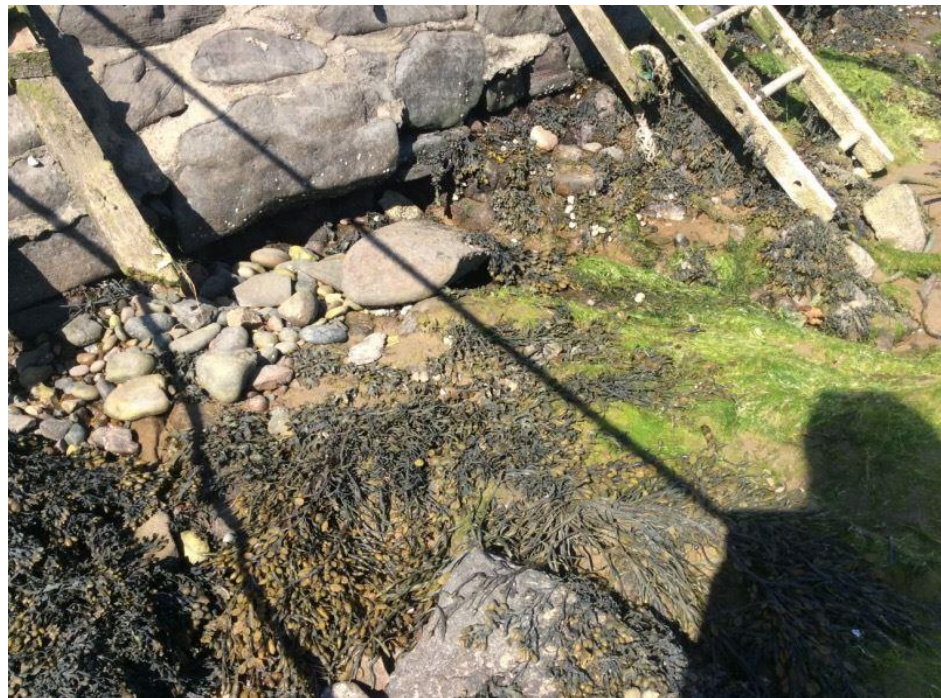
Section C
Exposed face
Defect Ref: D32
Description: D32 -
Undermining scour of
exposed face
approximately 10m
Photo number: 196

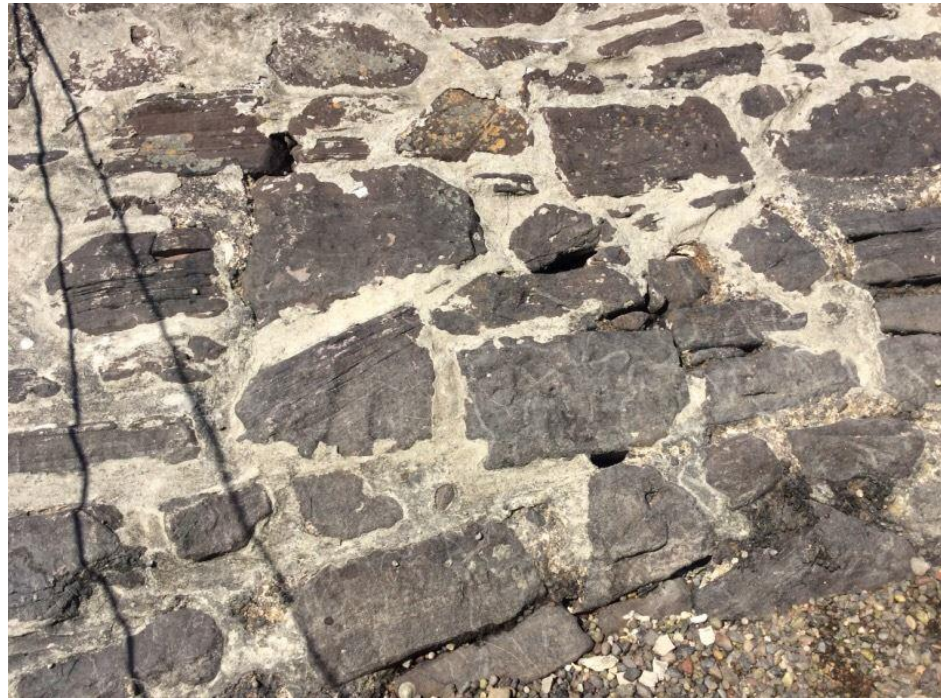
Section C
Exposed face
Defect Ref: D34
Description: D34 - Open joints
Photo number: 134

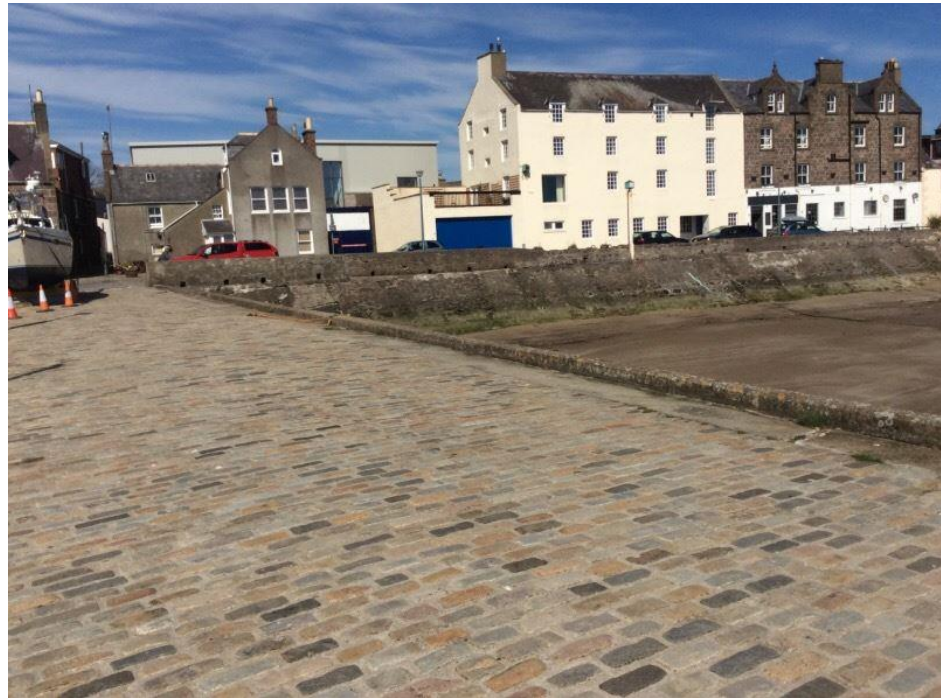
Section D
Deck
Defect Ref: D36
Description: D36 - H&S
Insufficient handrailing.
Photo number: 136

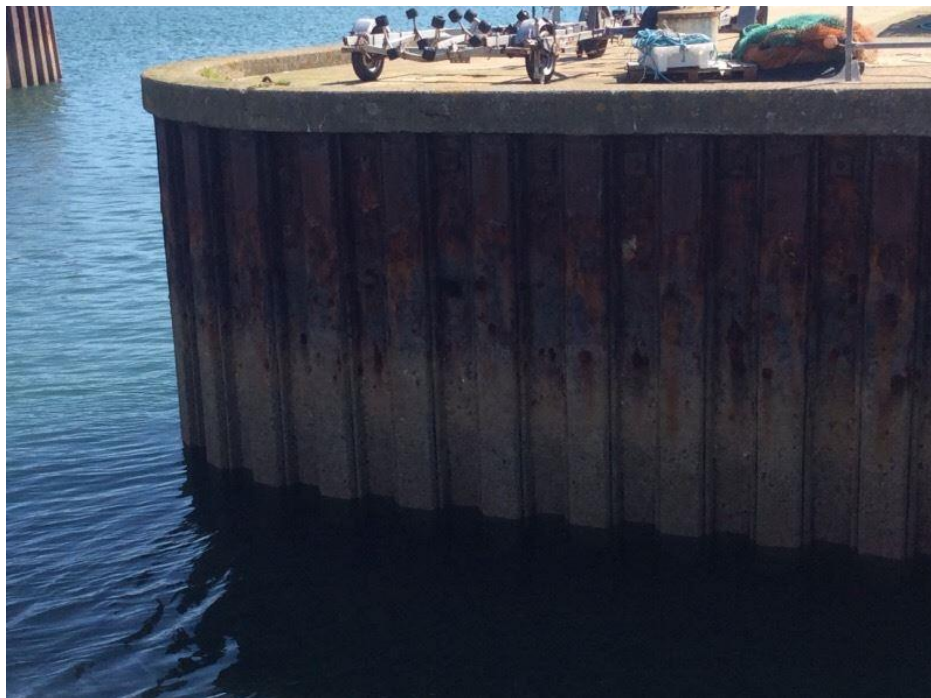
Section B
Piling
Defect Ref: D39
Description: D39 -
Missing anchors
Photo number: 139

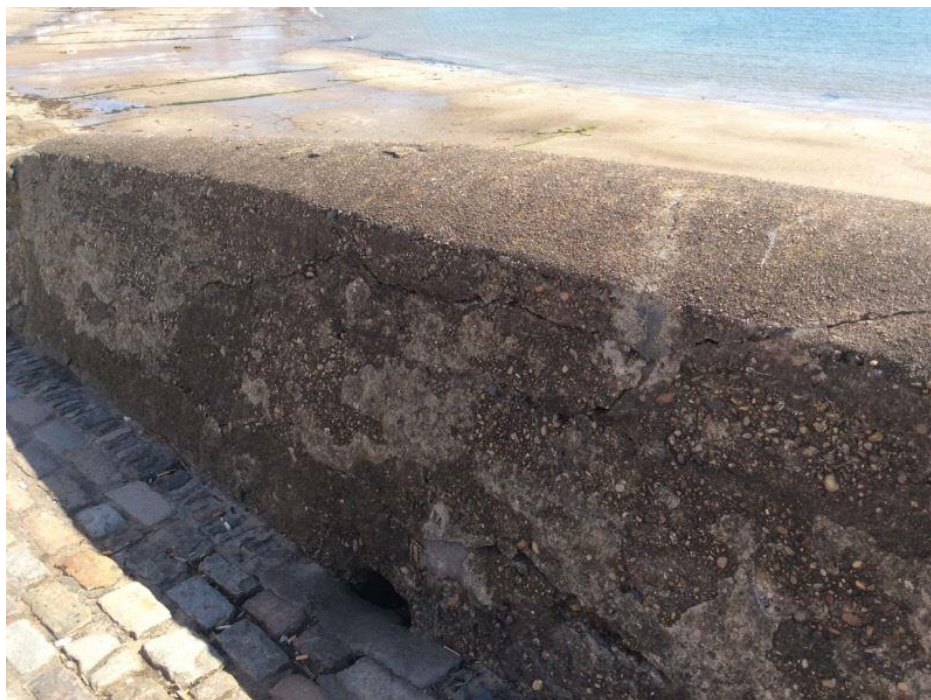
Section C
Capping wall
Defect Ref: D41
Description: D41 -
Large horizontal cracks.
Cracking also visible on
landward side
Photo number: 198

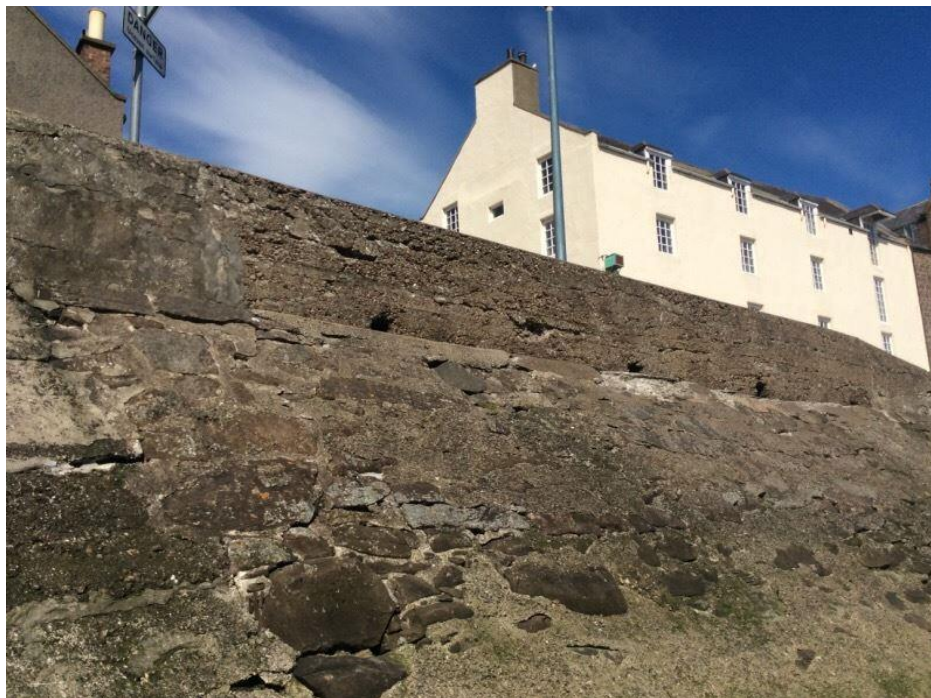
Section C
Capping wall
Defect Ref: D42
Description: D42 -
Spalling and
honeycombing of
concrete approx. 10m
Photo number: 144

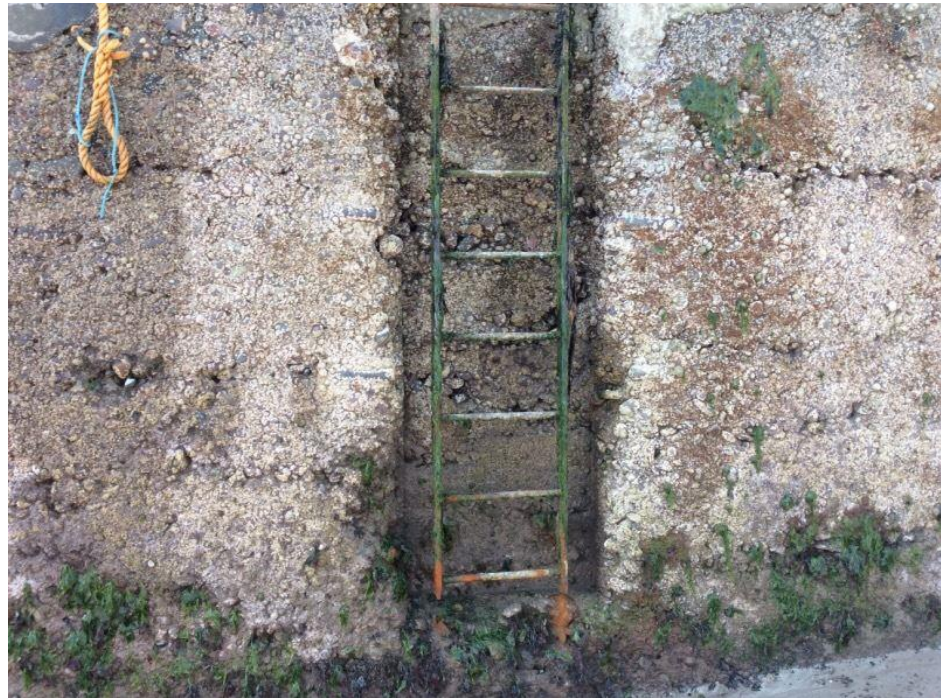
Section D
Quay face
Defect Ref: D43
Description: D43 -
Health and Safety -
Corroded and loose
ladder.
Photo number: 174

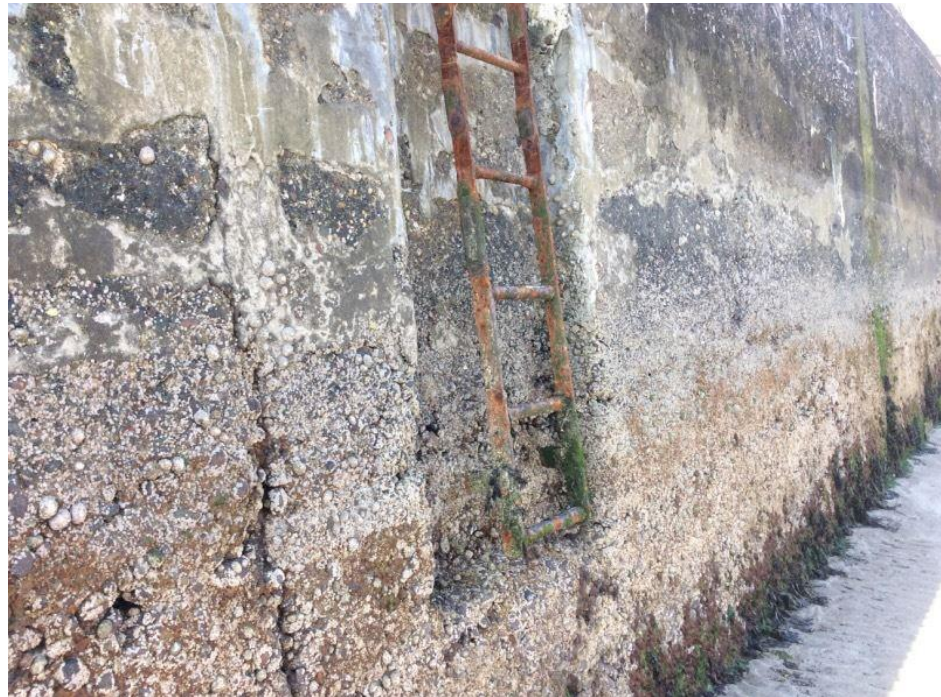
Section D
Quay face
Defect Ref: D43
Description: D43 -
Health and Safety -
Corroded and loose
ladder.
Photo number: 215

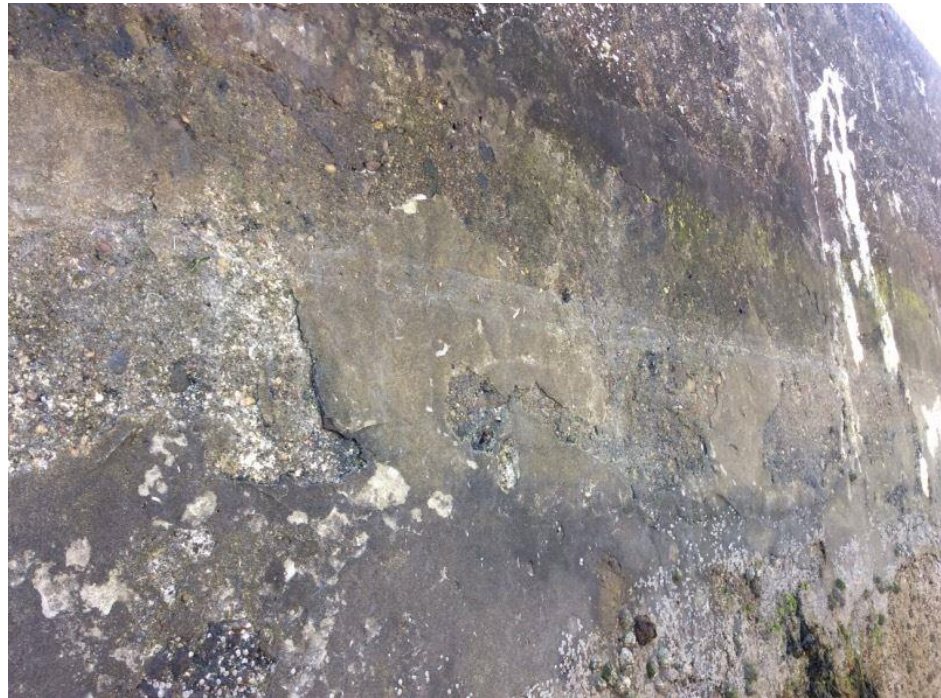
Section D
Quay face
Defect Ref: D44
Description: D44 -
Delaminated surfacing
Photo number: 142

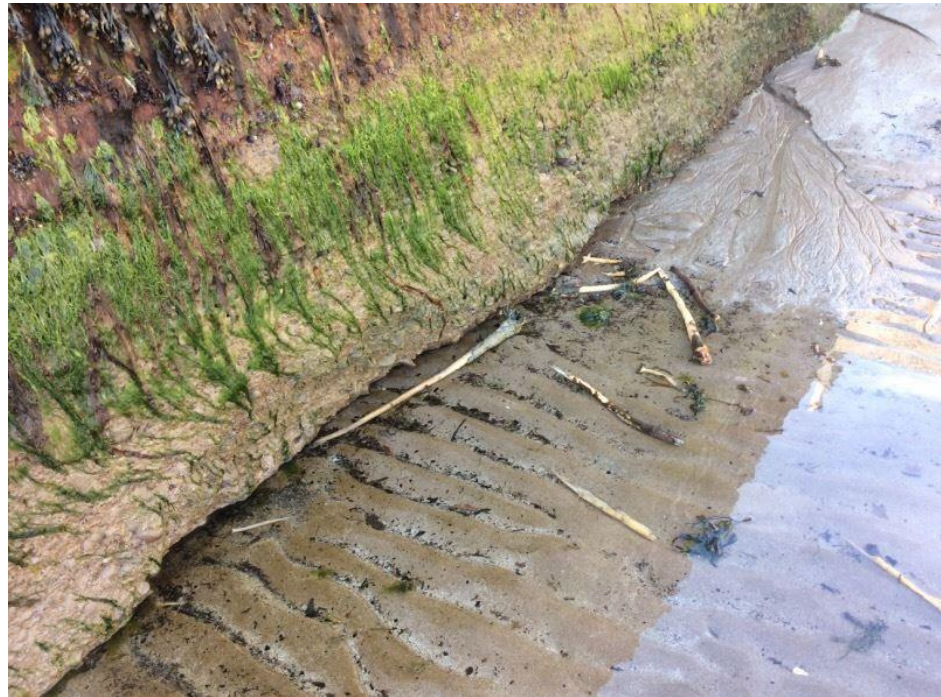
Section D
Quay face
Defect Ref: D45
Description: D45 -
Approximately 1m x 0.3
m scour.
Photo number: 143

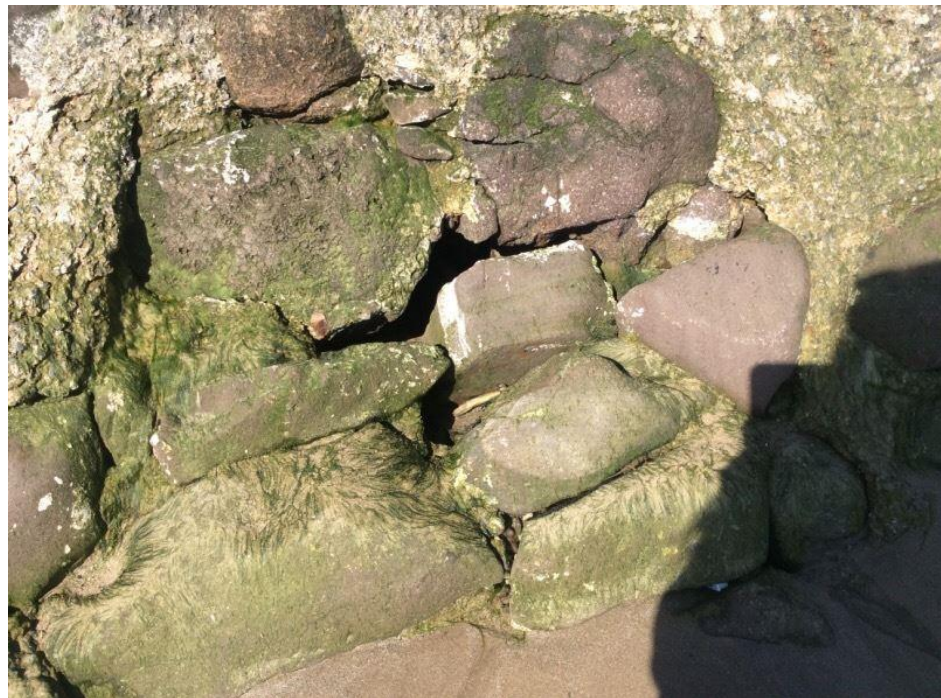
Section C
Exposed face
Defect Ref: D47
Description: D47 -
Voiding behind the
structure. Approximately
1m behind the structure
in 5 locations.
Photo number: 146

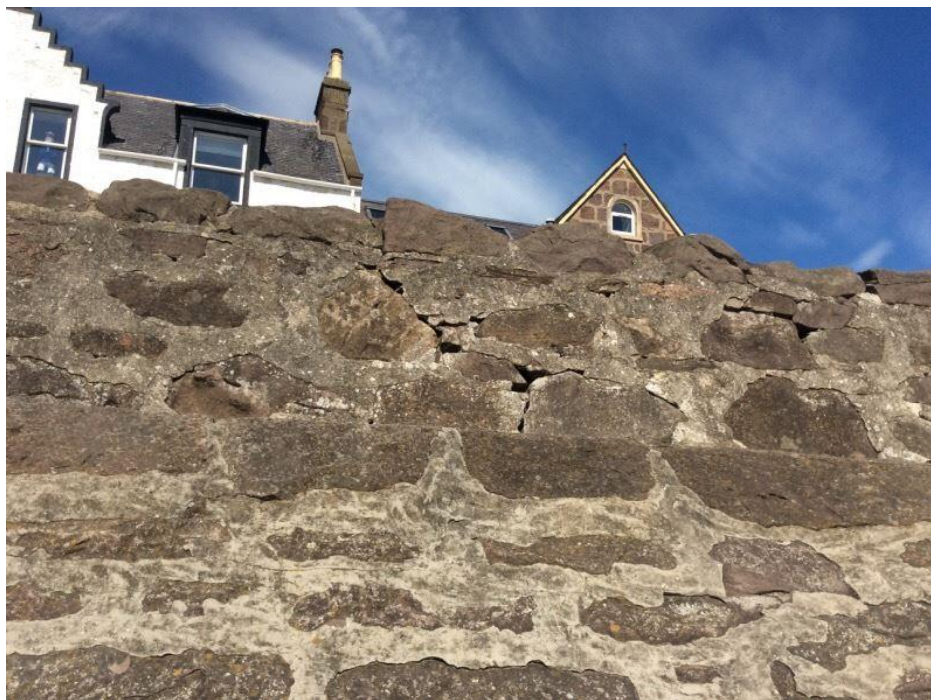
Section C
Capping wall
Defect Ref: D49
Description: D49 - Open joints
Photo number: 148

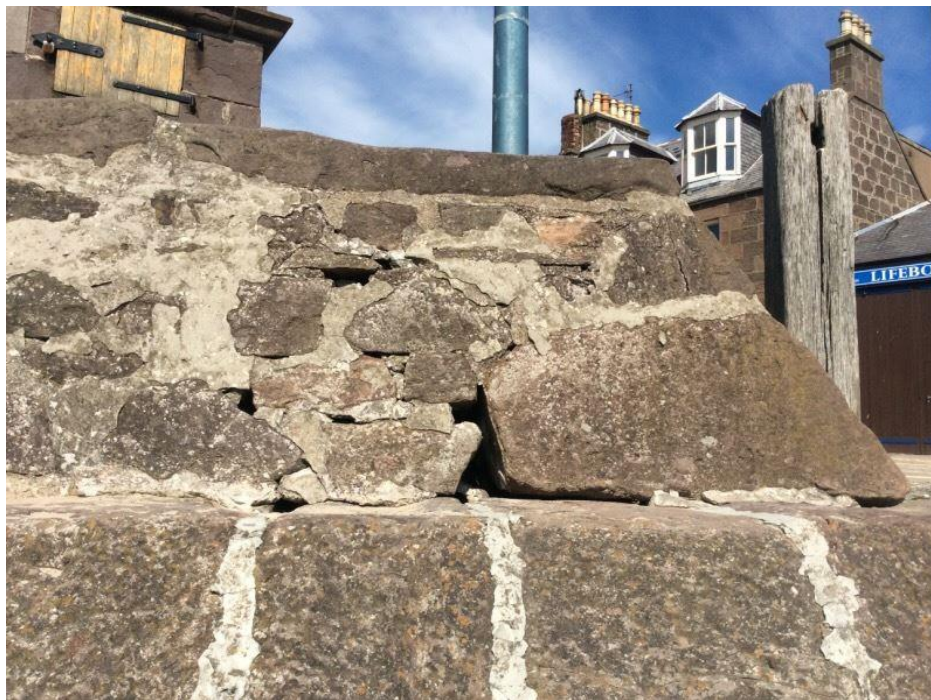
Section C
Capping wall
Defect Ref: D49
Description: D49 - Open joints
Photo number: 202

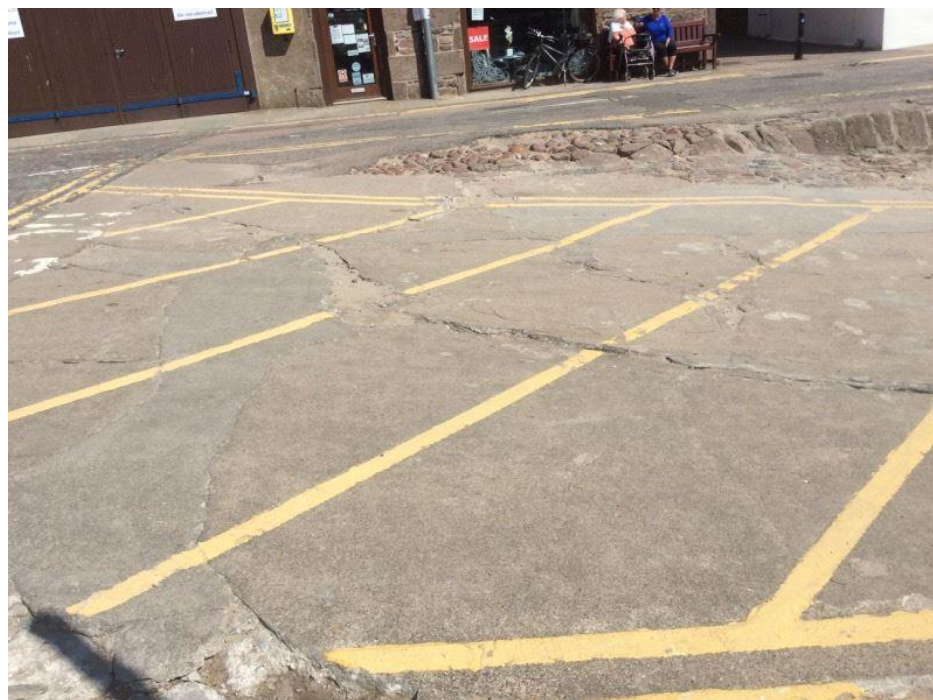
Section E
Access strip
Defect Ref: D50
Description: D50 -
Extensive cracking on
slipway
Photo number: 203

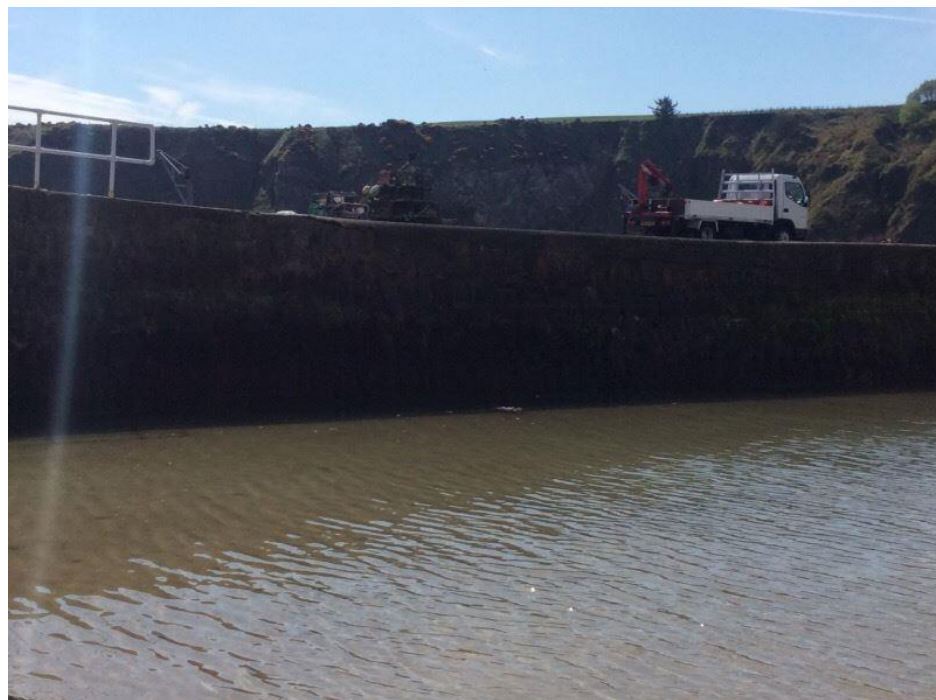
Section F
Quay face
Defect Ref: D53
Description: D53 - Long cracks approximately 3m
Photo number: 152

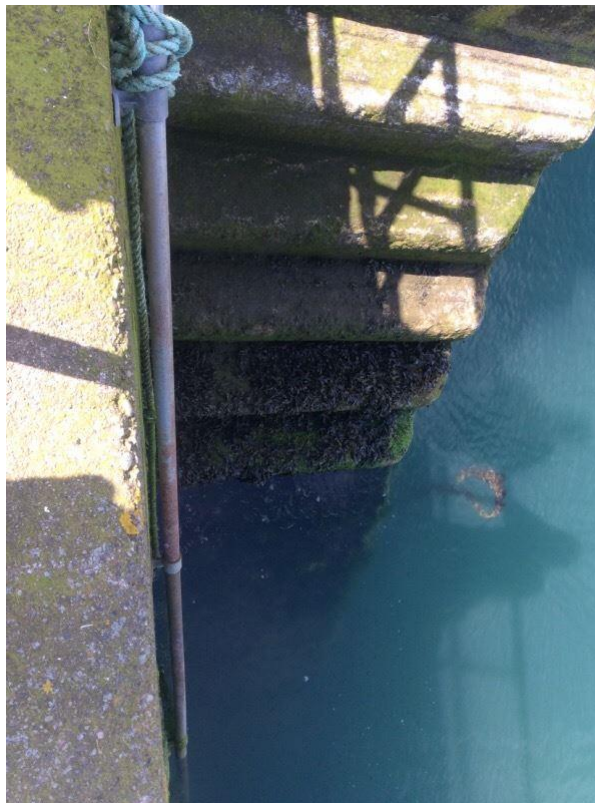
Section F
Quay face
Defect Ref: D57
Description: D57- Algae and seaweed growth on steps. Slipping hazard.
Photo number: 155

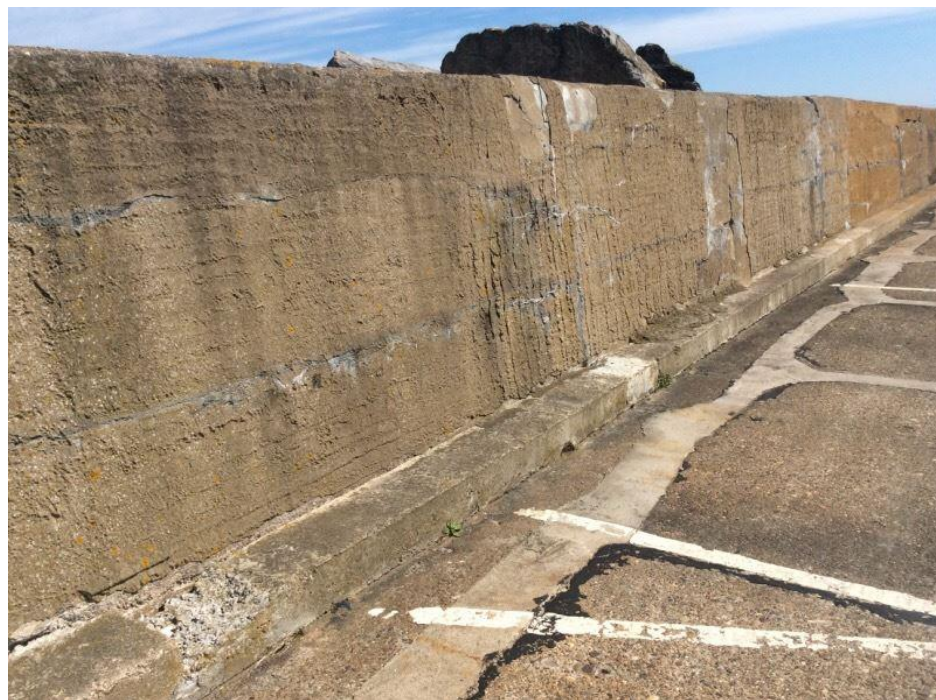
Section G
Capping
Defect Ref: D58
Description: D58 - Delaminating concrete repairs
Photo number: 156

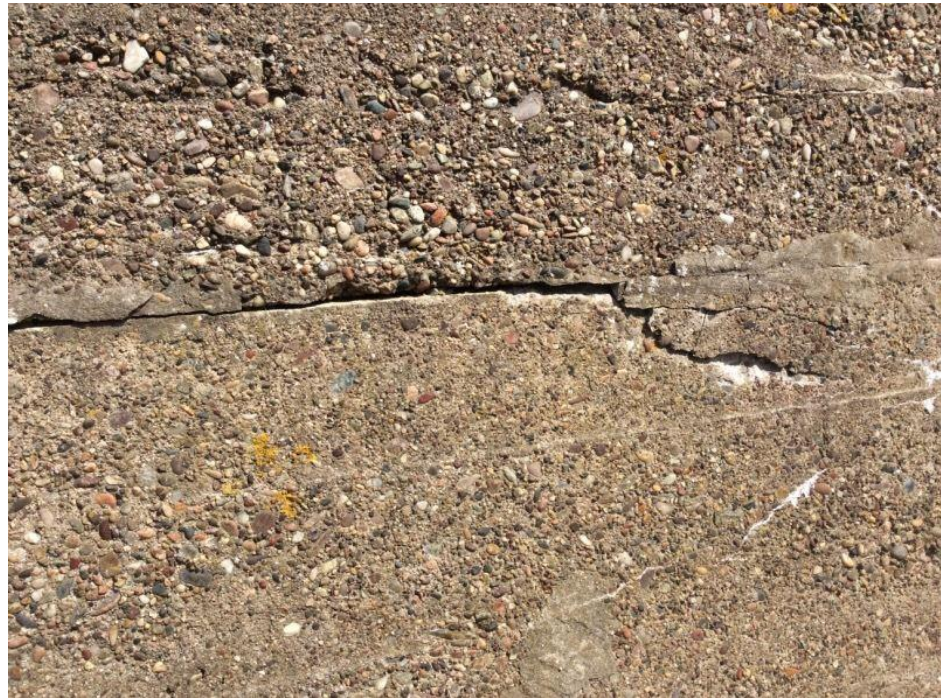
Section G
Capping
Defect Ref: D59
Description: D59 - Open joints
Photo number: 157

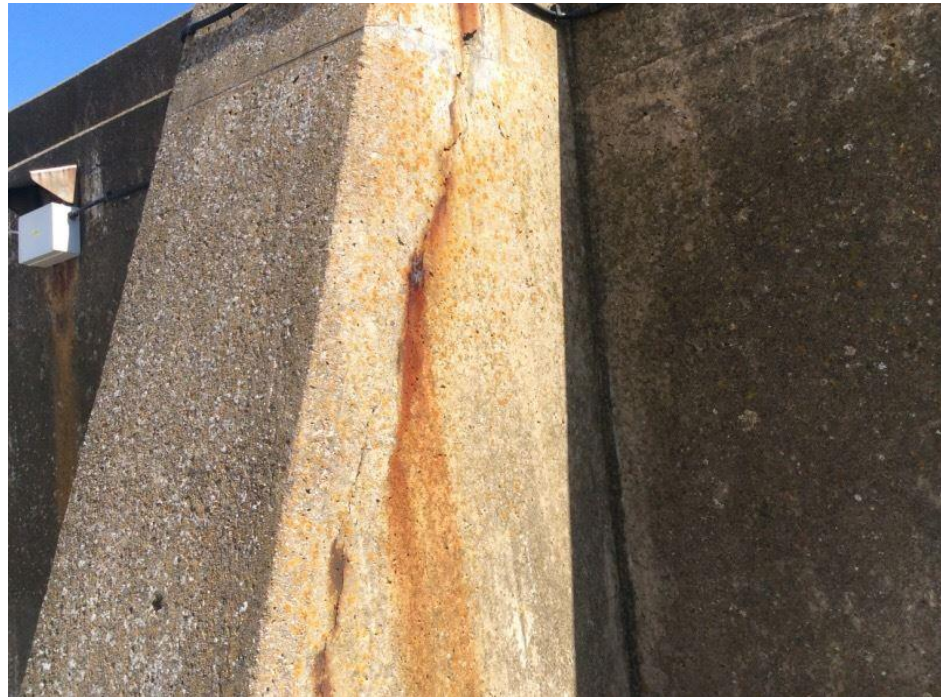
Section G
Seaward face
Defect Ref: D61
Description: D61 -
Stains of corroding
reinforcement.
Photo number: 206

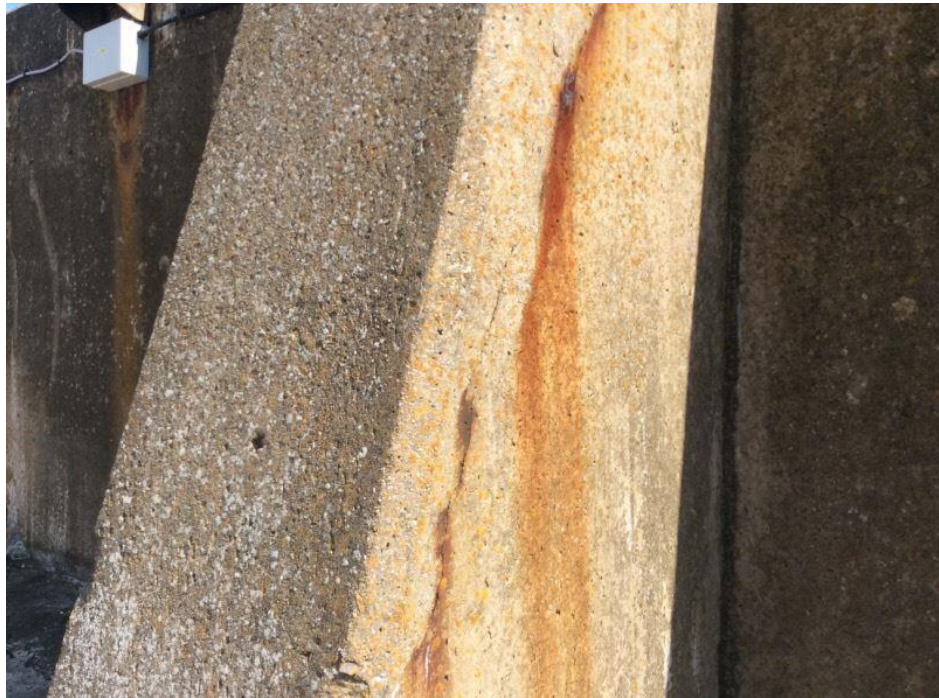
Section G
Seaward face
Defect Ref: D62
Description: D62 -
Cracking of concrete
Photo number: 160
