Location Plan:		Stonehaven harbour Assessment Date: 15/05/2018

Exam Type:	Detailed	
	Complete Survey:	Yes	
	Structure Ref:	1	
	OS Ref:	387867 , 785378	
	Survey Unit:	N/A	
	Governing SMP2:	N/A	
	SMP2 Policy Unit:	N/A	
	SMP2 Policy:	N/A	
<p>NOTE: This document has been prepared as an Asset Condition Survey Report for Aberdeenshire Council. JBA Consulting accepts no responsibility or liability for any use that is made of this document other than by the Client for the purposes for which it was originally commissioned and prepared.</p>

COASTAL ASSET CONDITION SURVEY REPORT

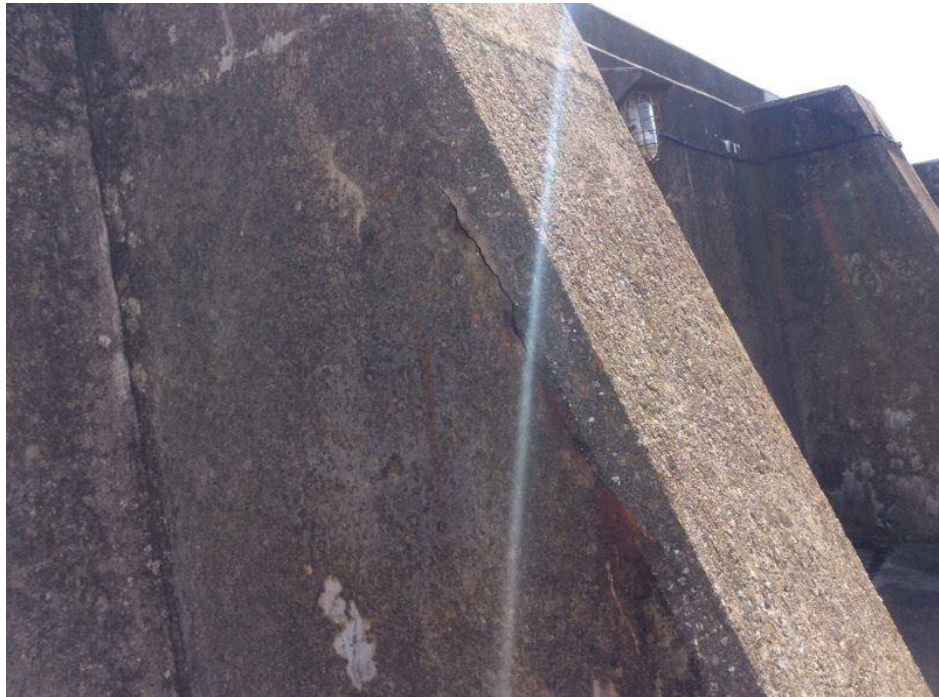
Section G
Seaward face
Defect Ref: D62
Description: D62 -
Cracking of concrete
Photo number: 207

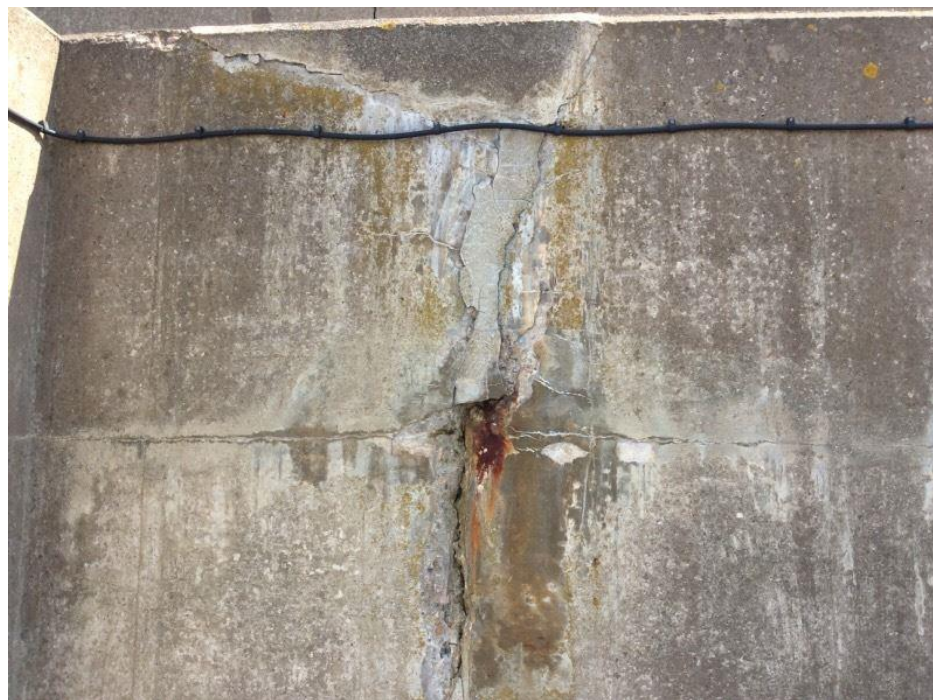
Section G
Seaward face
Defect Ref: D63
Description: D63 -
Cracking of walls.
Repairs coming off.
Photo number: 208

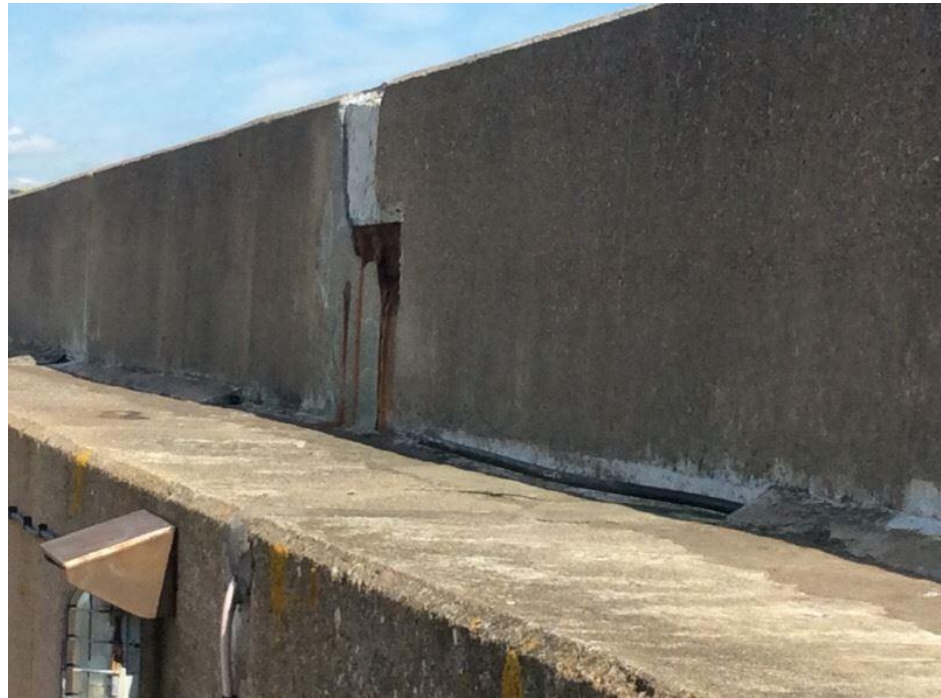
Section G
Seaward face
Defect Ref: D65
Description: D65 -
Exposed steel corroding.
Photo number: 163

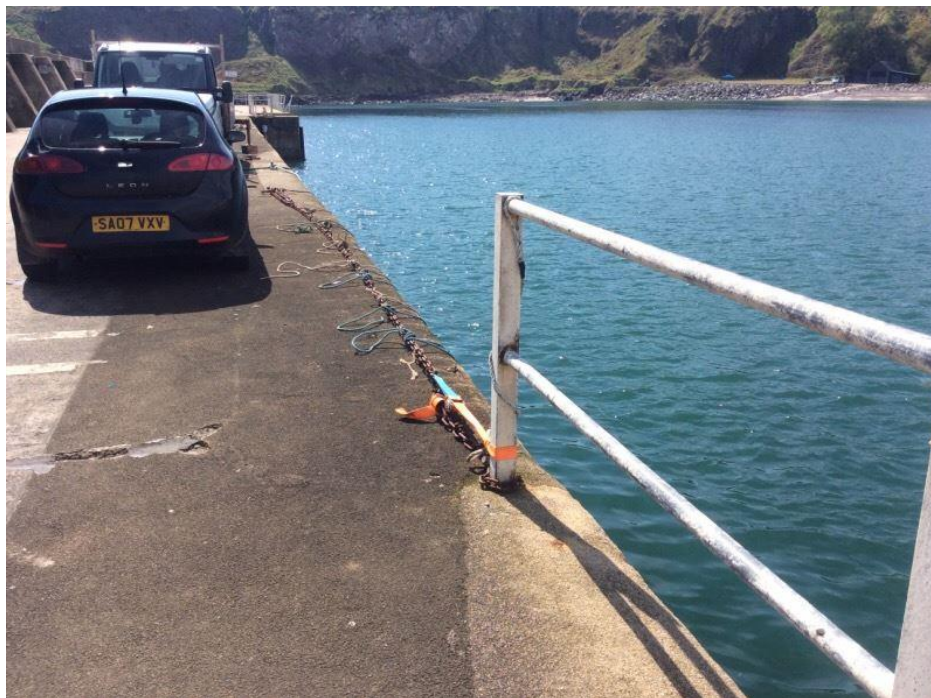
Section G
Deck
Defect Ref: D68
Description: D68 -
Insufficient handrailing
Photo number: 211

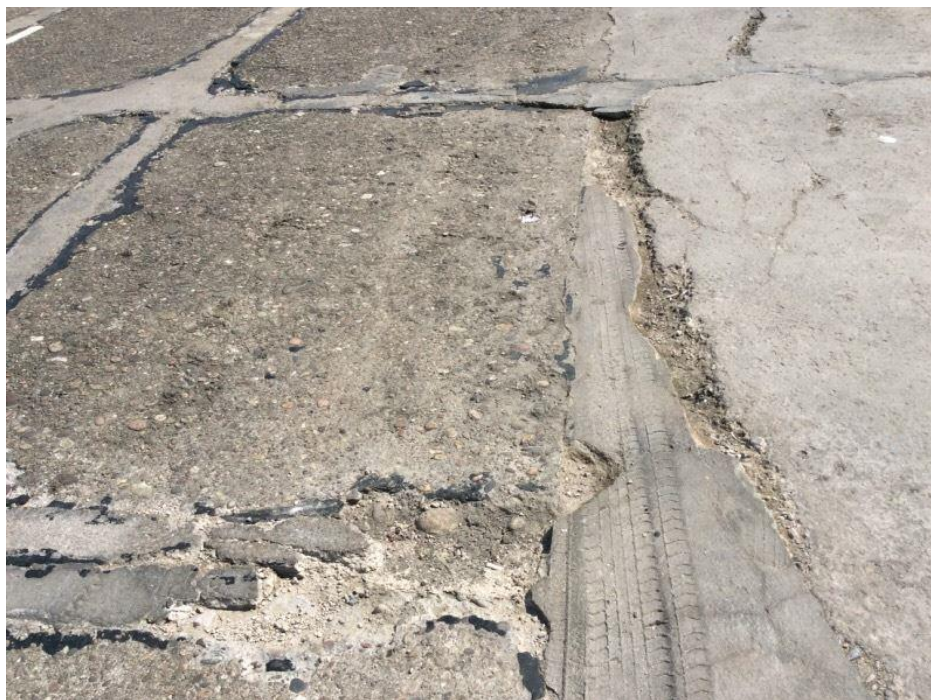
Section G
Deck
Defect Ref: D69
Description: D69 -
Damaged surfacing of
deck
Photo number: 167

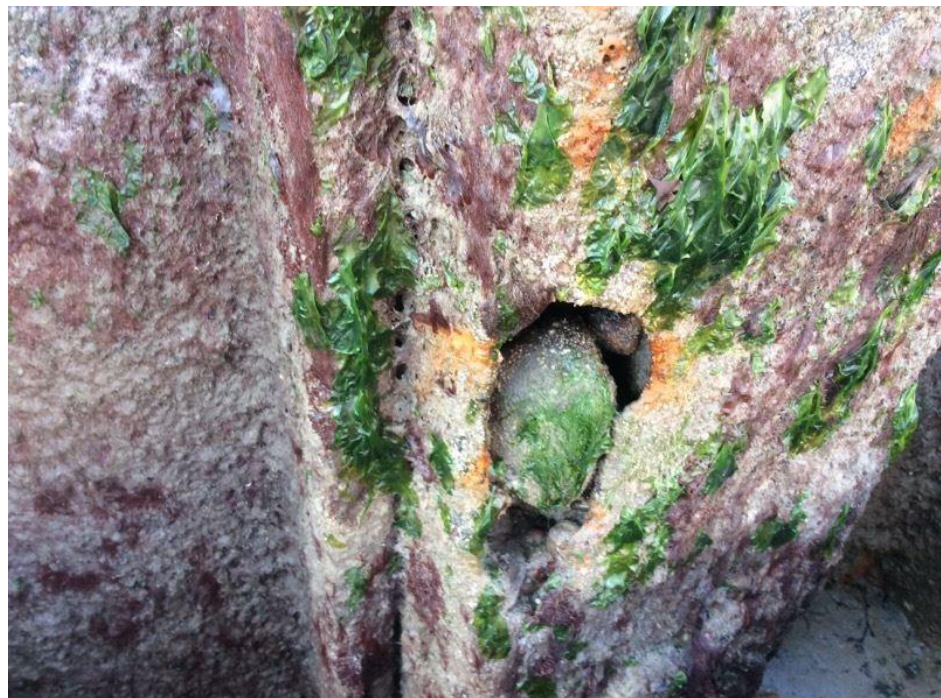
Section D
Sheet piling
Defect Ref: D72
Description: D72 - Two holes in piles, approximately 0.3x0.1m and 0.3x0.3
Photo number: 230

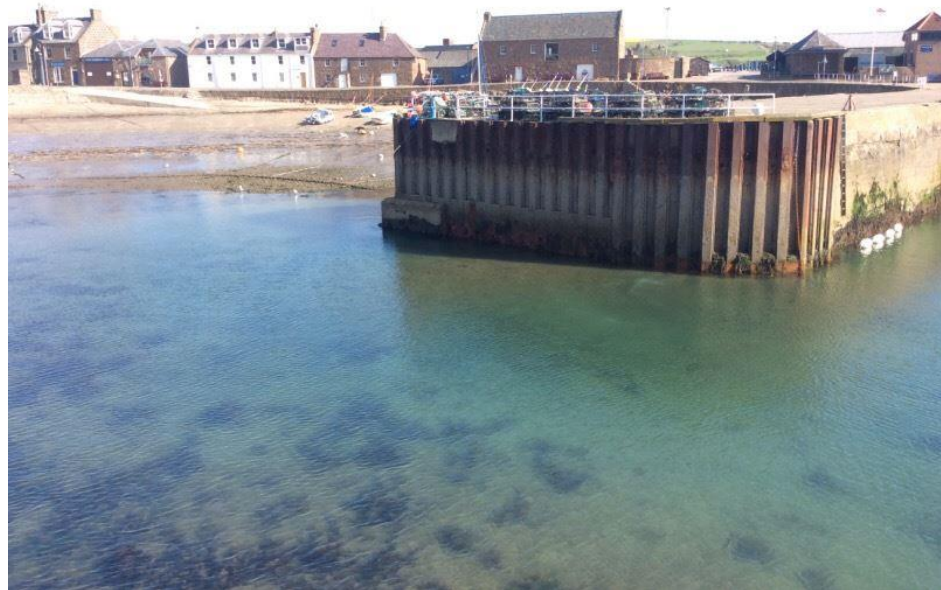
Section F
Sheet piling
Defect Ref: D75
Description: D75 -
Missing anchor plates.
Photo number: 171

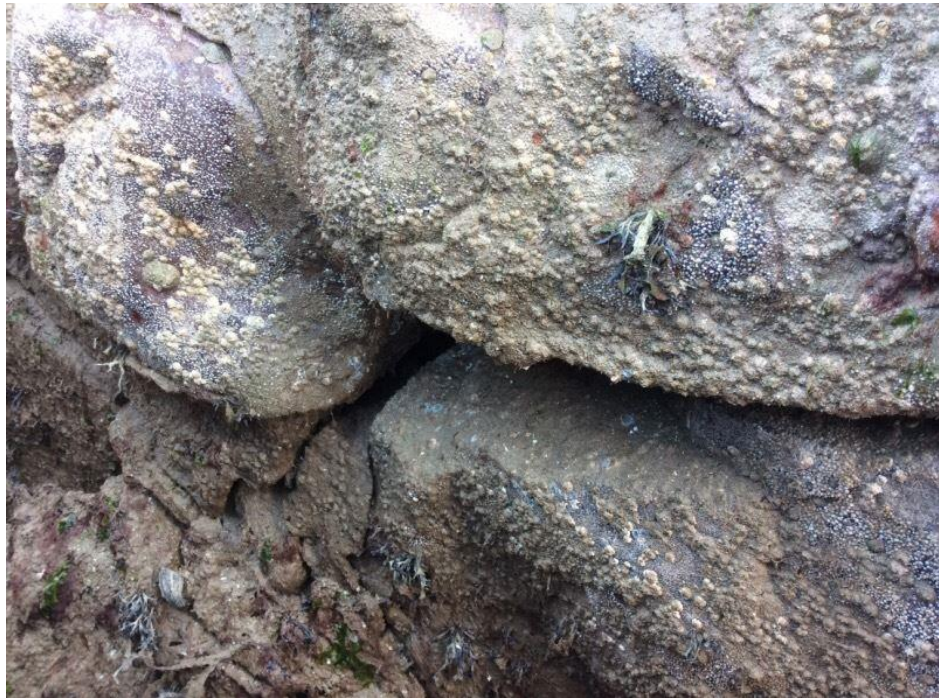
Section F
Quay face
Defect Ref: D78
Description: D78 - Open joints
Photo number: 176

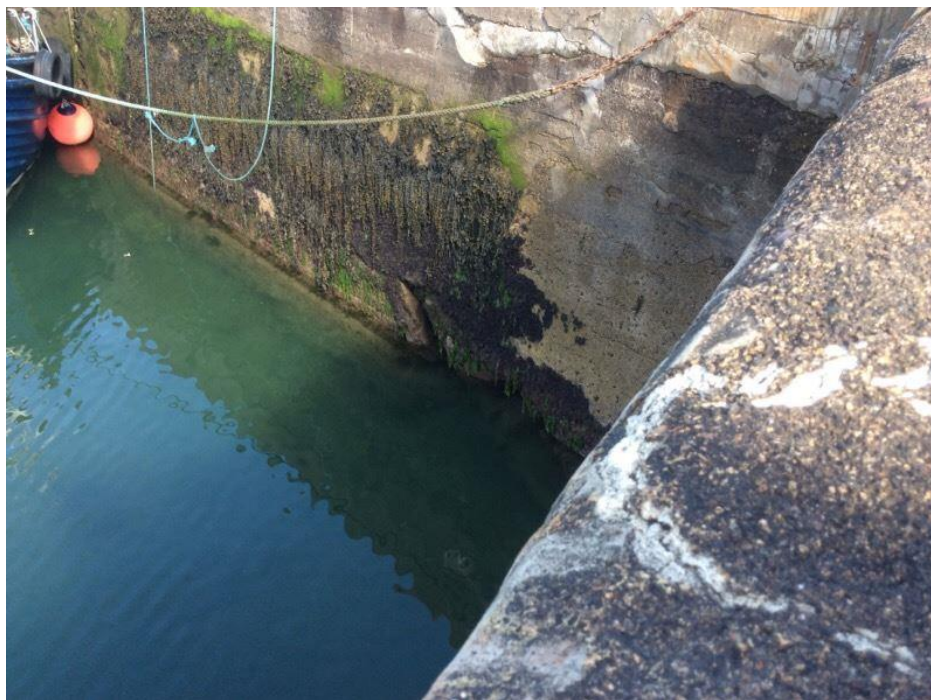
Section G
Quay face
Defect Ref: D83
Description: D83 -
Possible undermining
scour.
Photo number: 181

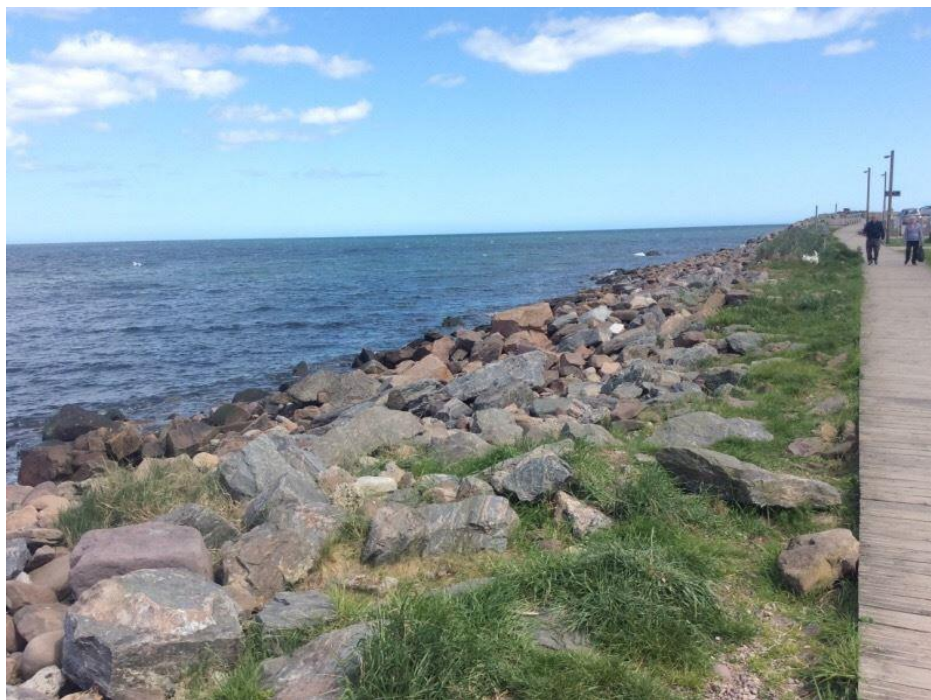
Section H
Rock armour
Defect Ref: D85
Description: D85 -
Undersized rock armour
units
Photo number: 183

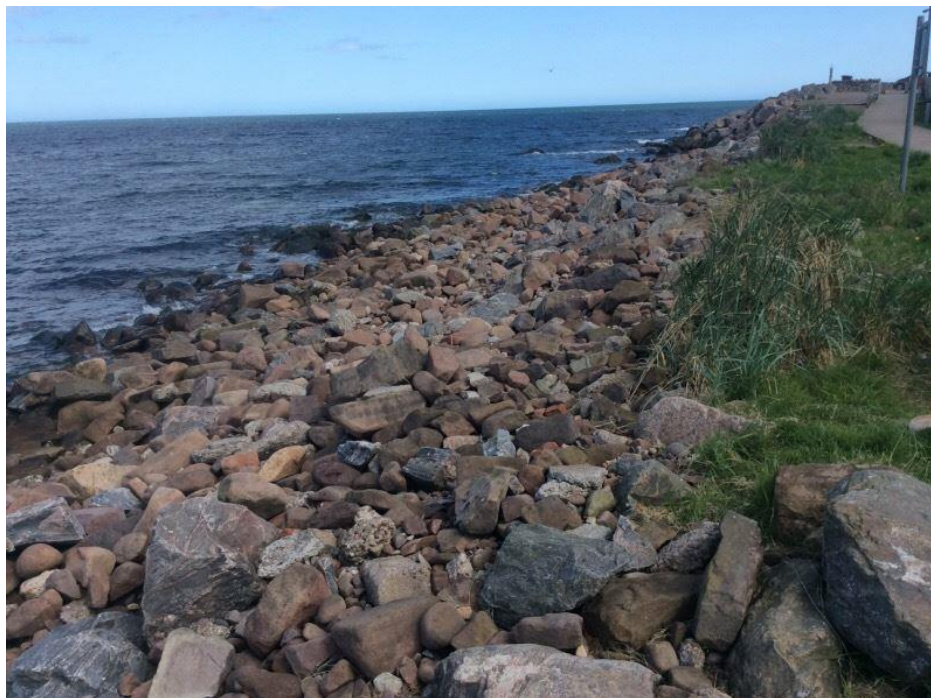
Section H
Rock armour
Defect Ref: D85
Description: D85 -
Undersized rock armour
units
Photo number: 220

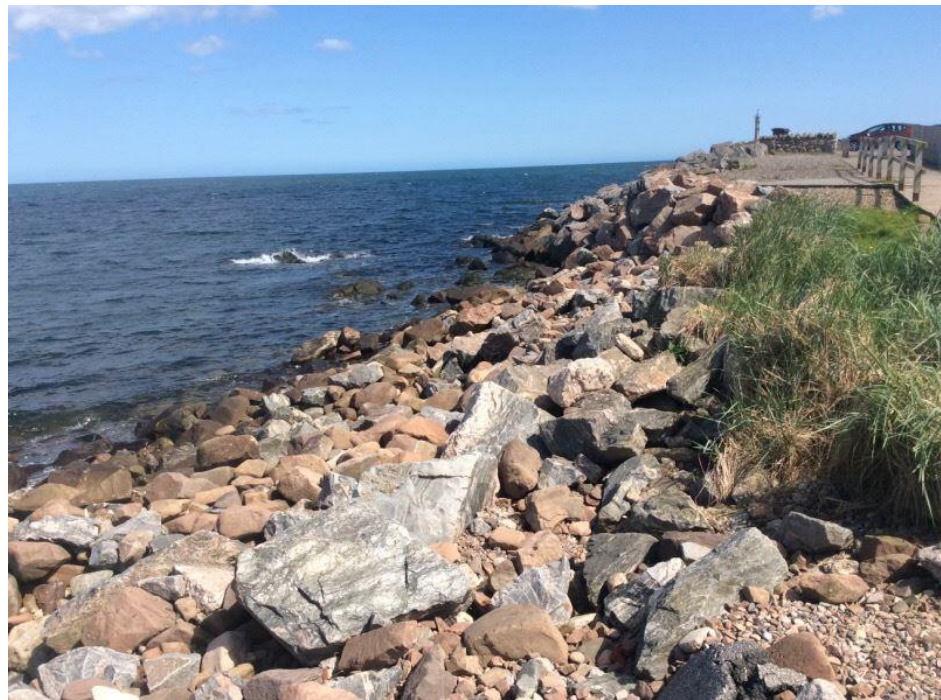
Section H
Rock armour
Defect Ref: D85
Description: D85 -
Undersized rock armour
units
Photo number: 232

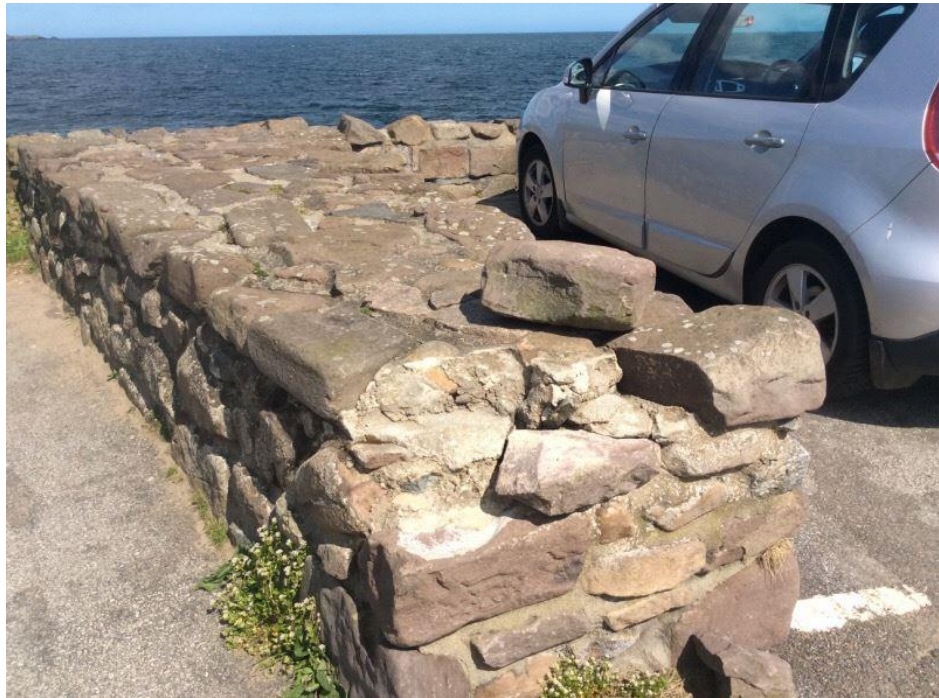
Section H
Splash wall
Defect Ref: D87
Description: D87 -
Blockwork missing
Photo number: 184
